DEPARTMENT OF PUBLIC WORKS

RE: Balch Pond Dam (MA00135) Follow-Up Inspection

Commonwealth of Massachusetts
Department of Conservation and Recreation
Office of Dam Safety Poor and Unsafe Condition Dam Follow-up Inspection Form

Dam Name: Balch Pond Dam

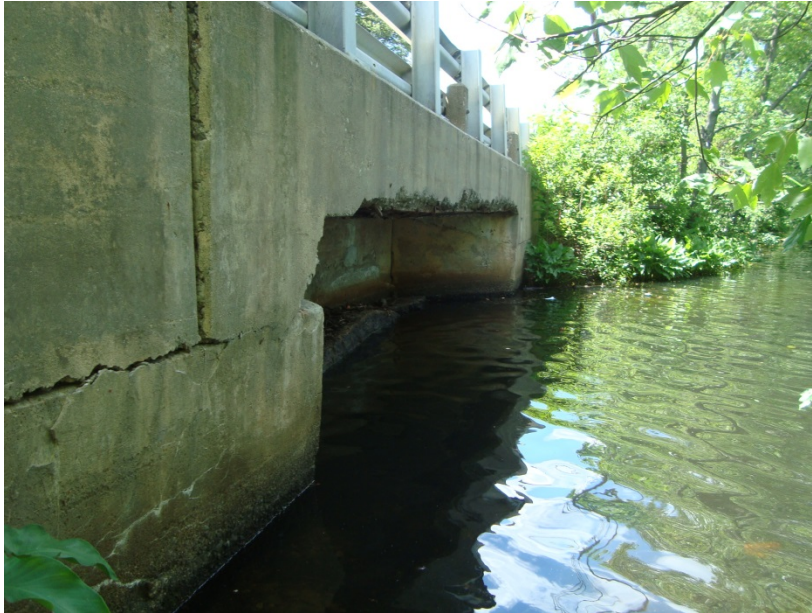
Photo 1:

View of Dam Structure from left side of Dam. Displacement of headwall and exposed reinforcing in similar condition to Phase II inspection.

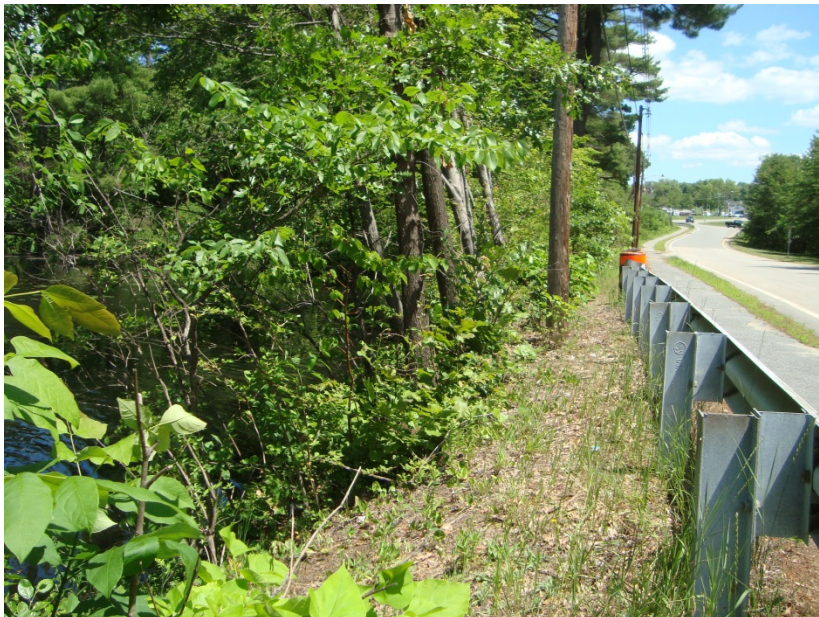
Photo 2:

View of left side of Dam.

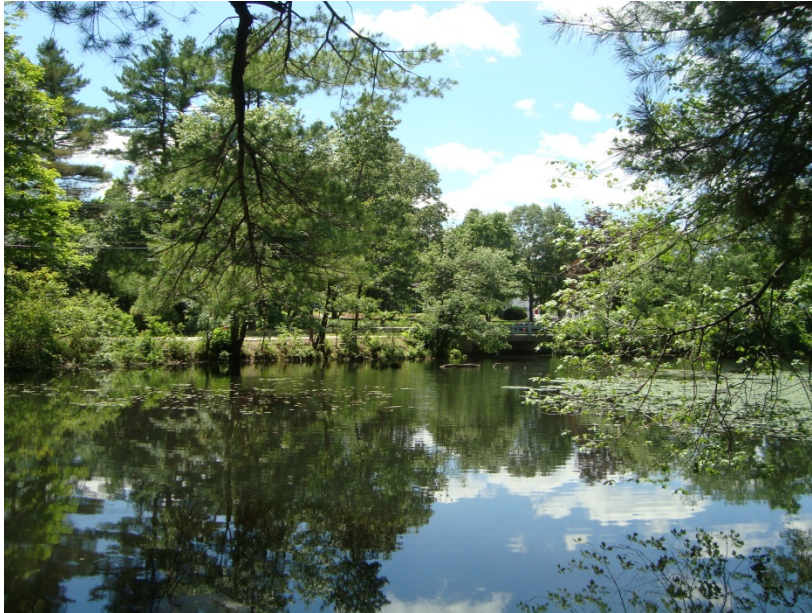
Photo 3:
Overview of the upstream slope from
the Dike.

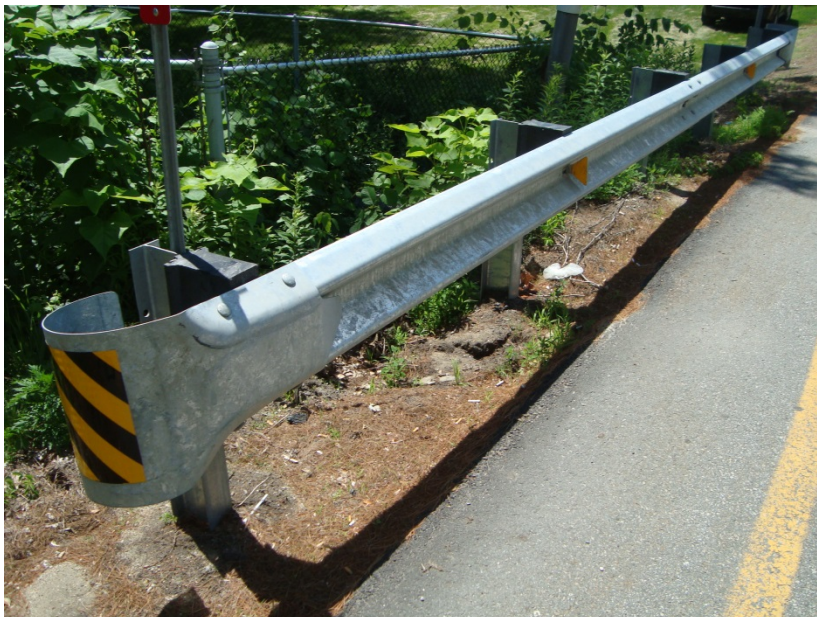
Photo 4:
Downstream slope at crest. Minor
erosion, rotation of downstream
headwall.

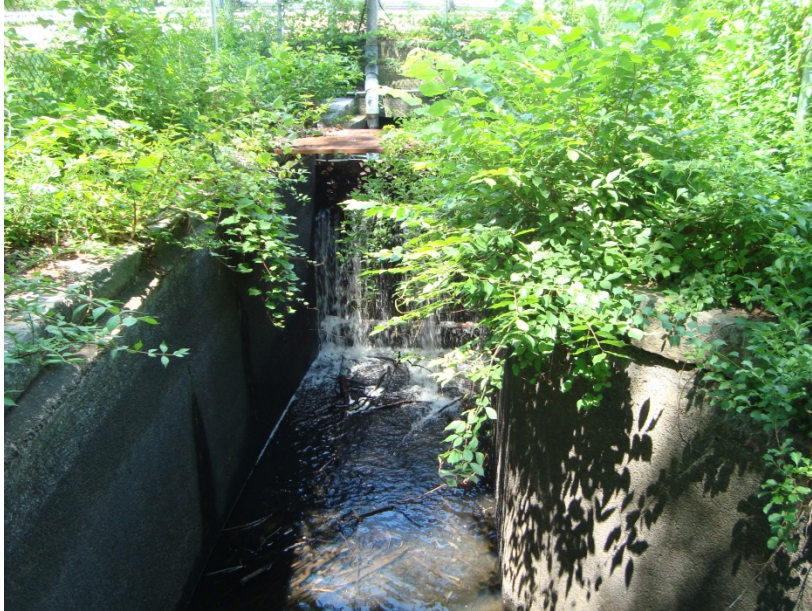
Photo 5:
View of stop logs and spillway from outlet.

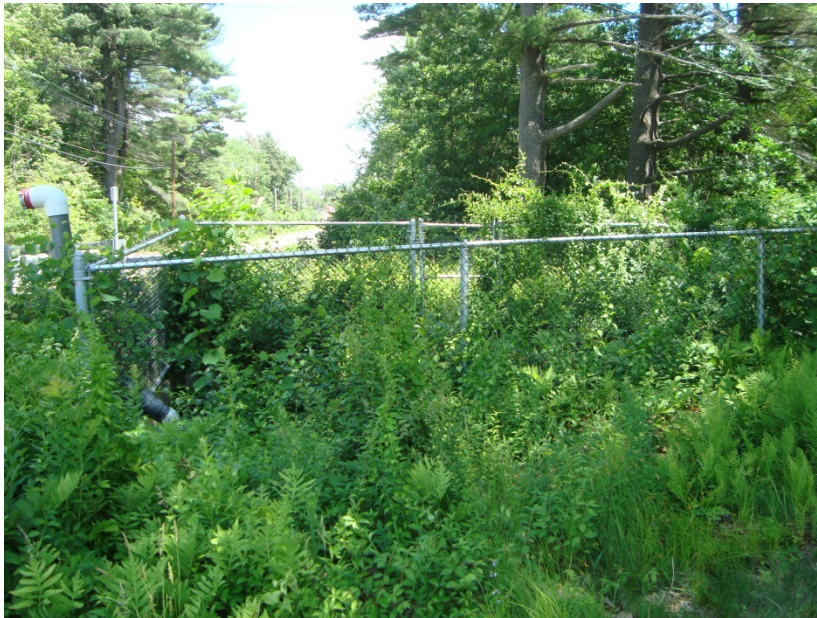
Photo 6:
Vegetation surrounding spillway scheduled to be removed.
