RE: Balch Pond Dike (MA01186) Follow-Up Inspection

Commonwealth of Massachusetts
Department of Conservation and Recreation
Office of Dam Safety Poor and Unsafe Condition Dam Follow-up Inspection Form

Dam Name: Balch Pond Dike
Dam Owner: Under Review
Nat. ID Number: MA01186
Hazard Potential: Significant
Location of Dam (town): Ayer
Coordinate location (lat,long): 42.554075°N / 71.573719°W
Date of Inspection: 06/24/2015
Weather: Clear, 75°F

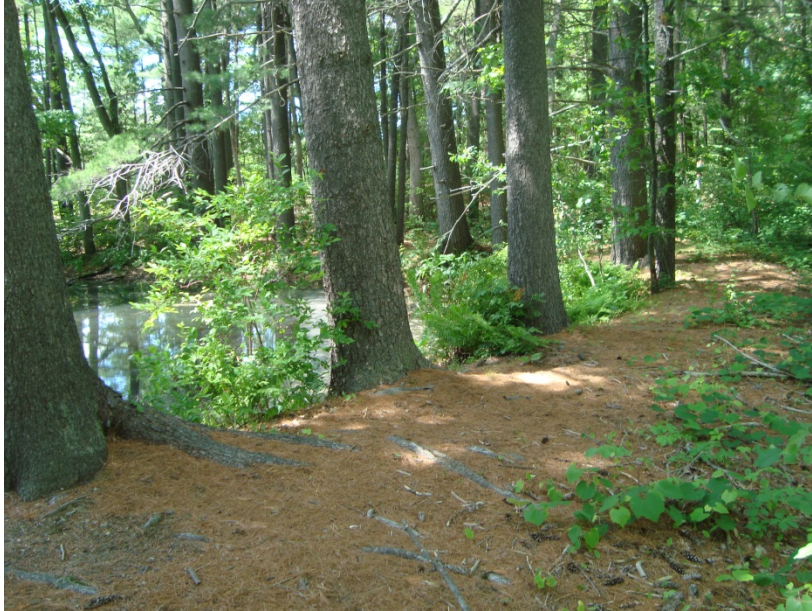
Photo 1:

Leaning trees on upstream slope of dike near Sta. 3+50.

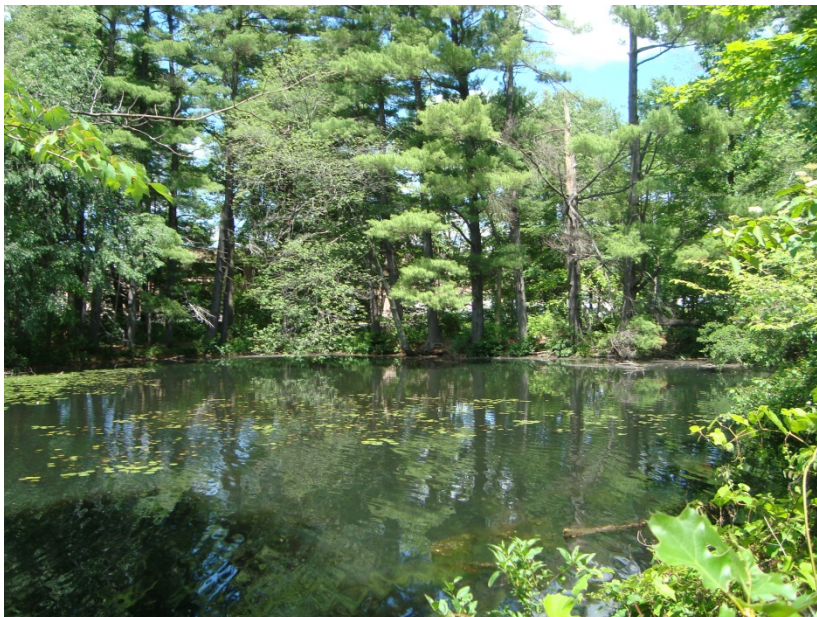
Photo 2:

View of dike from dam headwall, approximately Sta.'s 4+00 to 5+00.

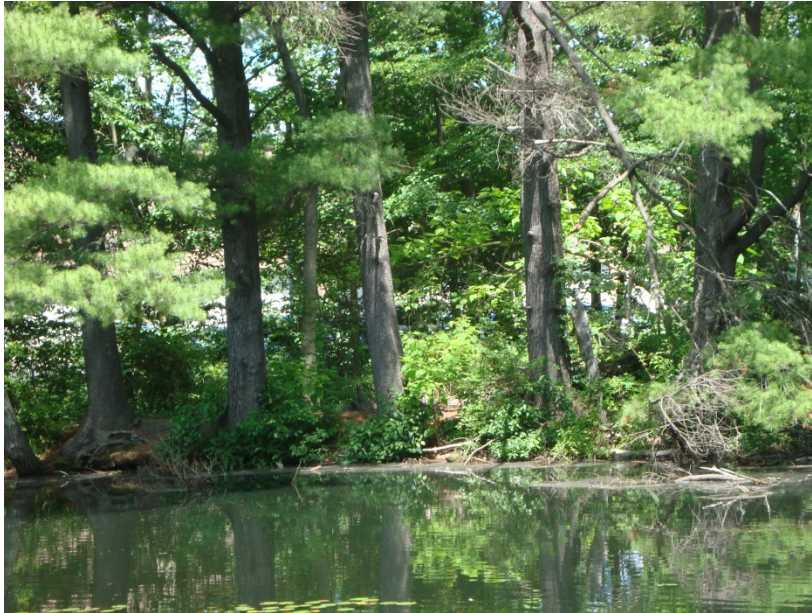
Photo 3:

View of dike from dam headwall.
Dead tree and fallen tree near Sta.
4+50.

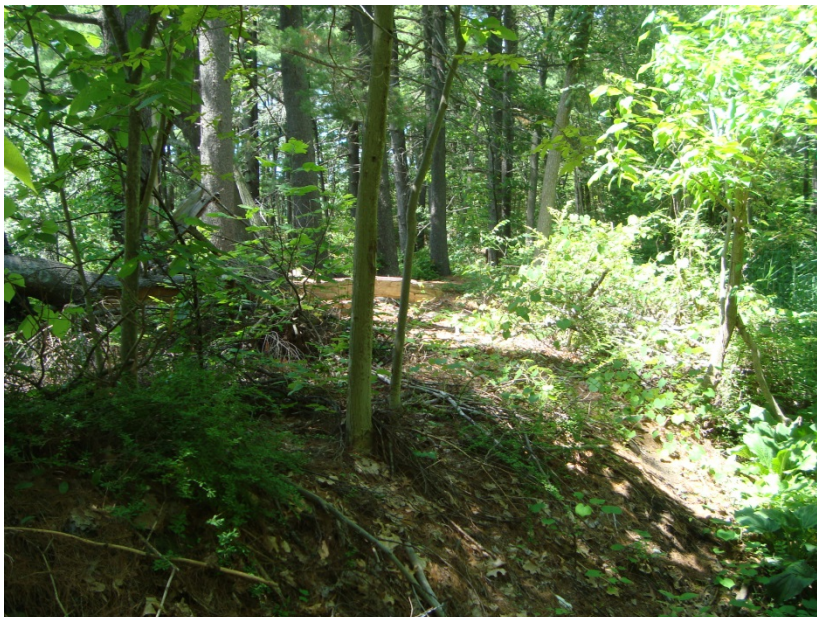
Photo 4:

Fallen tree and heavy vegetation
near Sta. 4+50.
