CENTRAL FIRE STATION BUILDING ASSESSMENT

14 WASHINGTON STREET, AYER, MA
JUNE 20, 2012

CENTRAL FIRE STATION
BUILDING ASSESSMENT
JUNE 20, 2012

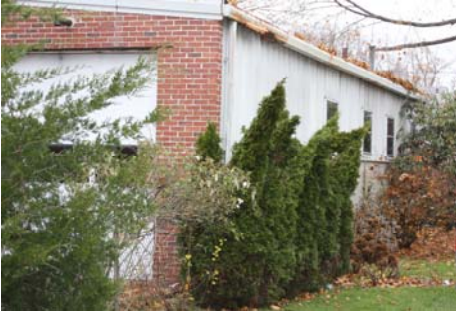
Figure 6: Addition up against northerly property line..

The 1970's addition is less visible from the street, but its design is equally uninspiring. It is located uncomfortably close to the north property line. (See Figure 6.) It blocks all natural light to the original apparatus bays, the space with the most potential for re-use. Similar to the 1996 addition, it was built as an inexpensive utilitarian solution to a space problem. The initial cost investment to erect a prefabricated

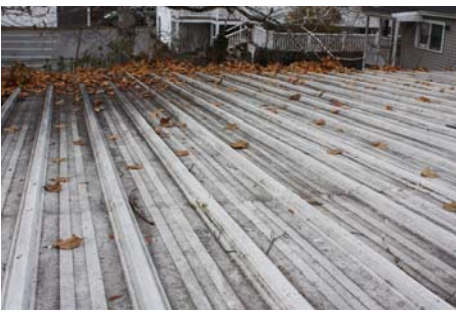
Figure 7: Metal roof needs repair or replacement.

steel buildings is relatively low, but its long term durability is poor, particularly in the absence of regular maintenance. The steel roof and siding are rusted and worn. (See Figure 7.) There is minimal insulation and no interior finishes. The cost to make needed repairs and improvements would be quite high and the quality of the improved space would still be less than ideal.

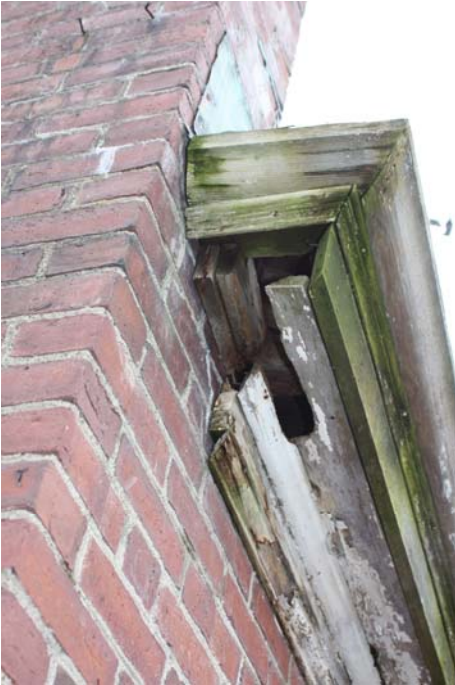
As can be expected, the wood is in the worst condition. Window sashes have already been replaced with vinyl replacement windows, but original wood window frames, sills, casings, and cornice trims are still in place and in various stages of deterioration. Paint is extensively peeling on all components, leaving the

Figure 9: Rotted wood cornice.

wood unprotected and exposed to the elements. Cornice moldings are in poor condition and complete replacement is recommended. (See Figure 9.) New custom moldings, to match existing profiles, can be milled from polyvinyl chloride (PVC) or cedar or molded in high density polyurethane, to provide improved durability.

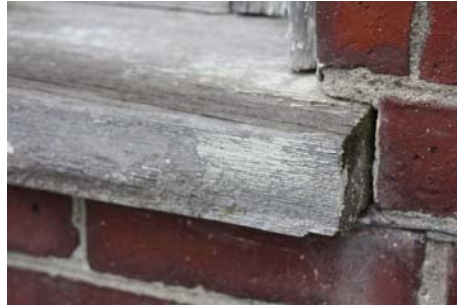
Figure 10: Window sill horns.

Complete removal of window components down to existing masonry openings is recommended. Existing window sills have horns that extend into the surrounding brick. (See Figure 10.) These should be replaced with a non-wood material. Cast stone sills would be durable and a good match to the parapet copings. To replace the vinyl windows, new aluminum clad wood units are recommended to provide a maintenance-free exterior and a historical appearance. Some of the more elaborate wood casings, such as the arched door pediments on the north and south sides, should be carefully restored or replicated in either PVC, polyurethane, or cedar. (See Figure 11.)

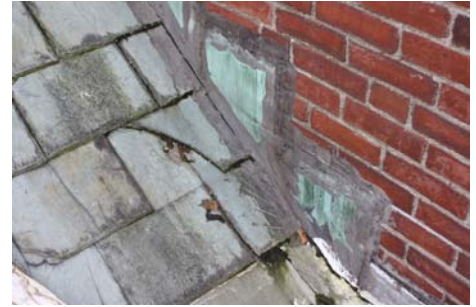
Figure 15: Broken slate and flashing repairs.

Copper roofing and flashing are in poor condition. There is evidence of attempts to repair flashing with bituminous coatings and sealants. (See Figure 15.) Only a stop-gap measure, these repairs, that have irreversibly compromised the surface of the copper, suggest that leaks have become a problem. Water damage to interior finishes confirm this deduction.

Selective replacement of copper roofing and flashing should be avoided in favor of complete replacement. Leaks through the roof are more often than not, attributable to failures in the flashing that protects the joints between dissimilar exterior materials. And once a leak has developed, it is very difficult to definitively trace its source, as water migrates very easily and quickly. Also, the copper is all the same age and if one area has failed, similar deterioration can be anticipated to quickly follow in other locations. Flashing should be considered an integrated system that protects against water intrusion and, as such, should be replaced in its

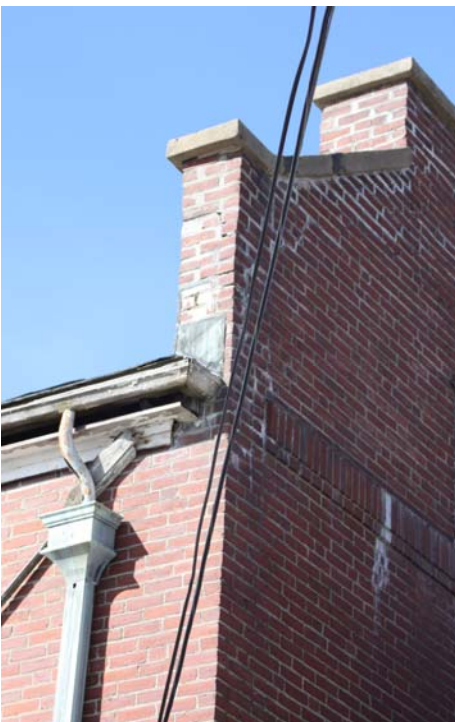
Luckily, there is no evidence of serious structural damage to the exterior brick walls. But the unsupported height of the parapet walls are concerning. (See Figure 12.) Some stepped hairline cracks on the interior of the second floor south gable end wall suggest some structural movement. (See Figure 13.) To prevent serious failure, the parapet walls should be taken down to the eave line and re-built with steel reinforcing.

Figure 12: Tall parapet walls.

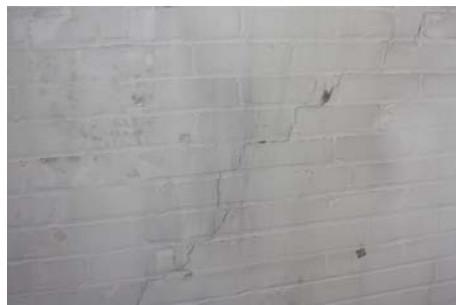
Figure 13: Crack in gable end wall.

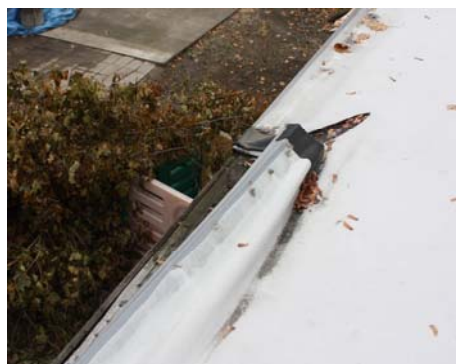
The existing EPDM (rubber) roofing on the flat roof area over the 1960's addition is very poorly installed and actively leaking along its westerly edge. (See Figure 14.) With the demolition of the 1996 addition, an additional flat roof area will be created along the south side of the original garage. New EPDM is recom-

Figure 14: Damaged EPDM.

mended for both these roof areas. Re-roofing will provide the opportunity to add much needed insulation and to properly pitch the roofs to new drains.

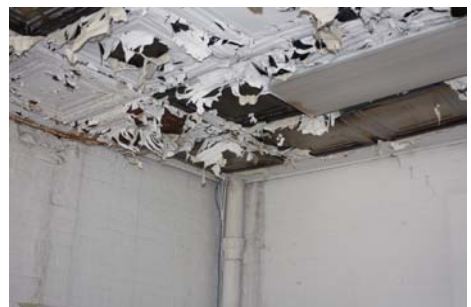
Figure 16: Peeling paint on tin ceilings.

The existing plaster and tin ceilings are installed at the bottom of the wood framing, providing no space for modern building needs, such as ductwork, electrical conduits, and recessed lights. As such, new finished ceilings are recommended throughout. Acoustical tiles are an inexpensive choice that provide sound attenuation and easy access to building systems components above the ceilings. Acoustical tiles that simulate the appearance of tin ceilings are an option if desired.

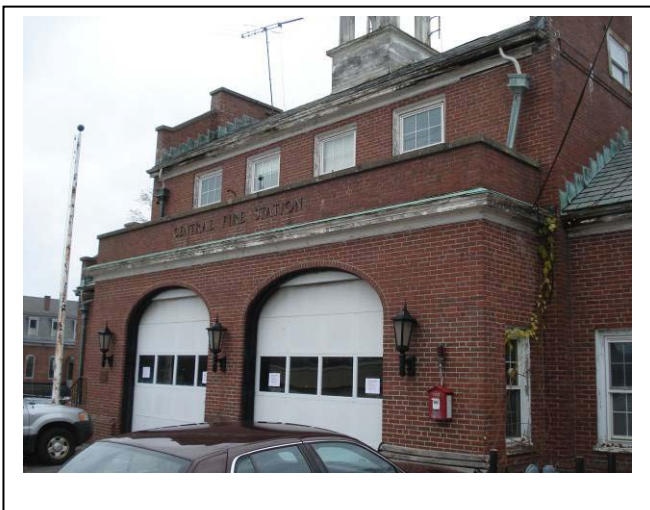
Flat roof over doors does not drain properly.

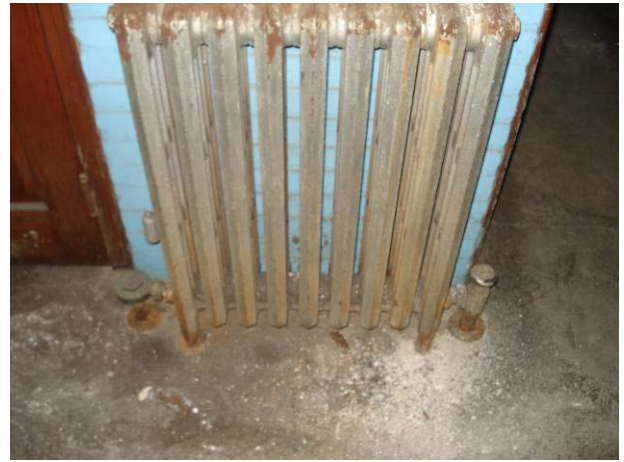
The building was originally heated by a wet return steam system. The system was incompletely (improperly) made into a dry return system at some time in the past. The lack of pipe insulation Indicates asbestos abatement may have occurred (without re-insulating steam or return piping).

Radiator Piped as a Dry Return

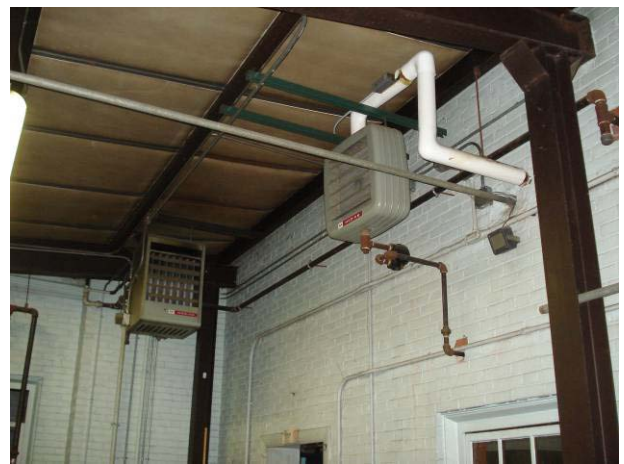
Gas Unit Heater & Steam Unit Heater together – why?

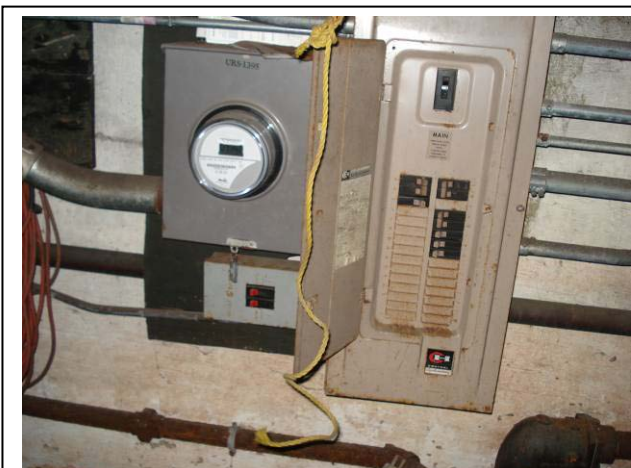
Assuming the new building use will require an elevator, the size of the current electrical service is inadequate. A three phase service will be required. There is three phase power on the utility pole nearest the building.

240/120/Single Phase Electrical Service

Due to the age, condition and specific fire station design of the electrical system, plus the fact a single phase generator cannot be easily adapted to a three phase building, we recommend the entire electrical system be replaced.
