**ANNUAL LANDFILL INSPECTION**  
**Shepley's Hill Landfill**  
**Devens, Massachusetts**

**Date of Inspection:** 4 October 2013  
**Inspector/Company:** Thomas Hevner, LSP, P.E. / Jonathan Chaffee of Sovereign Consulting Inc.  
**Site Location:** Shepley's Hill Landfill, Devens, Massachusetts

**Shepley's Hill Landfill  
Annual Inspection  
September 2013**

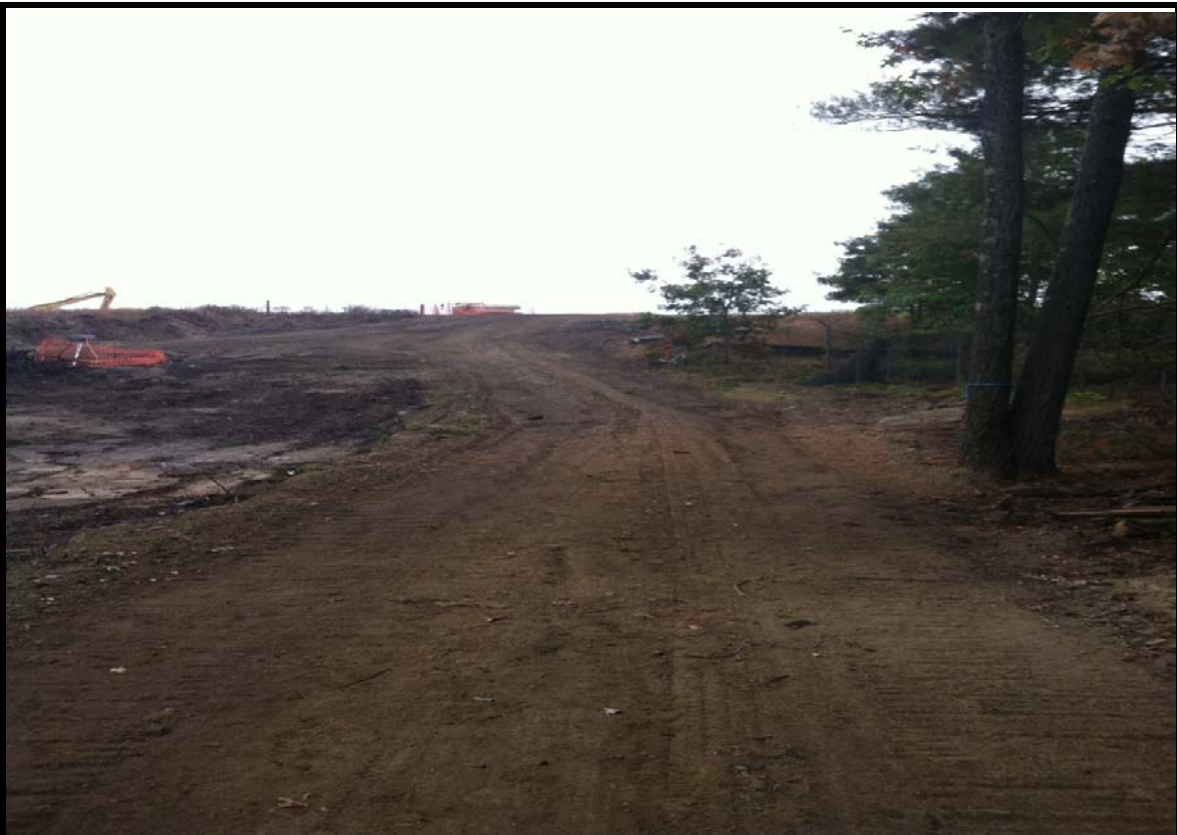
1. Overall, there was no erosion observed. However, due to Plow Shop Pond (Red Cove) construction activities, minimal erosion was observed due removal of vegetative growth in the vicinity of monitoring well SHL-4.	Upon completion of Red Cove construction activities, reseed slope and allow for vegetative growth to fill in preventing further erosion of the slope.	<input type="checkbox"/>	<input checked="" type="checkbox"/>
<b>Access Roads</b>

Description - Erosion of Eastern Slope during Plow Shop Pond Construction Activities

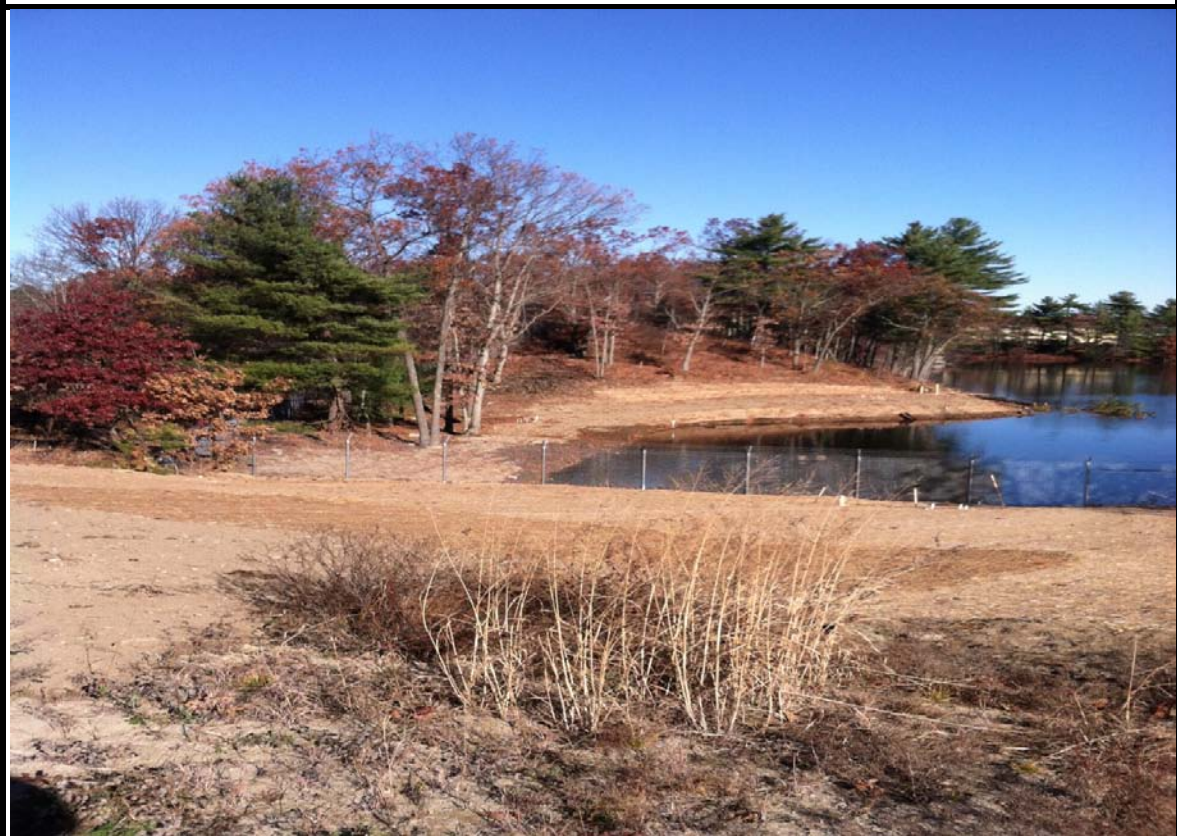
Description - Site Restoration of Eastern Slope and Fencing Following Plow Shop Pond Construction Activities

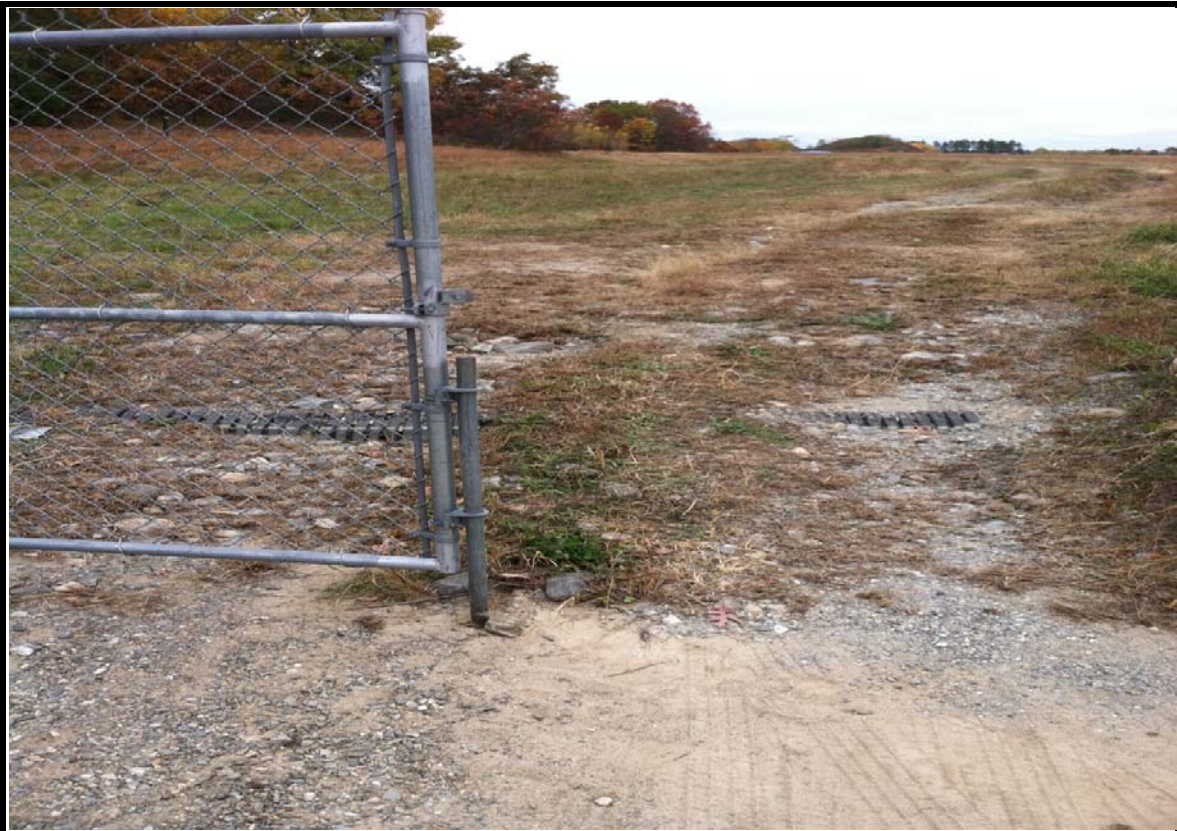
1. Erosion of the access road at the northern end of the landfill was observed. Erosion is assumed to be the result of a heavy precipitation event.	Make necessary repairs to the northern end of the access road to prevent continued erosion during heavy precipitation events.	<input type="checkbox"/>	<input checked="" type="checkbox"/>

Description - Northern Access Road Erosion

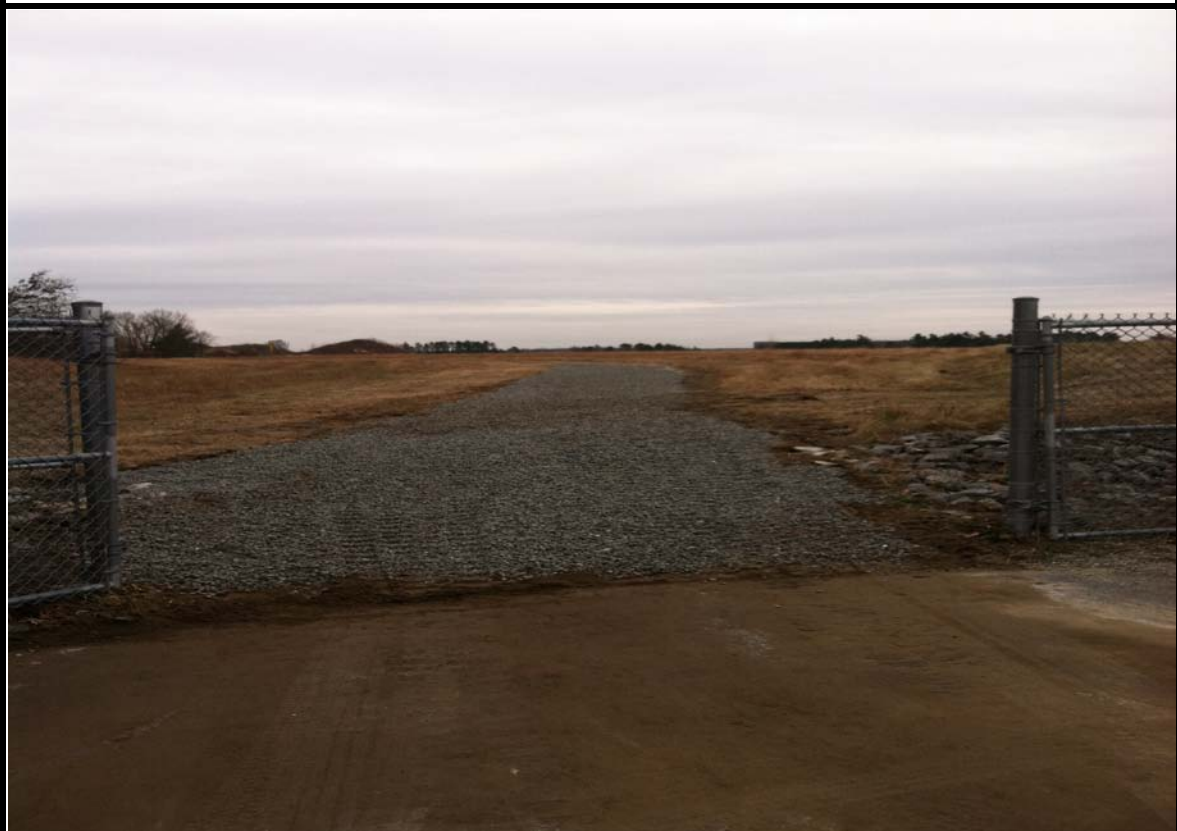
Description - Northern Access Road Repaired

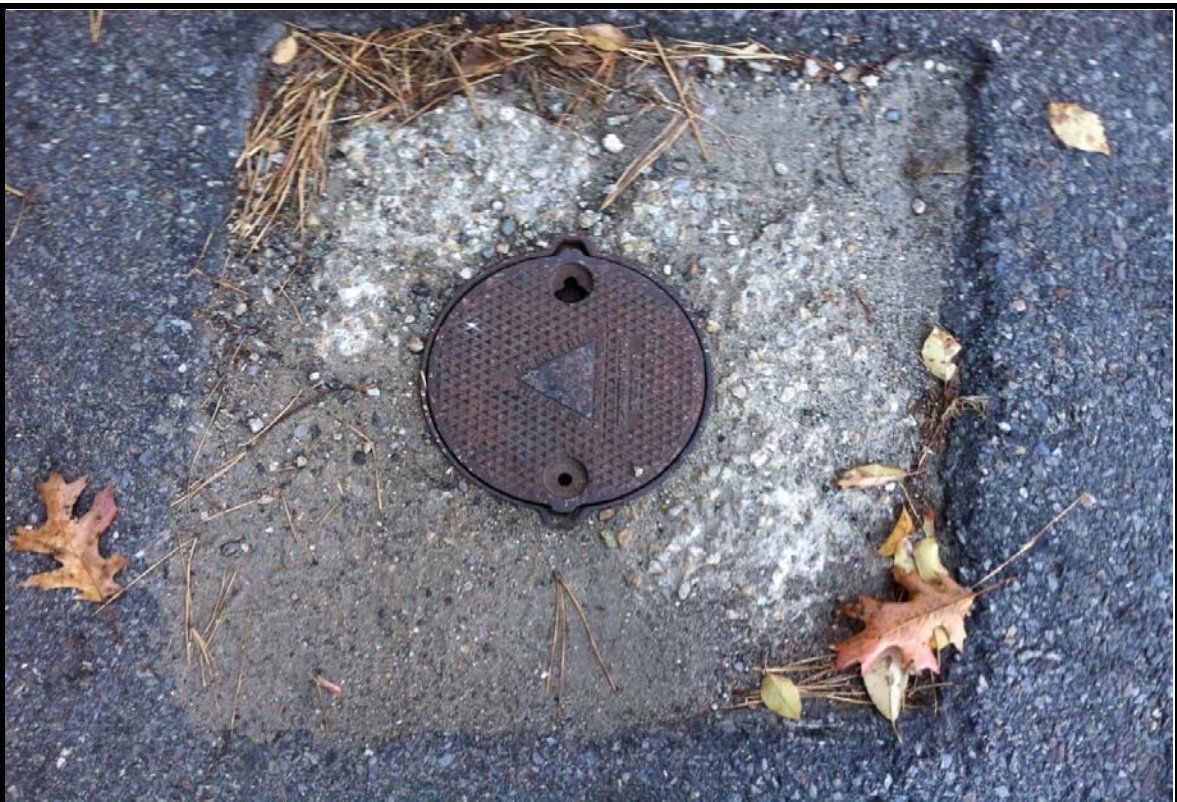
Description - Condition of Monitoring Well Road Boxes on Sculley Road

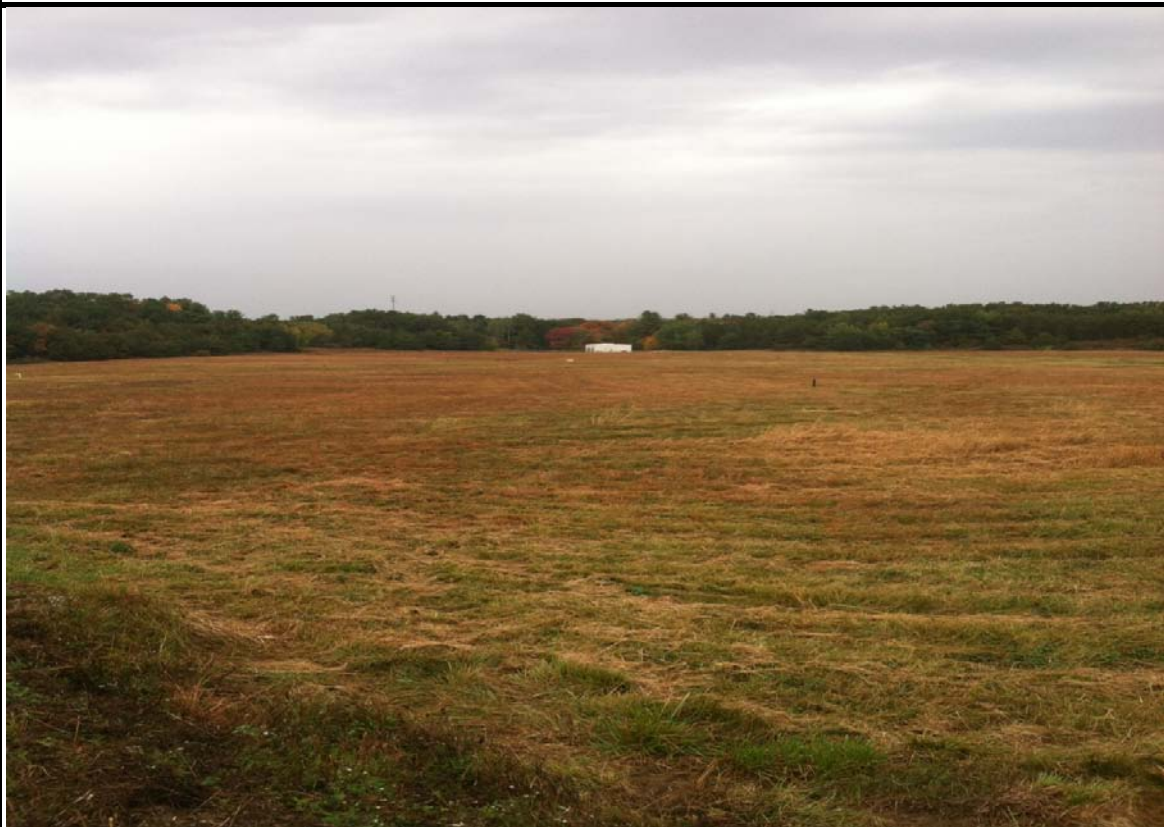
Description - Current Conditions of Northern Portion of Landfill

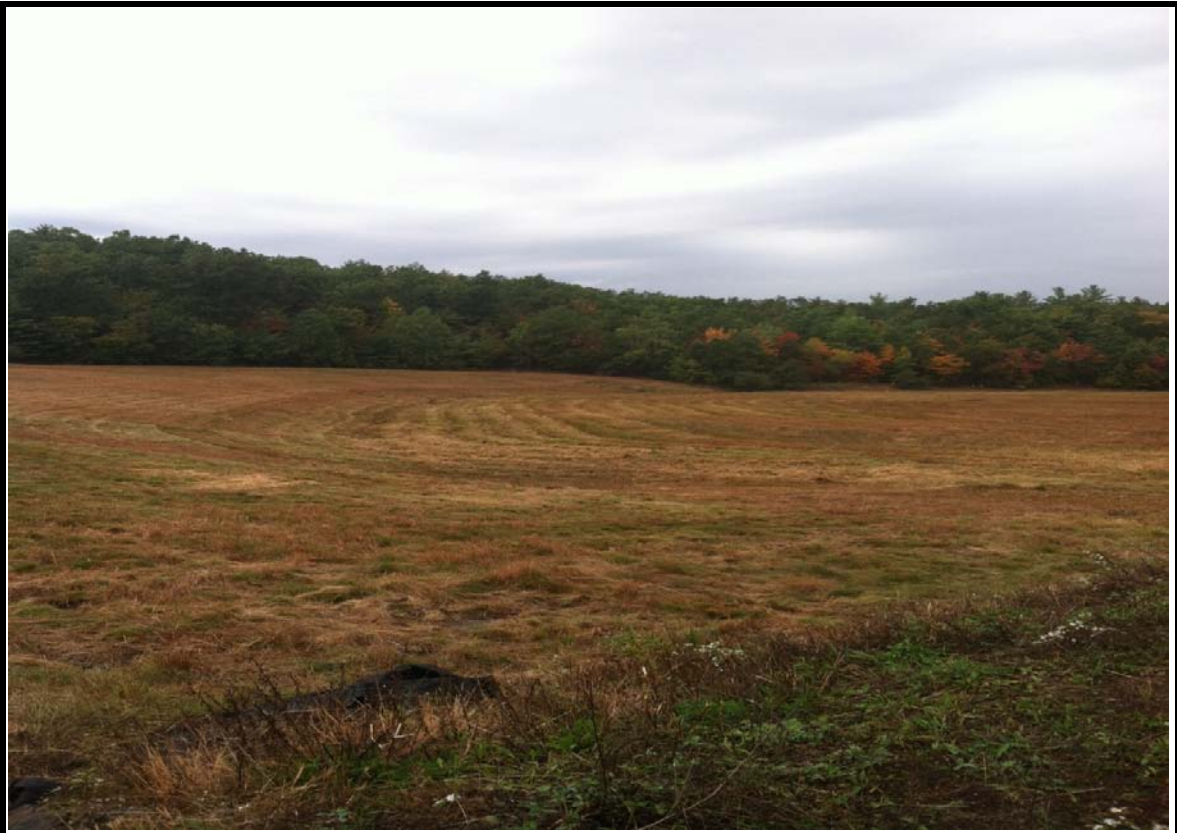
Description - Current Condition of Western Portion of Landfill

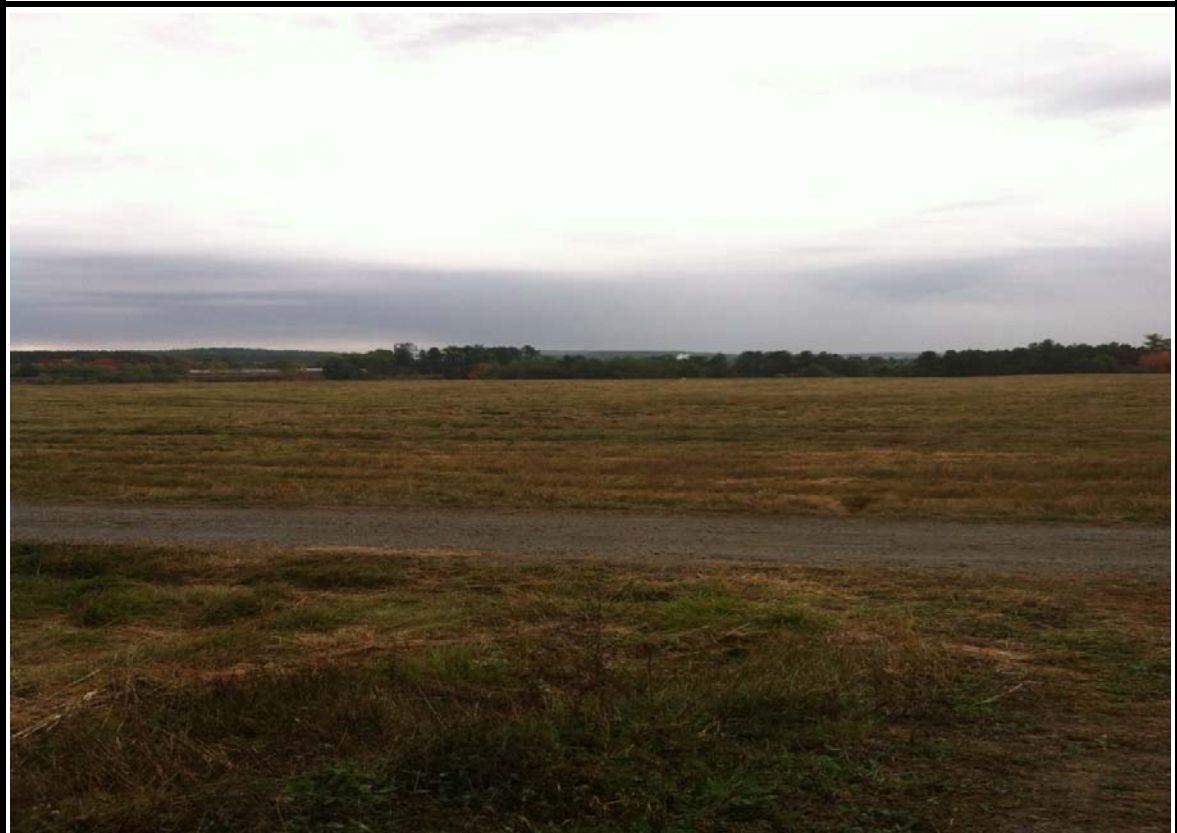
Description - Current Condition of Souther Portion of Landfill

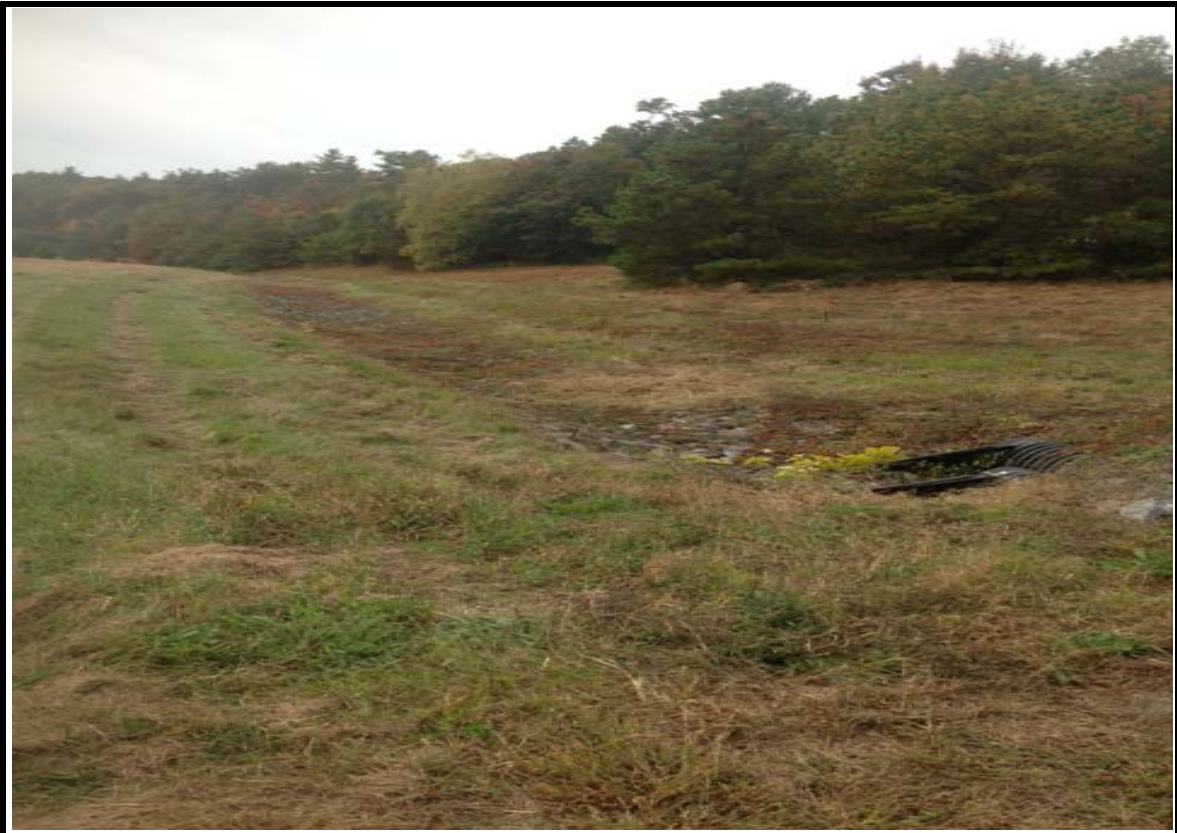
Description - Northwestern Drainage Swale

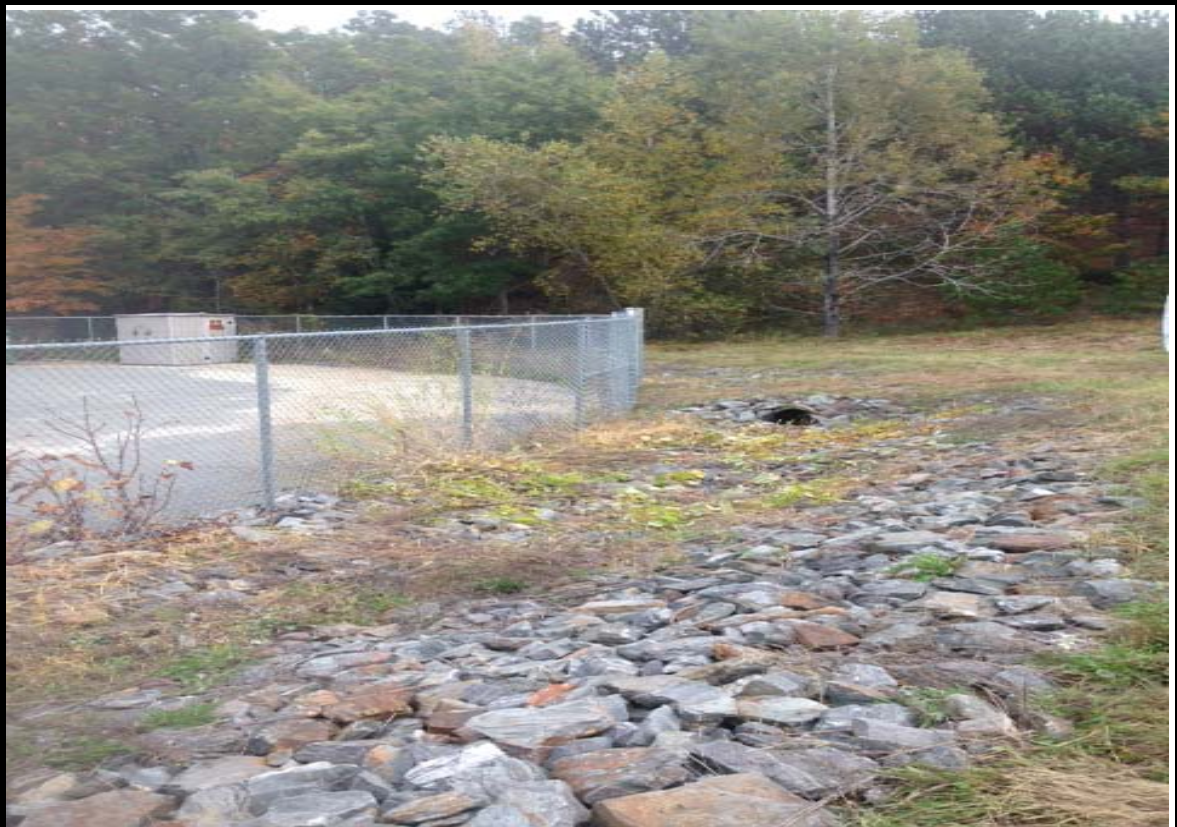
2. The northern drainage swales in the vicinity of the ATP exhibited minor vegetative growth. Large growth was removed during the September 2013 mowing activities	Continue to monitor and clear drainage swales of invasive vegetative growth.	<input checked="" type="checkbox"/>	<input type="checkbox"/>

Description - Northern Drainage Swale
