AYER-SHIRLEY REGIONAL SCHOOL DISTRICT

Elementary Schools Facilities Assessment

April 6, 2018

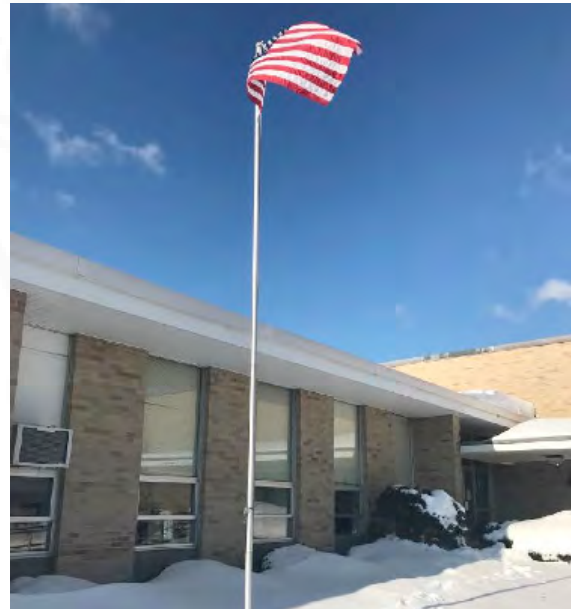
Flag at near school entrance

Few site furnishings exist within the vicinity of the school building. There is a flagpole located adjacent to the secondary entrance. The flagpole does not appear to have an MAAB compliant accessible route.

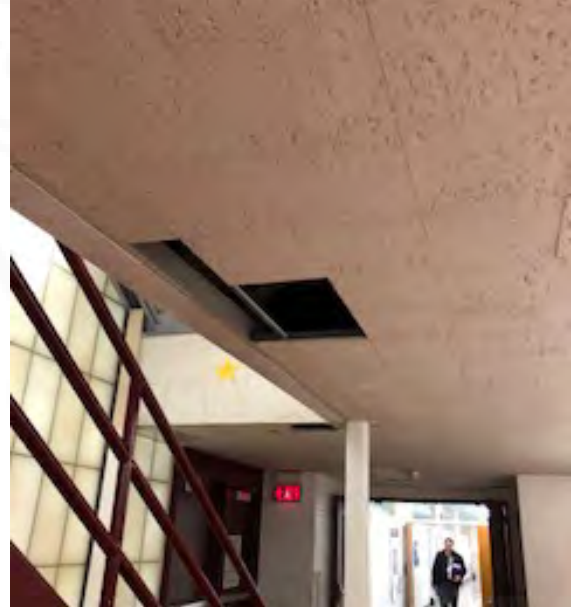
Missing panels in hallway ceiling

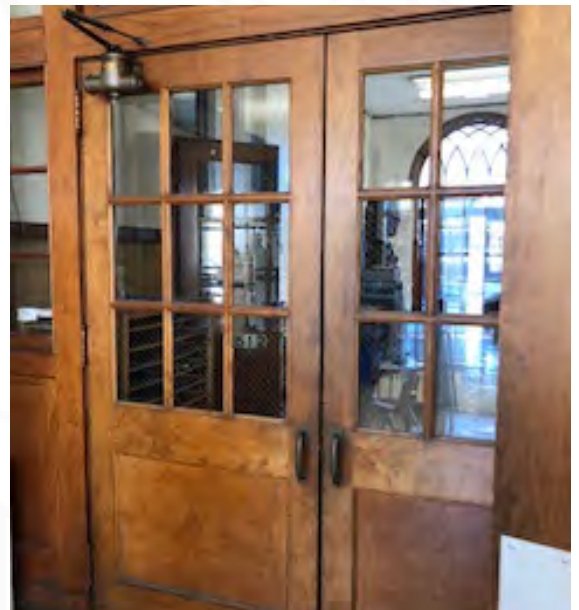
Typical doors

Doors are generally wood and metal and some are chipped. The conditions of the doors and frames are good. Lever handle hardware to meets accessibility guidelines.

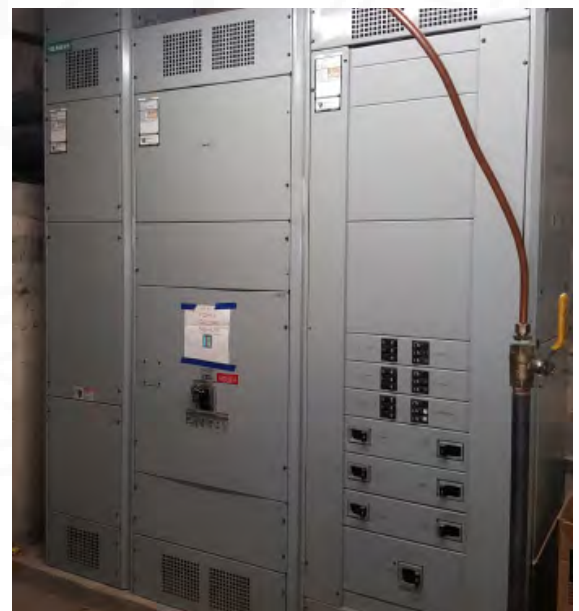
Electrical panels

The existing installations appear safe and operational, but the building is not supported by full smoke detection throughout the building. Full smoke detection coverage is required when no fire protection systems such as fire sprinklers are present.

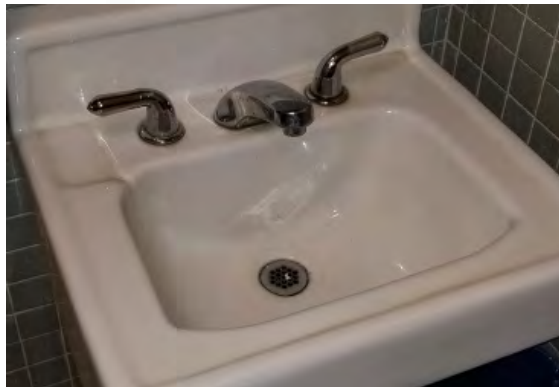
Typical sink in restroom

Sanitary and roof drainage piping systems are made of cast iron. Where visible the piping appears to be in fair condition. Small pipe sizes appear to be copper.
