Ayer's Stormwater Asset Management Plan

Department of
Public Works
Town of Ayer

February 2022

Stormwater Asset
Management Plan
Ayer, Massachusetts
November 2022

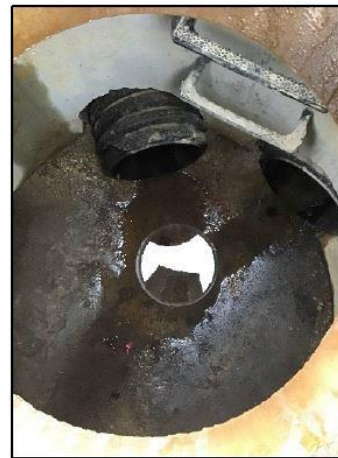
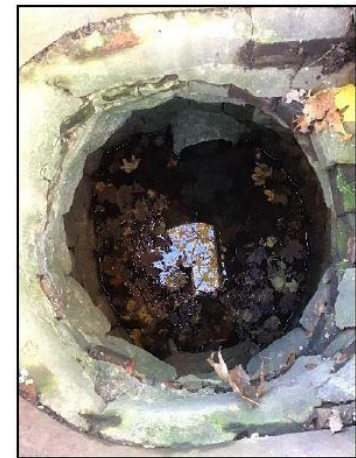
Figure 3-5 Example of a Precast Drain Manhole (Left) and Brick/Block Catch Basin (Right)

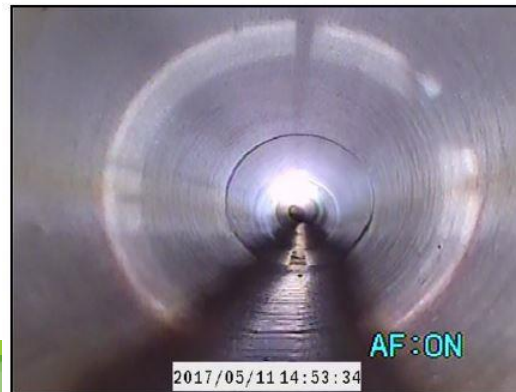
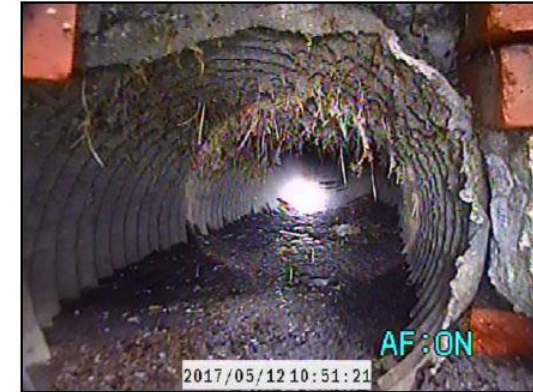
- Pipe condition shows approximately 61% are in good or excellent condition
- 60% of RCP and 92% of HDPE pipes inspected were in good or excellent condition
- 70% of CMP inspected were in fair or poor condition

Figure 3-7 Example of a RCP in Excellent Condition (Left) and CMP in Poor Condition (Right)
