Shirley Street/ West Main Street Culvert Capital Improvement Project

Shirley Street Bridge

West Main Street Culvert

Ayer Department of Public Works January 2016

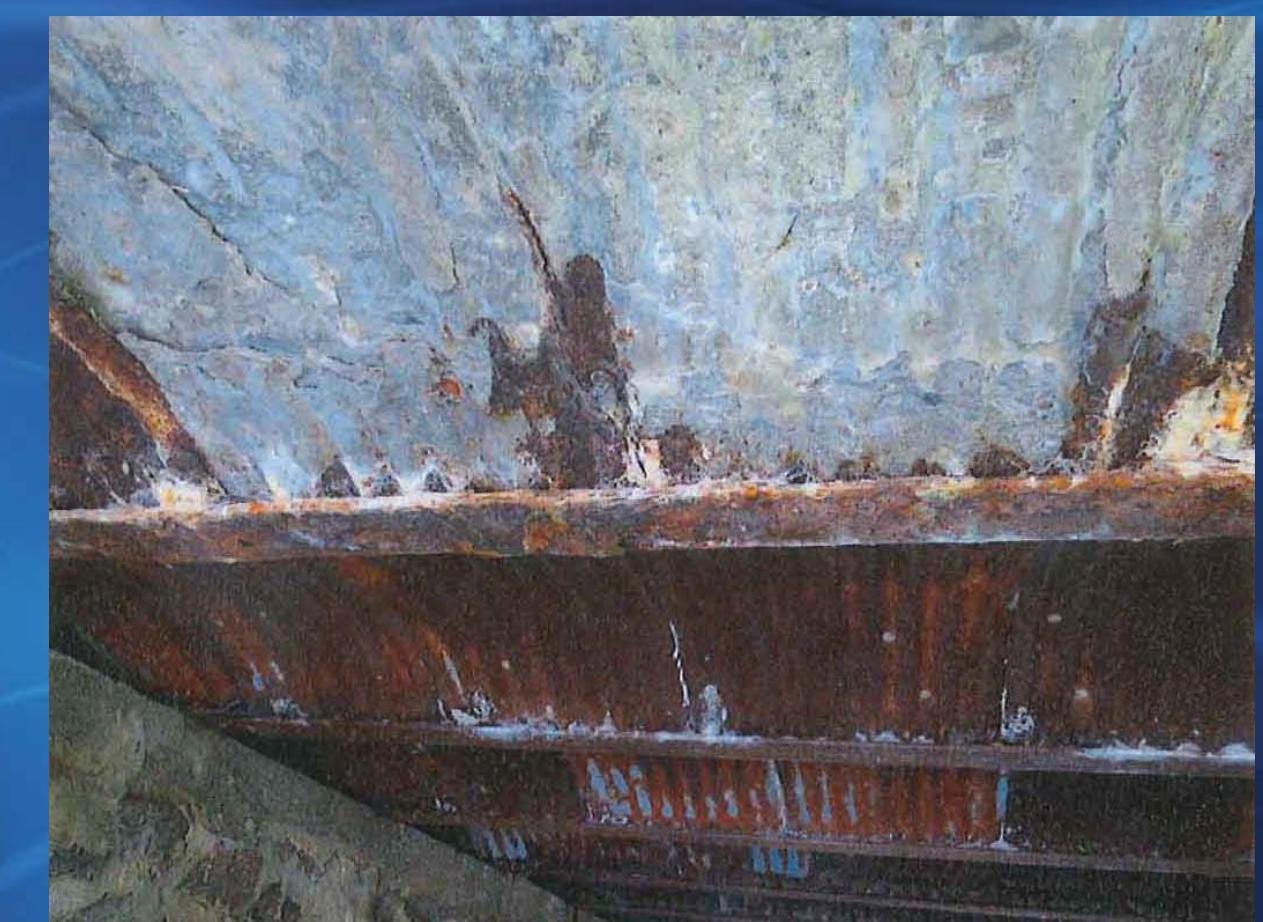
Severe Hazard: 100% Section Loss in all stay-in-place forms, severe spalling to concrete deck where visible

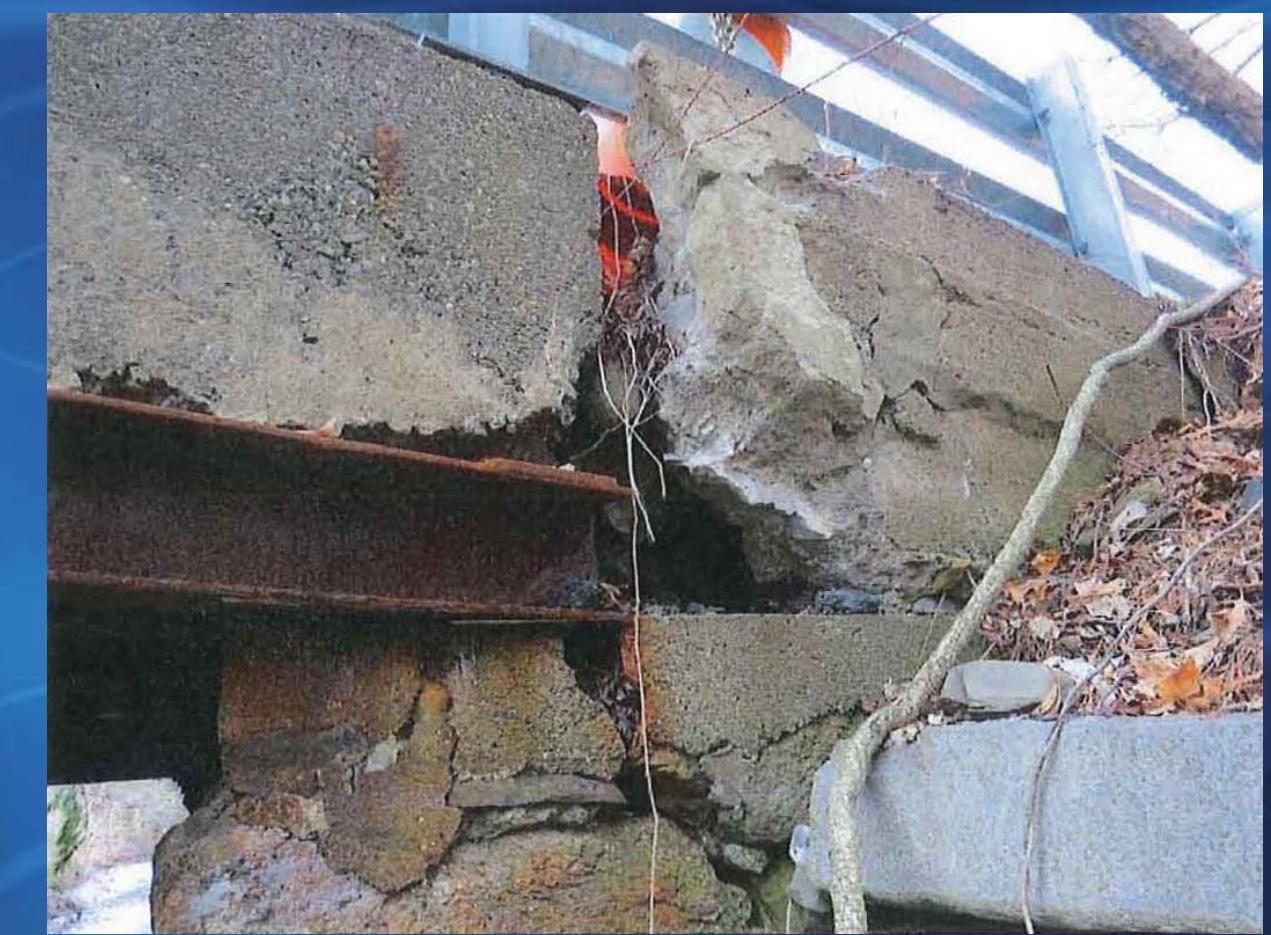
Severe Hazard: Severe concrete deterioration and separation on southeast retaining wall

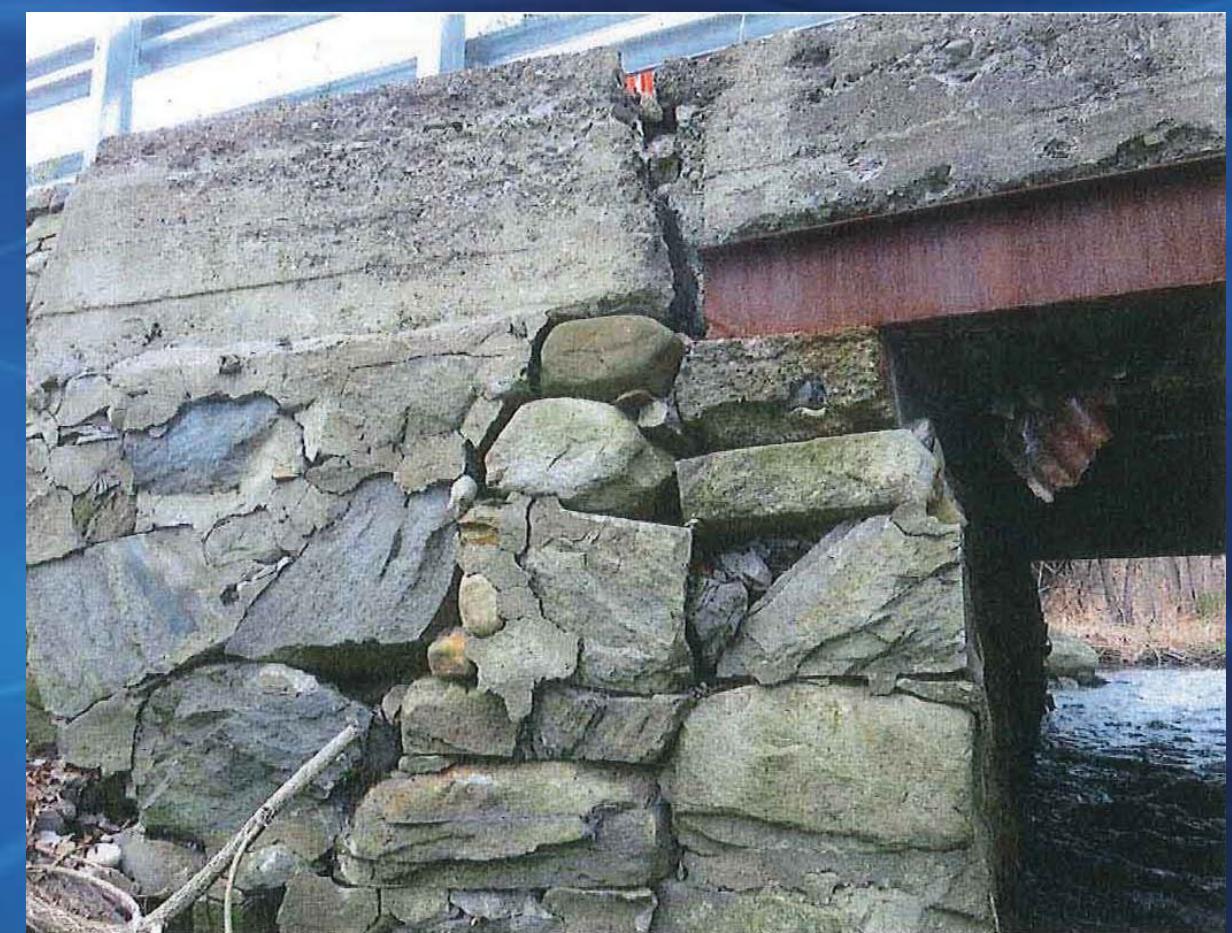
Severe Hazard: Separation of the retaining wall and large voids at the northeast corner of the bridge

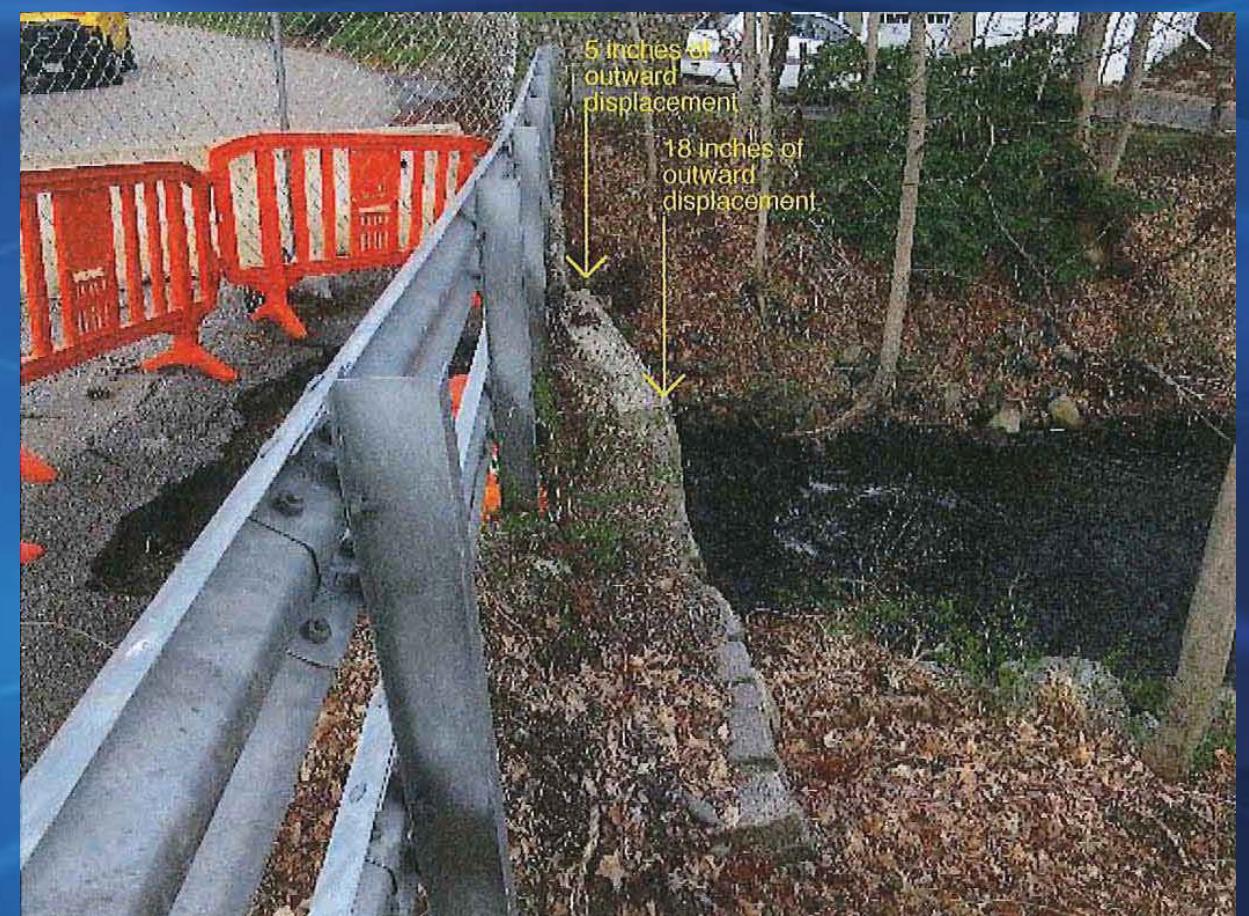
Critical Hazard: Outward displacement at the east end of the northeast retaining wall

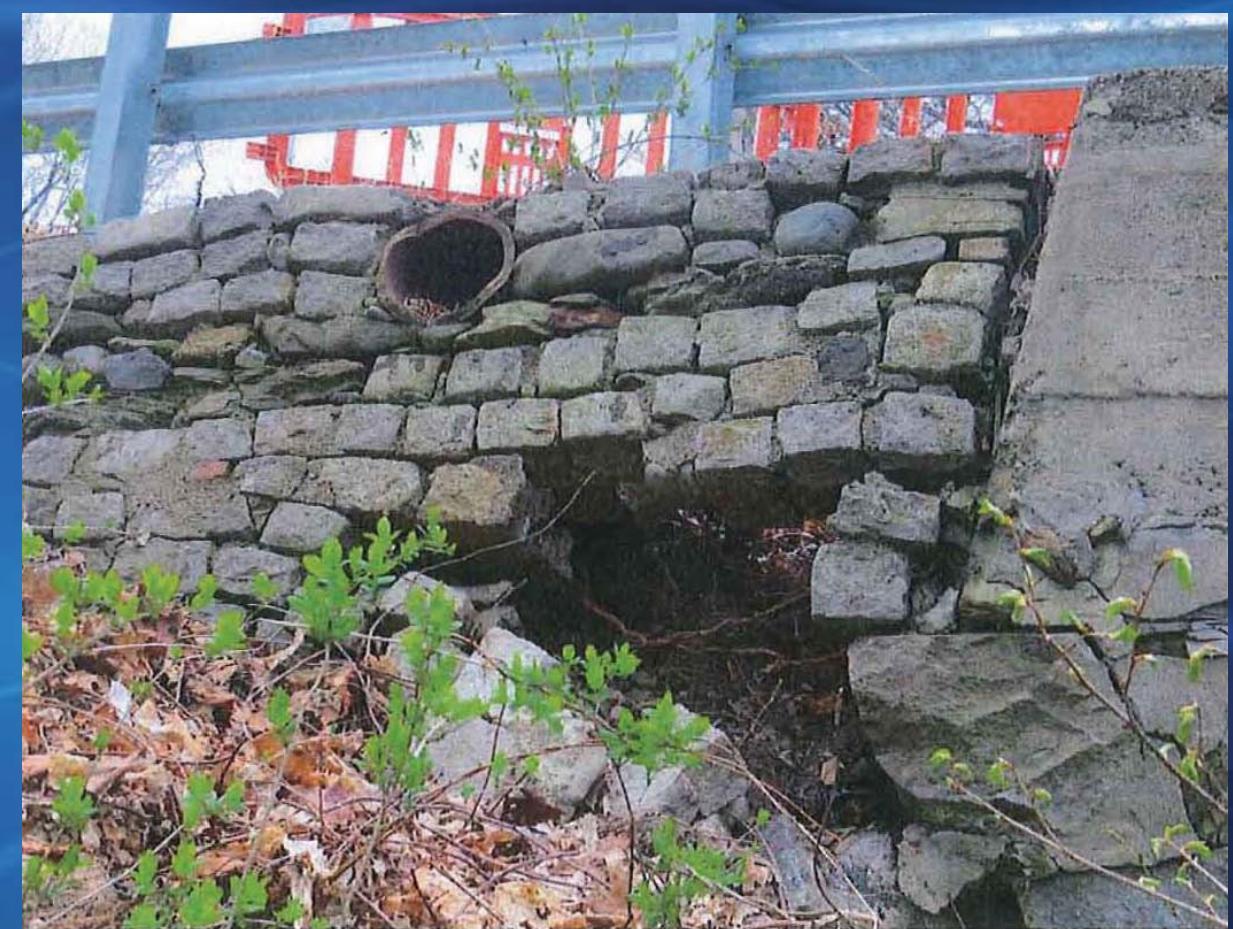
Critical Hazard: Hole in northeast retaining wall below the collapsed embankment

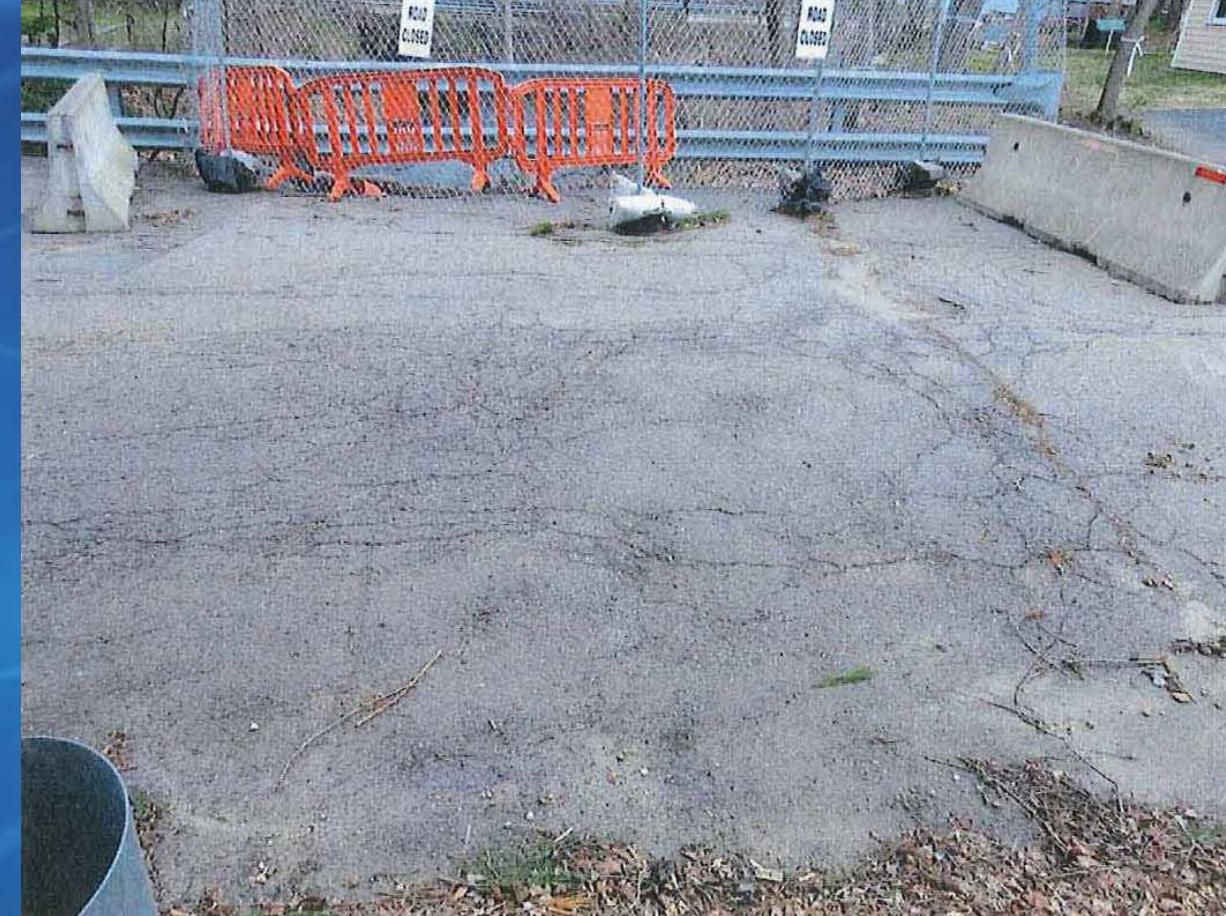
Critical Hazard: Severe cracking, moderate breakup and heavy settlement throughout the east approach pavement

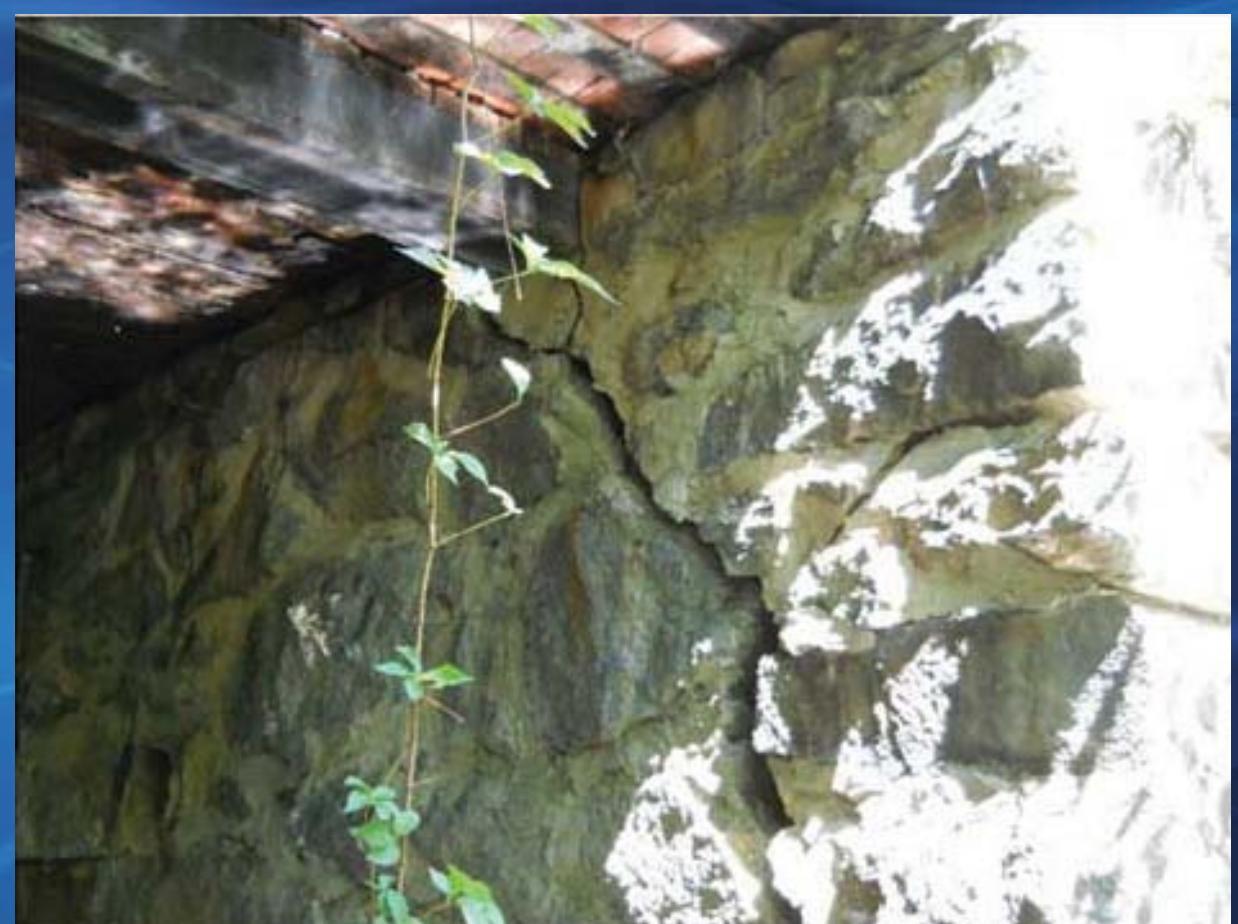
Masonry Crack on East Sidewall

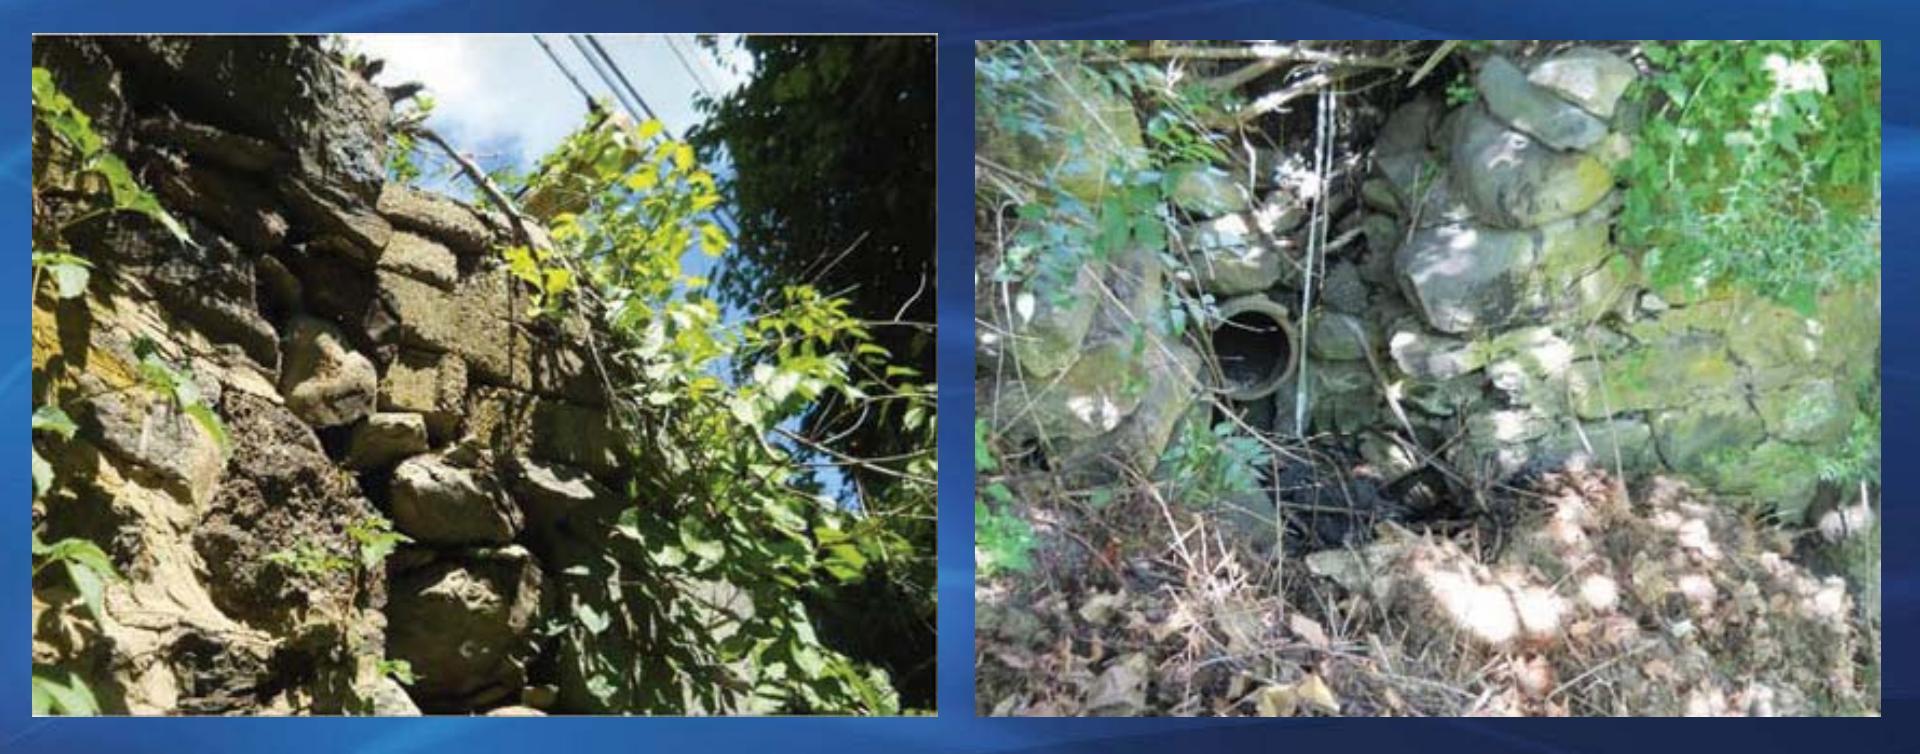
Southeast Wingwall Degradation
