Stormwater Asset Management Plan

Ayer, Massachusetts

November 2022

Tighe&Bond

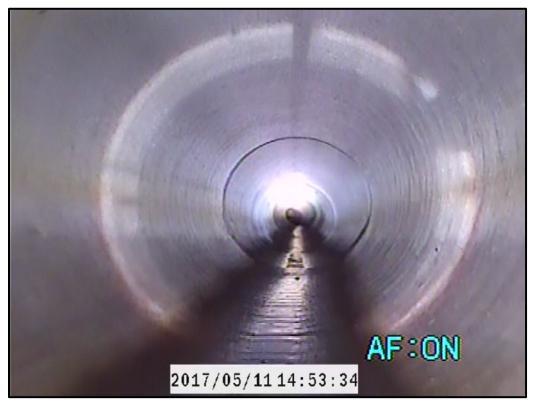
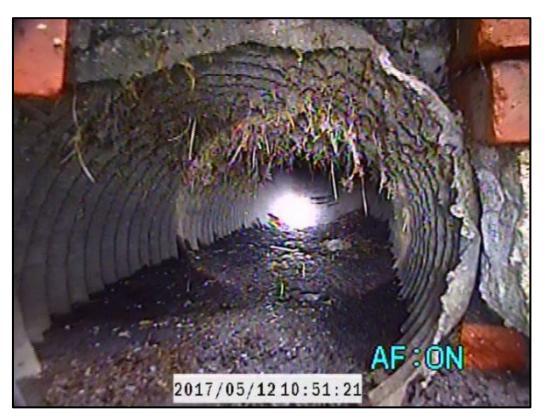
Figure 3-7 Example of a RCP in Excellent Condition (Left) and CMP in Poor Condition (Right)

Figure 3-7 includes an example of a reinforced concrete drain pipe that is in excellent condition and a corrugated metal pipe that is in poor condition due to root intrusion.

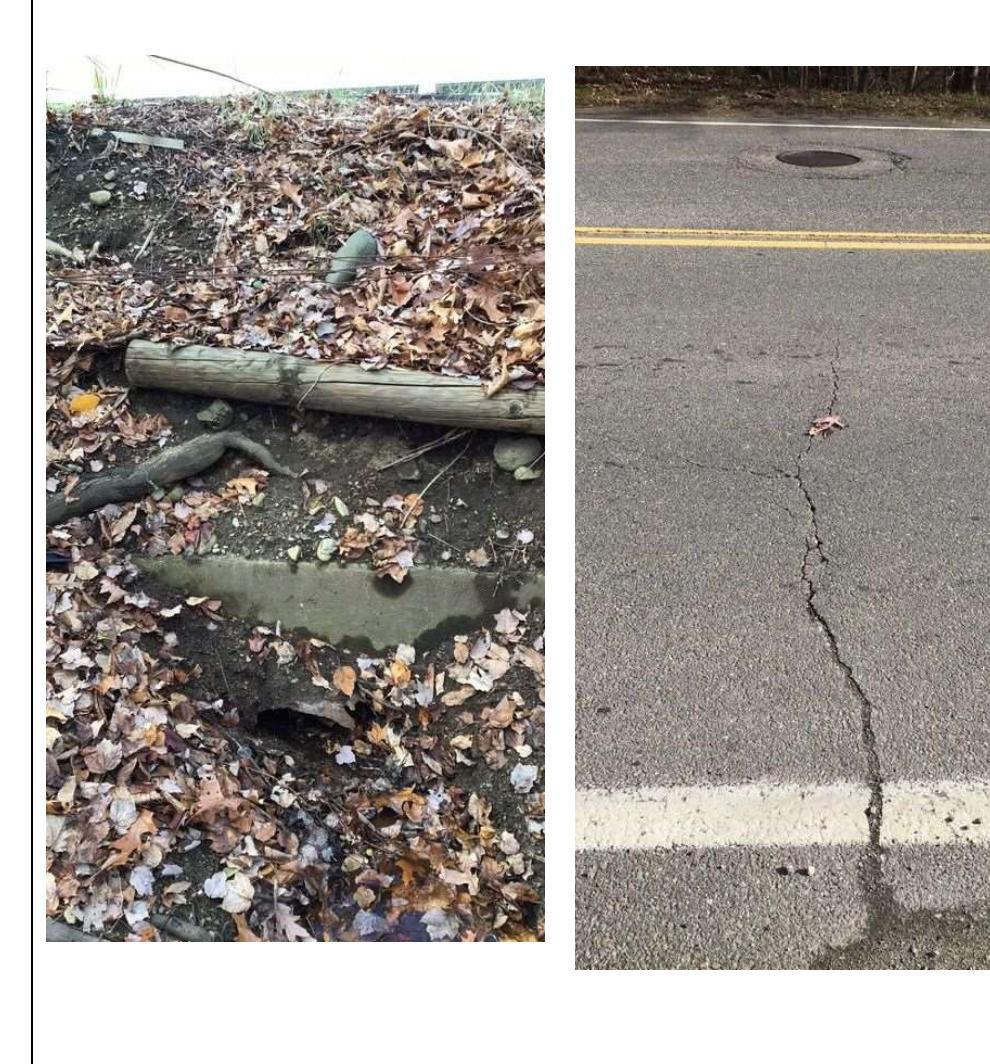
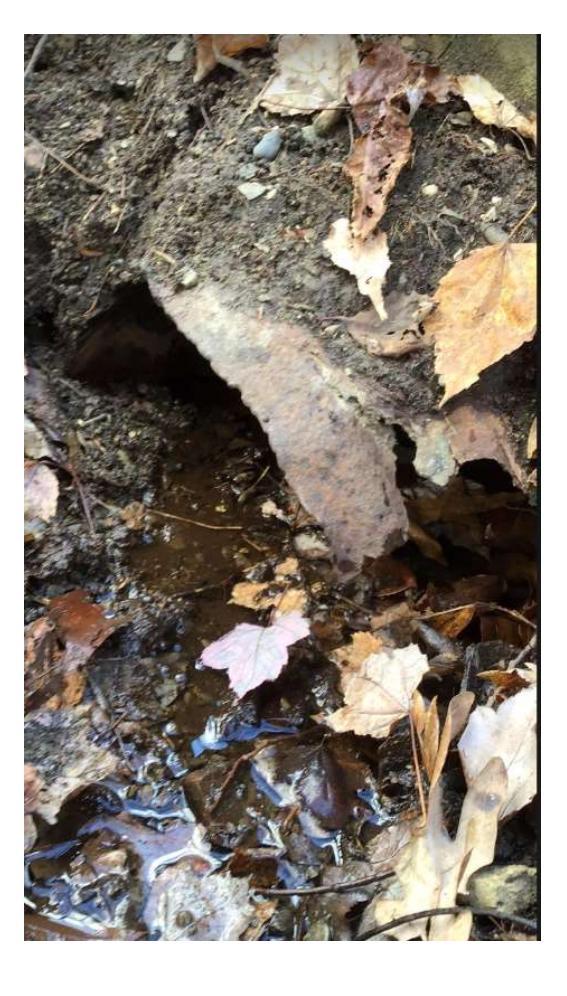
Asset ID	Summary of Statistics	Summary of Inventory Findings and Observations	Probability of Failure (PoF)	Consequence of Failure (CoF)	Re
Culvert ID: P-1096	corrugated metal	 Fair roadway condition Fair Upstream embankment, poor 	High PoF (0.54)	High CoF (0.55)	• Re
Willow Road		 downstream embankment Material present in crossing, substrate depth 25% and 75%, tree present High invert deterioration High Cross section deformation Some section loss in pipe at interface of material in culvert pipe

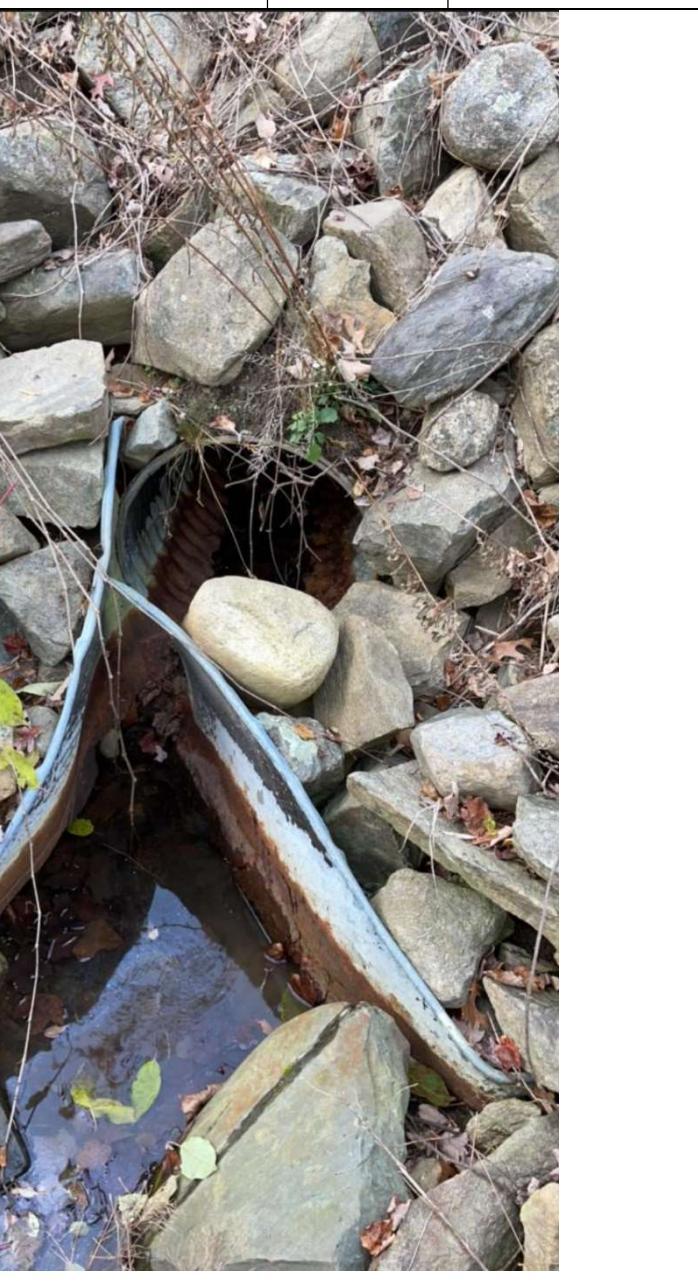
Asset ID	Summary of Statistics	Summary of Inventory Findings and Observations	Probability of Failure (PoF)	Consequence of Failure (CoF)	Recommendations	Criticality Rank	OPC ¹
P-711 Madigan Lane	corrugated metal	 Poor Roadway condition High invert deterioration Critical/failing apron condition High cross section deformation 100% section loss deep in pipe High obstruction severity Full section loss 2.5', riprap slope failure 	High PoF (0.61)	High CoF (0.52)	Replacement	High	\$884,000
		<image/>

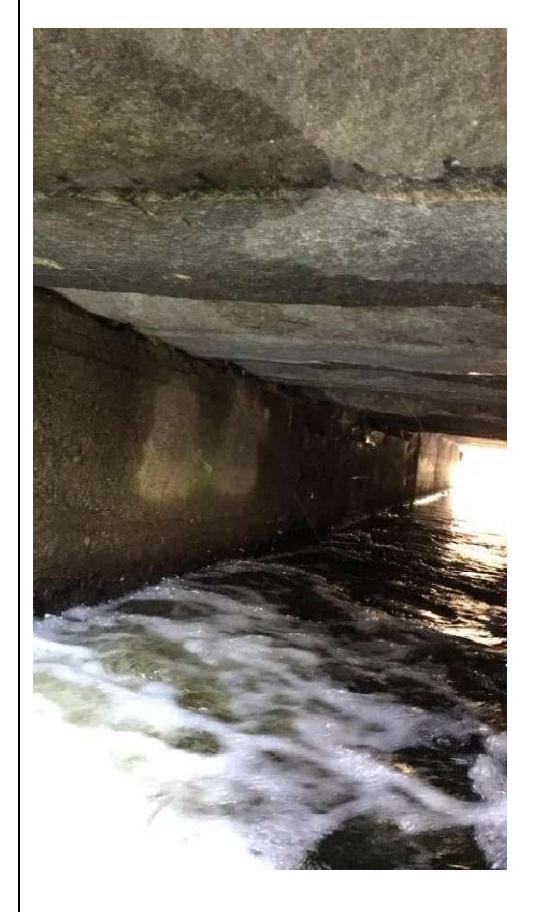
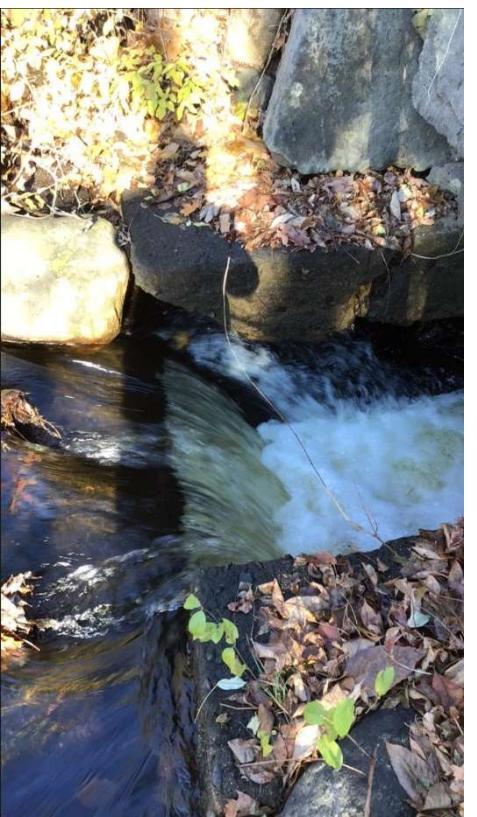
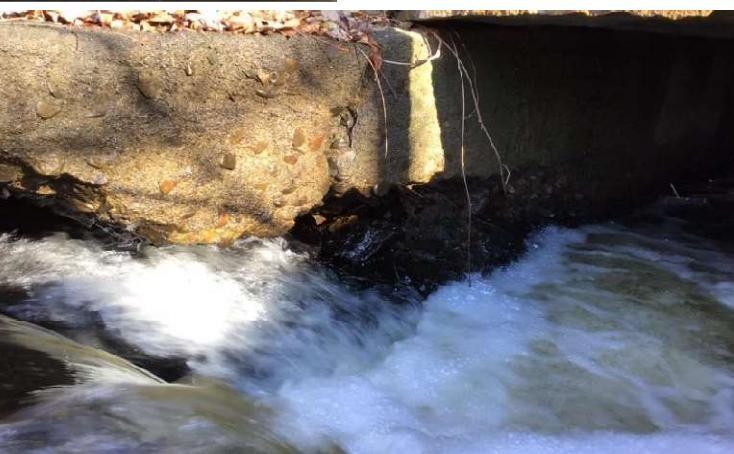
Asset ID	Summary of Statistics	Summary of Inventory Findings and Observations	Probability of Failure (PoF)	Consequence of Failure (CoF)	Re
P-1539	Concrete Scour under both	 Poor Roadway condition Guardrail failing/critical 	High PoF (0.59)	High CoF (0.61)	• Re
Willow Road	abutments, joints deteriorating in headwall and wingwalls, stone sliding forward, heavy spalling due to deteriorated concrete. Dam at culvert inlet.	 Poor condition of upstream embankment Poor joints/seams High invert deterioration Poor headwall condition Tree present

ecommendations	Criticality Rank	OPC ¹
eplacement	High	\$1,300,000
Nor 1		
	and the second	
188

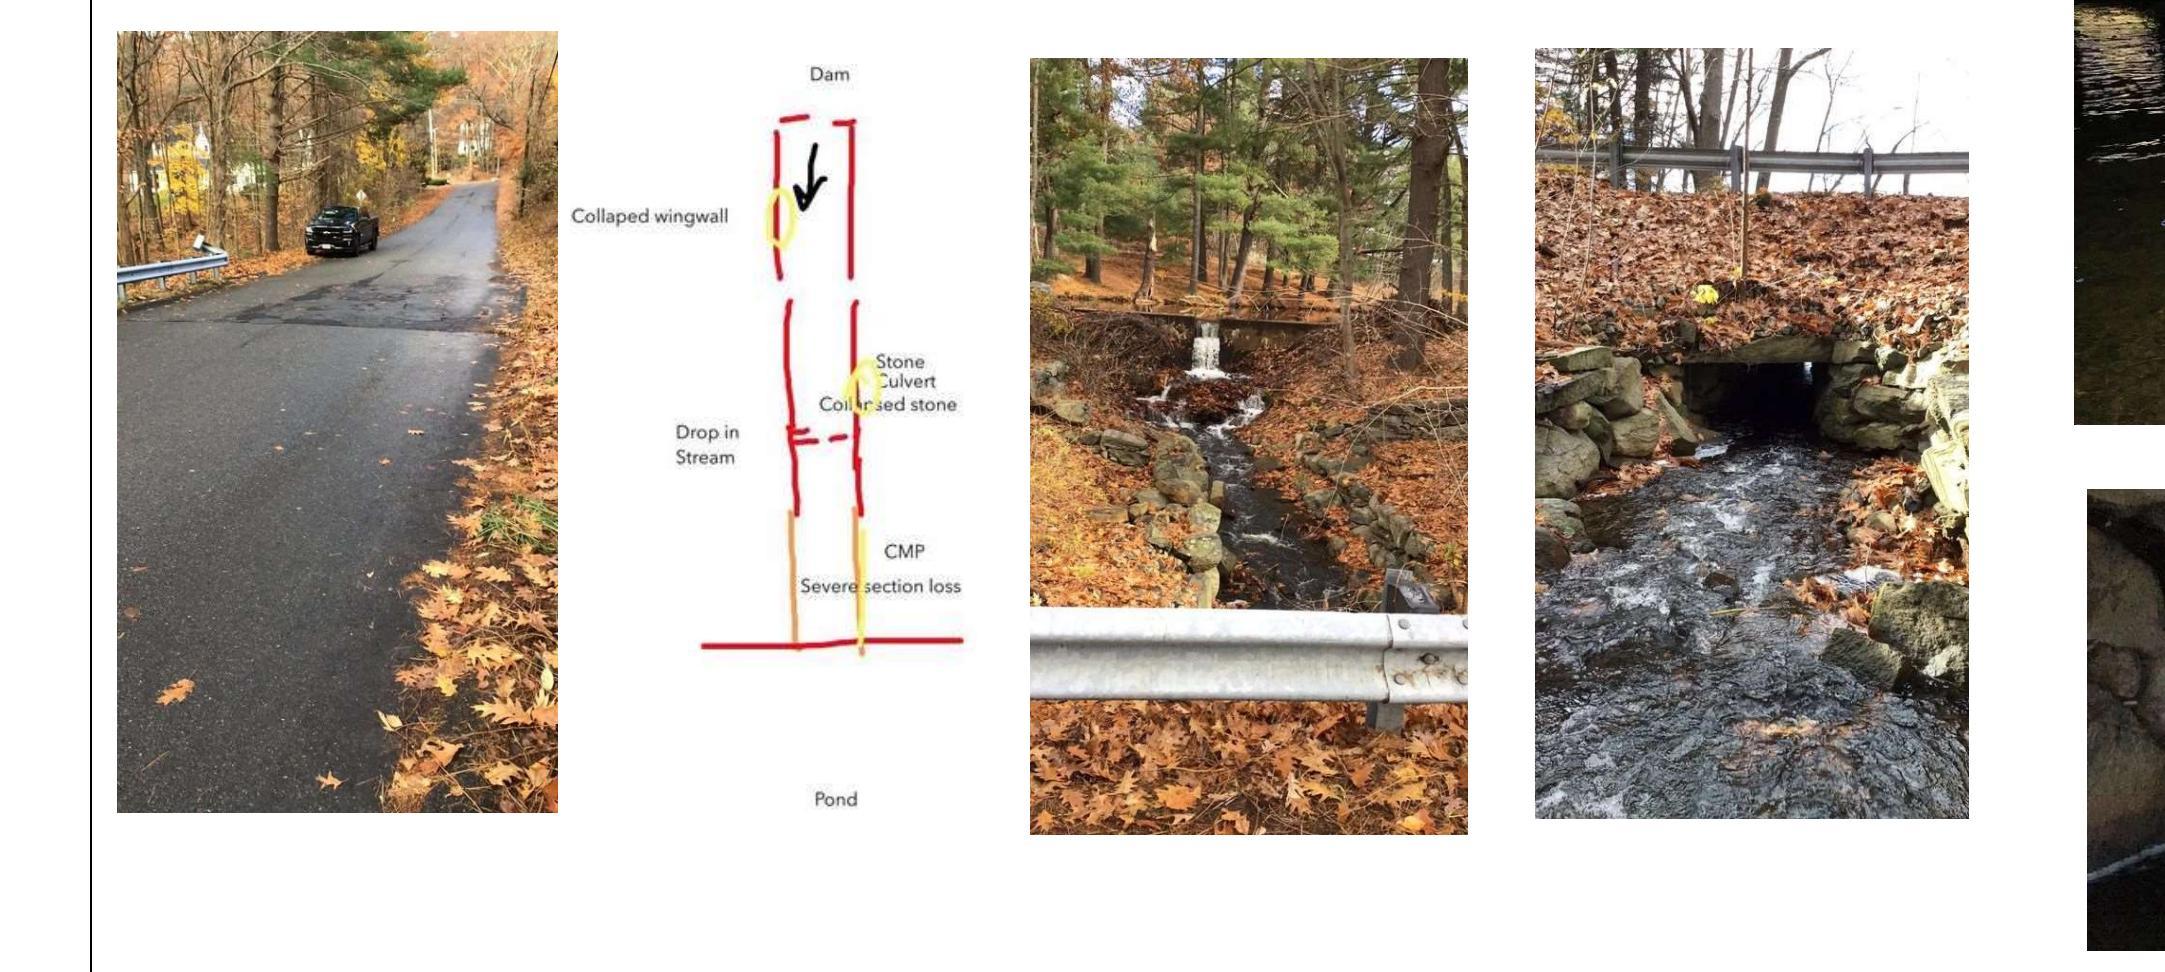
Asset ID	Summary of Statistics	Summary of Inventory Findings and Observations	Probability of Failure (PoF)	Consequence of Failure (CoF)	Recommendations	Criticality Rank	OPC ¹
P-550	 Collapsed stones from wing walls in 	 Poor roadway conditions Guardrail failing 	High PoF (0.56)	High CoF (0.65)	Replacement	High	\$1,268,000
Oak Ridge Drive	 stream. Wing wall about to collapse. Large joints and gaps between stones in culvert. Minimal support length for top slab stone 	- Wingwall critical/failing

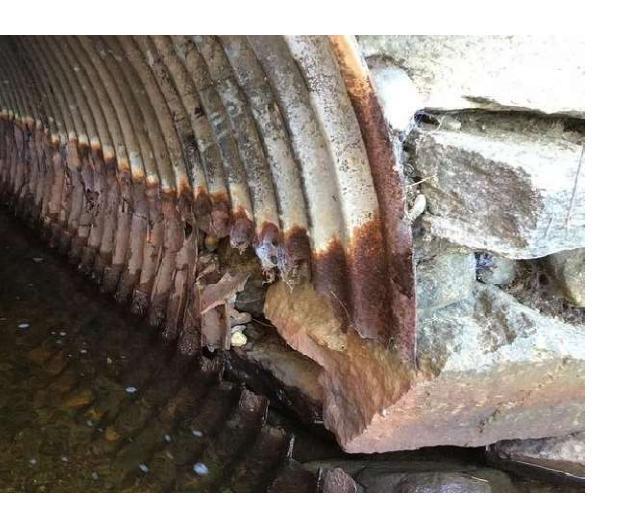
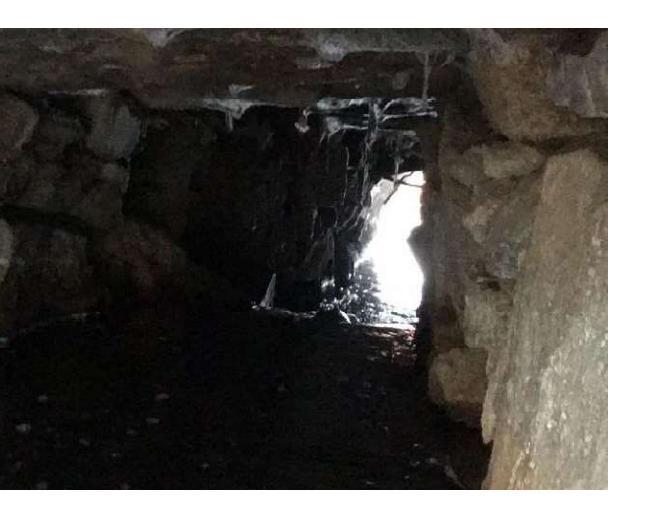
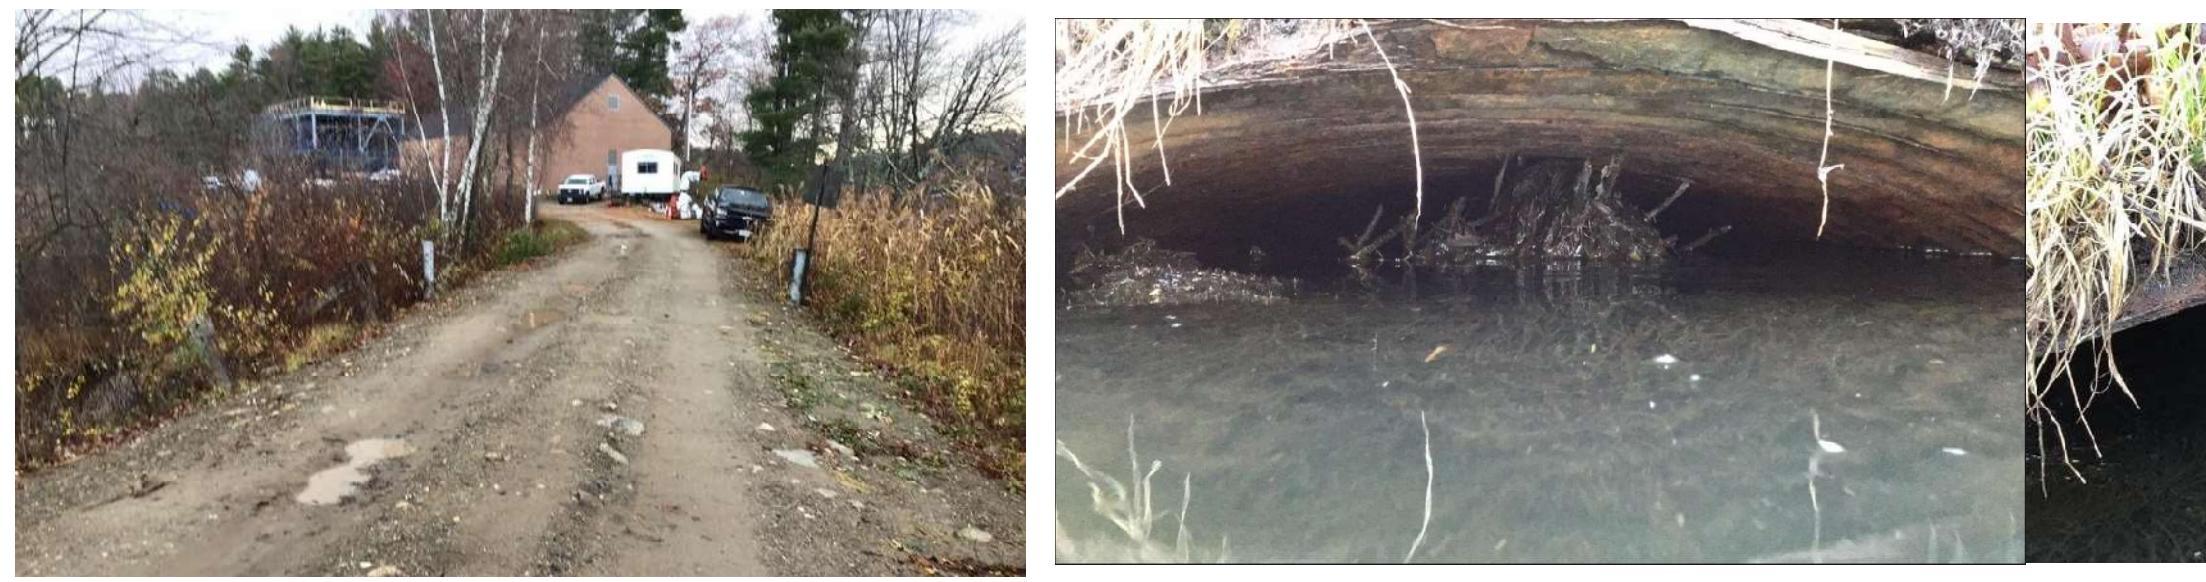
Asset ID	Summary of Statistics	Summary of Inventory Findings and Observations	Probability of Failure (PoF)	Consequence of Failure (CoF)	Recommendations	Criticality Rank	OPC ¹
Potential – 11	- Guard rail falling off posts and	 Guardrail critical/failing condition High invert deterioration 	High PoF (0.56)	High CoF (0.55)	Replacement	High	\$1,371,000
Spectacle Road	located on ground or missing	 Poor joints and seams Section loss in pipe. Blockage in middle of 					
	 CMP cuivert Identified culvert 	- Clogged/ Collapsed/ Submerged					
	able to get eyes						
	Appears to be set						
	streambed elevation but						
	embedded into embankment and						
	fully submerged						
El Hande		General Maria				A ANTRA

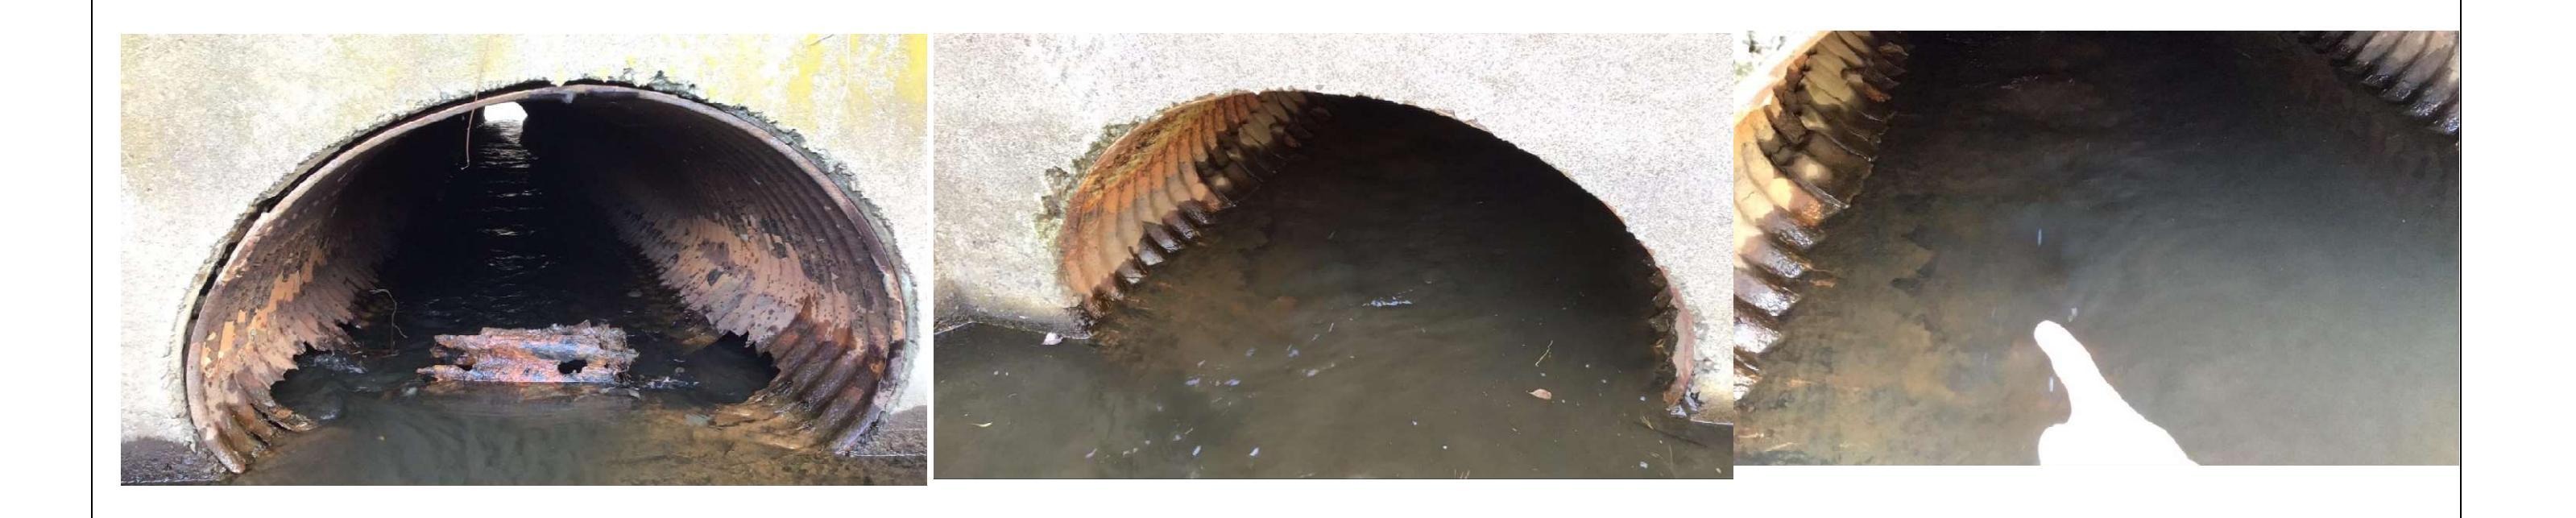
Asset ID	Summary of Statistics	Summary of Inventory Findings and Observations	Probability of Failure (PoF)	Consequence of Failure (CoF)	Recommendations	Criticality Rank	OPC ¹
P-New-1	 Severe section loss and rust Culvert is deformed 		Medium PoF (0.498)	High CoF (0.63)	• Replacement	Medium	\$1,279,000
