# Former Fort Devens Army Installation Project Status Update 24 January 2019

Restoration  
Advisory Board  
Meeting

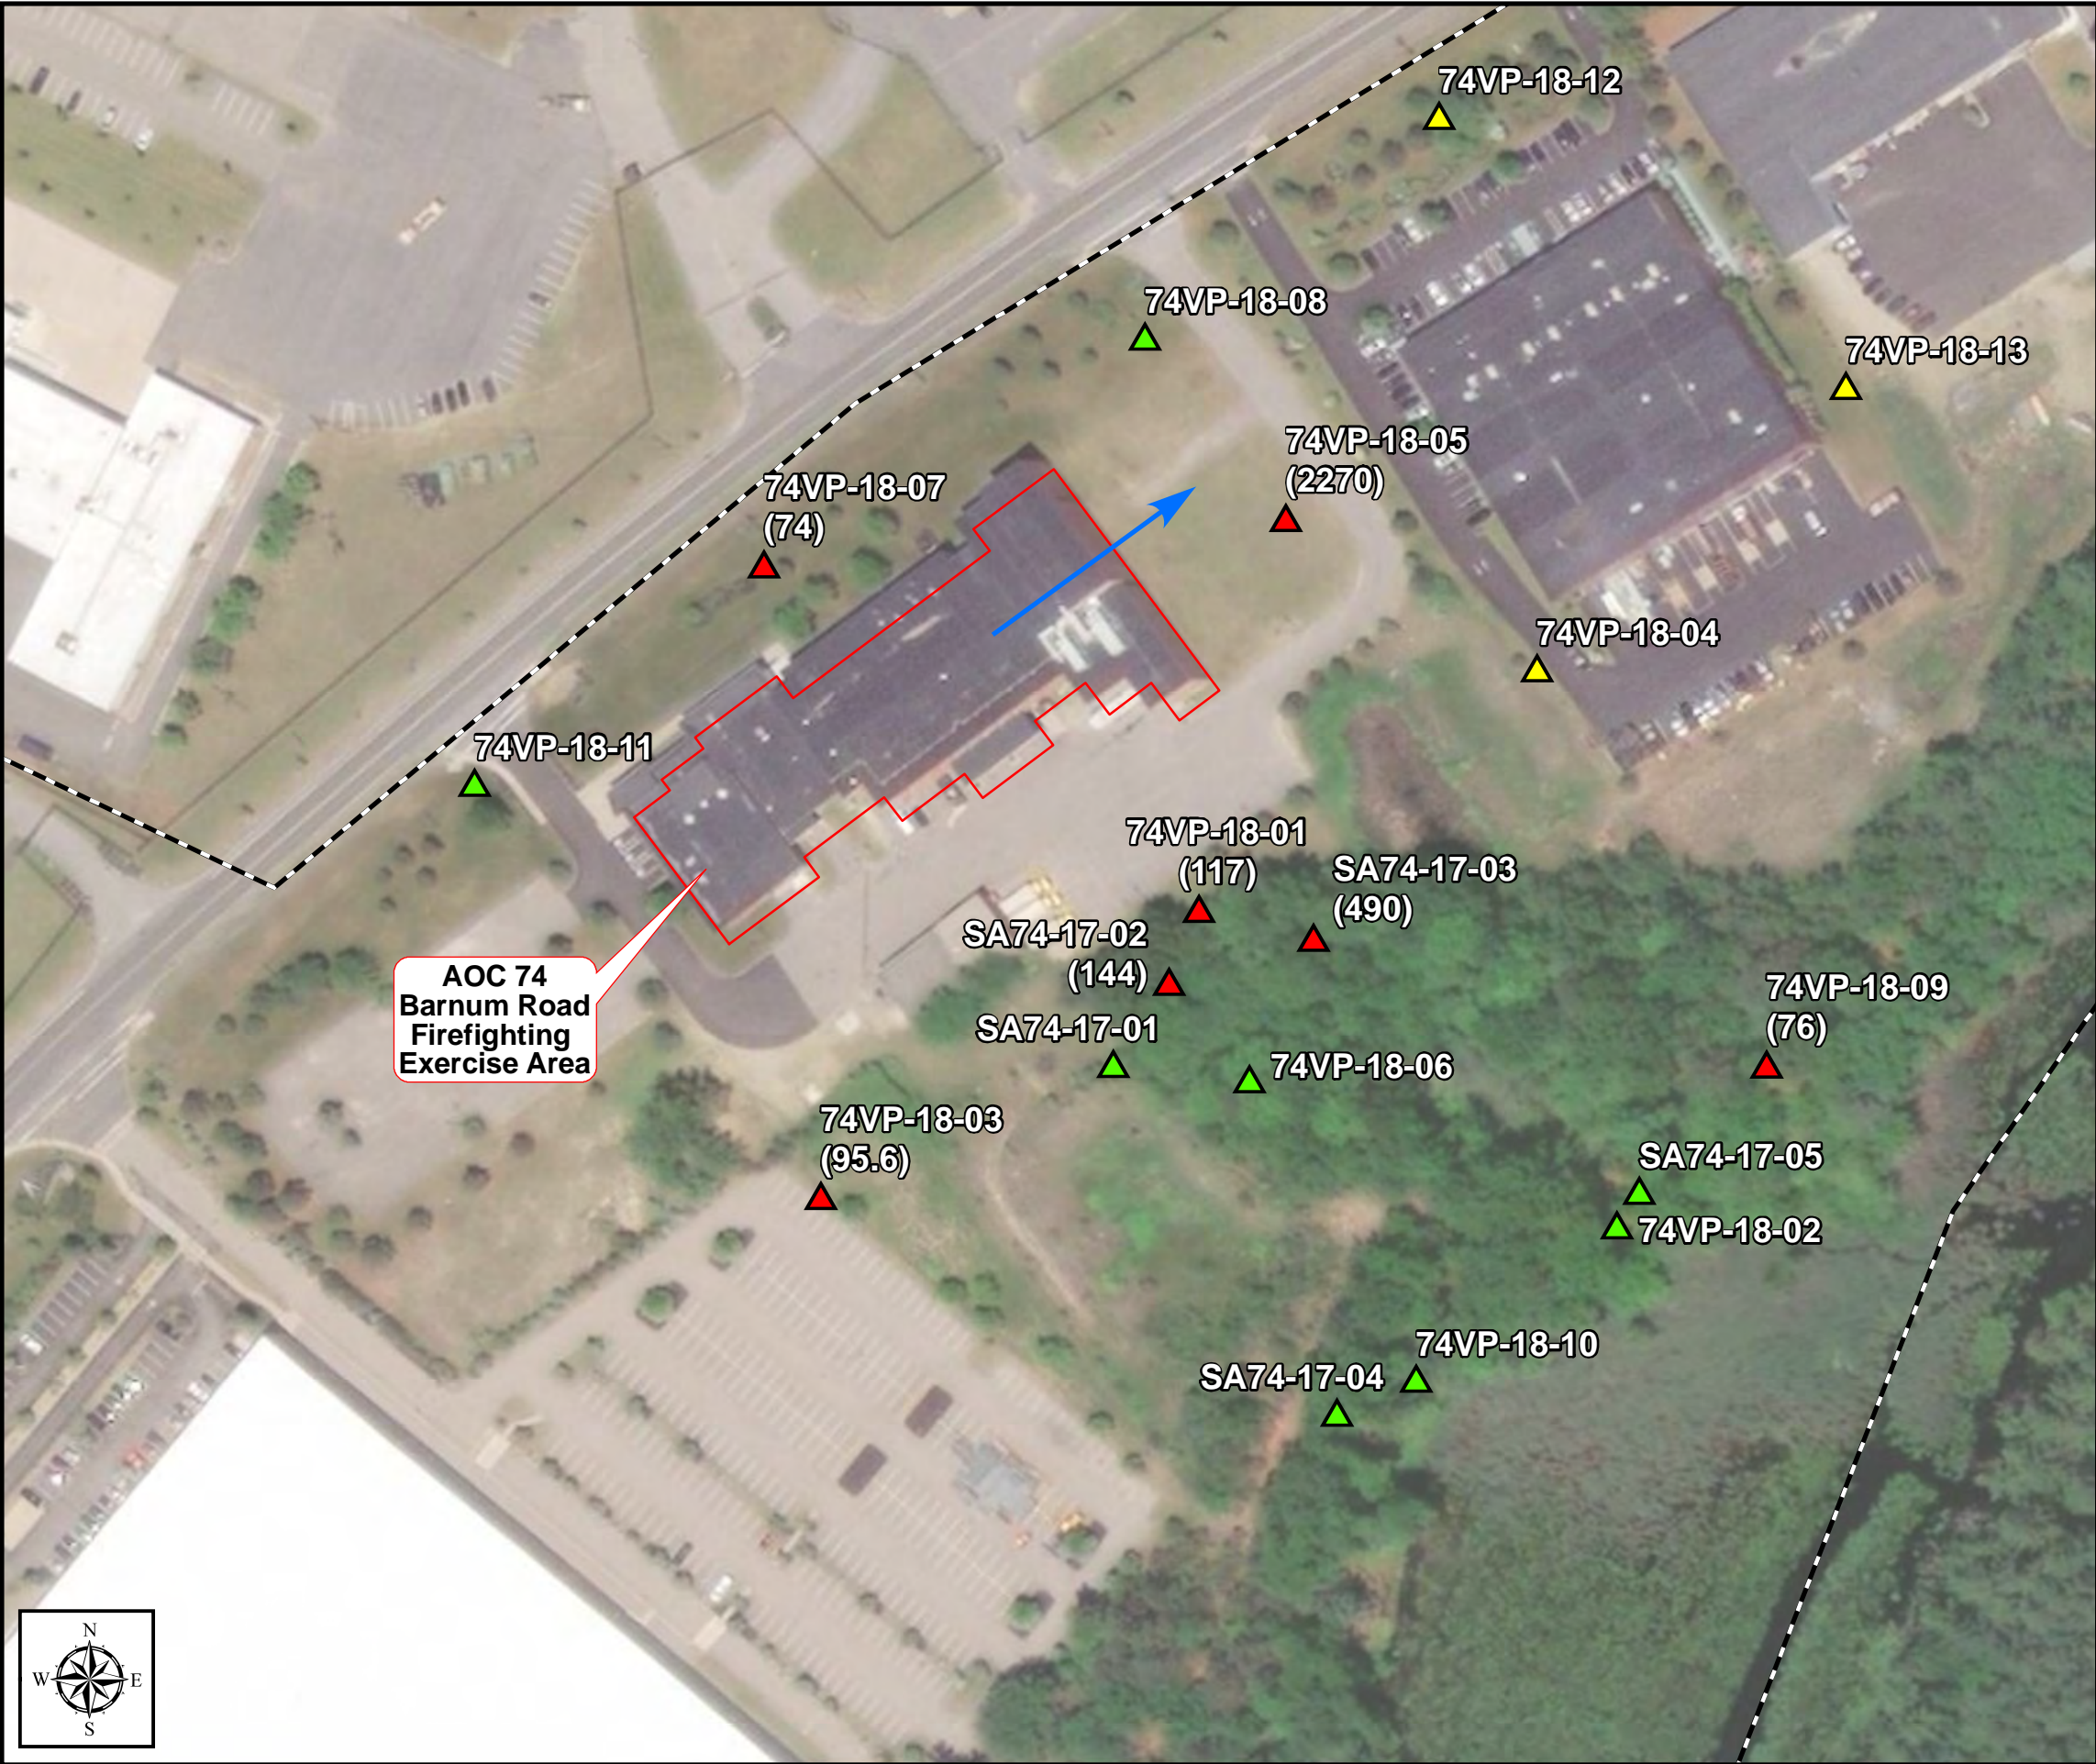
AOC 74 Preliminary Results Devens PFAS RI			
Former Fort Devens Army Installation Devens, Massachusetts			
KOMAN Government Solutions, LLC 293 Boston Post Road West, Suite 100, Marlborough, MA 01752			
0 60 120 Feet	Date: 01/17/2019	Figure .

- AOC 74
  - ▶ 7 soil borings complete (awaiting results)
  - ▶ 13 vertical profiles complete (awaiting results at 3 locations)
  - ▶ 8 locations with groundwater concentrations less than the EPA LHA
  - ▶ 7 locations with groundwater concentrations greater than the EPA LHA
  - ▶ Maximum PFOA+PFOS detection in groundwater is 2,270 ppt

- PFOA+PFOS > 70 ng/l
- PFOA+PFOS < 70 ng/l
- Drilled, results pending
- Yet to be Drilled
- (120) Sum of PFOA and PFOS above 70 ng/L
- ▲ Vertical Profiling Location
- Groundwater Flow Direction
- Former Fort Devens Boundary

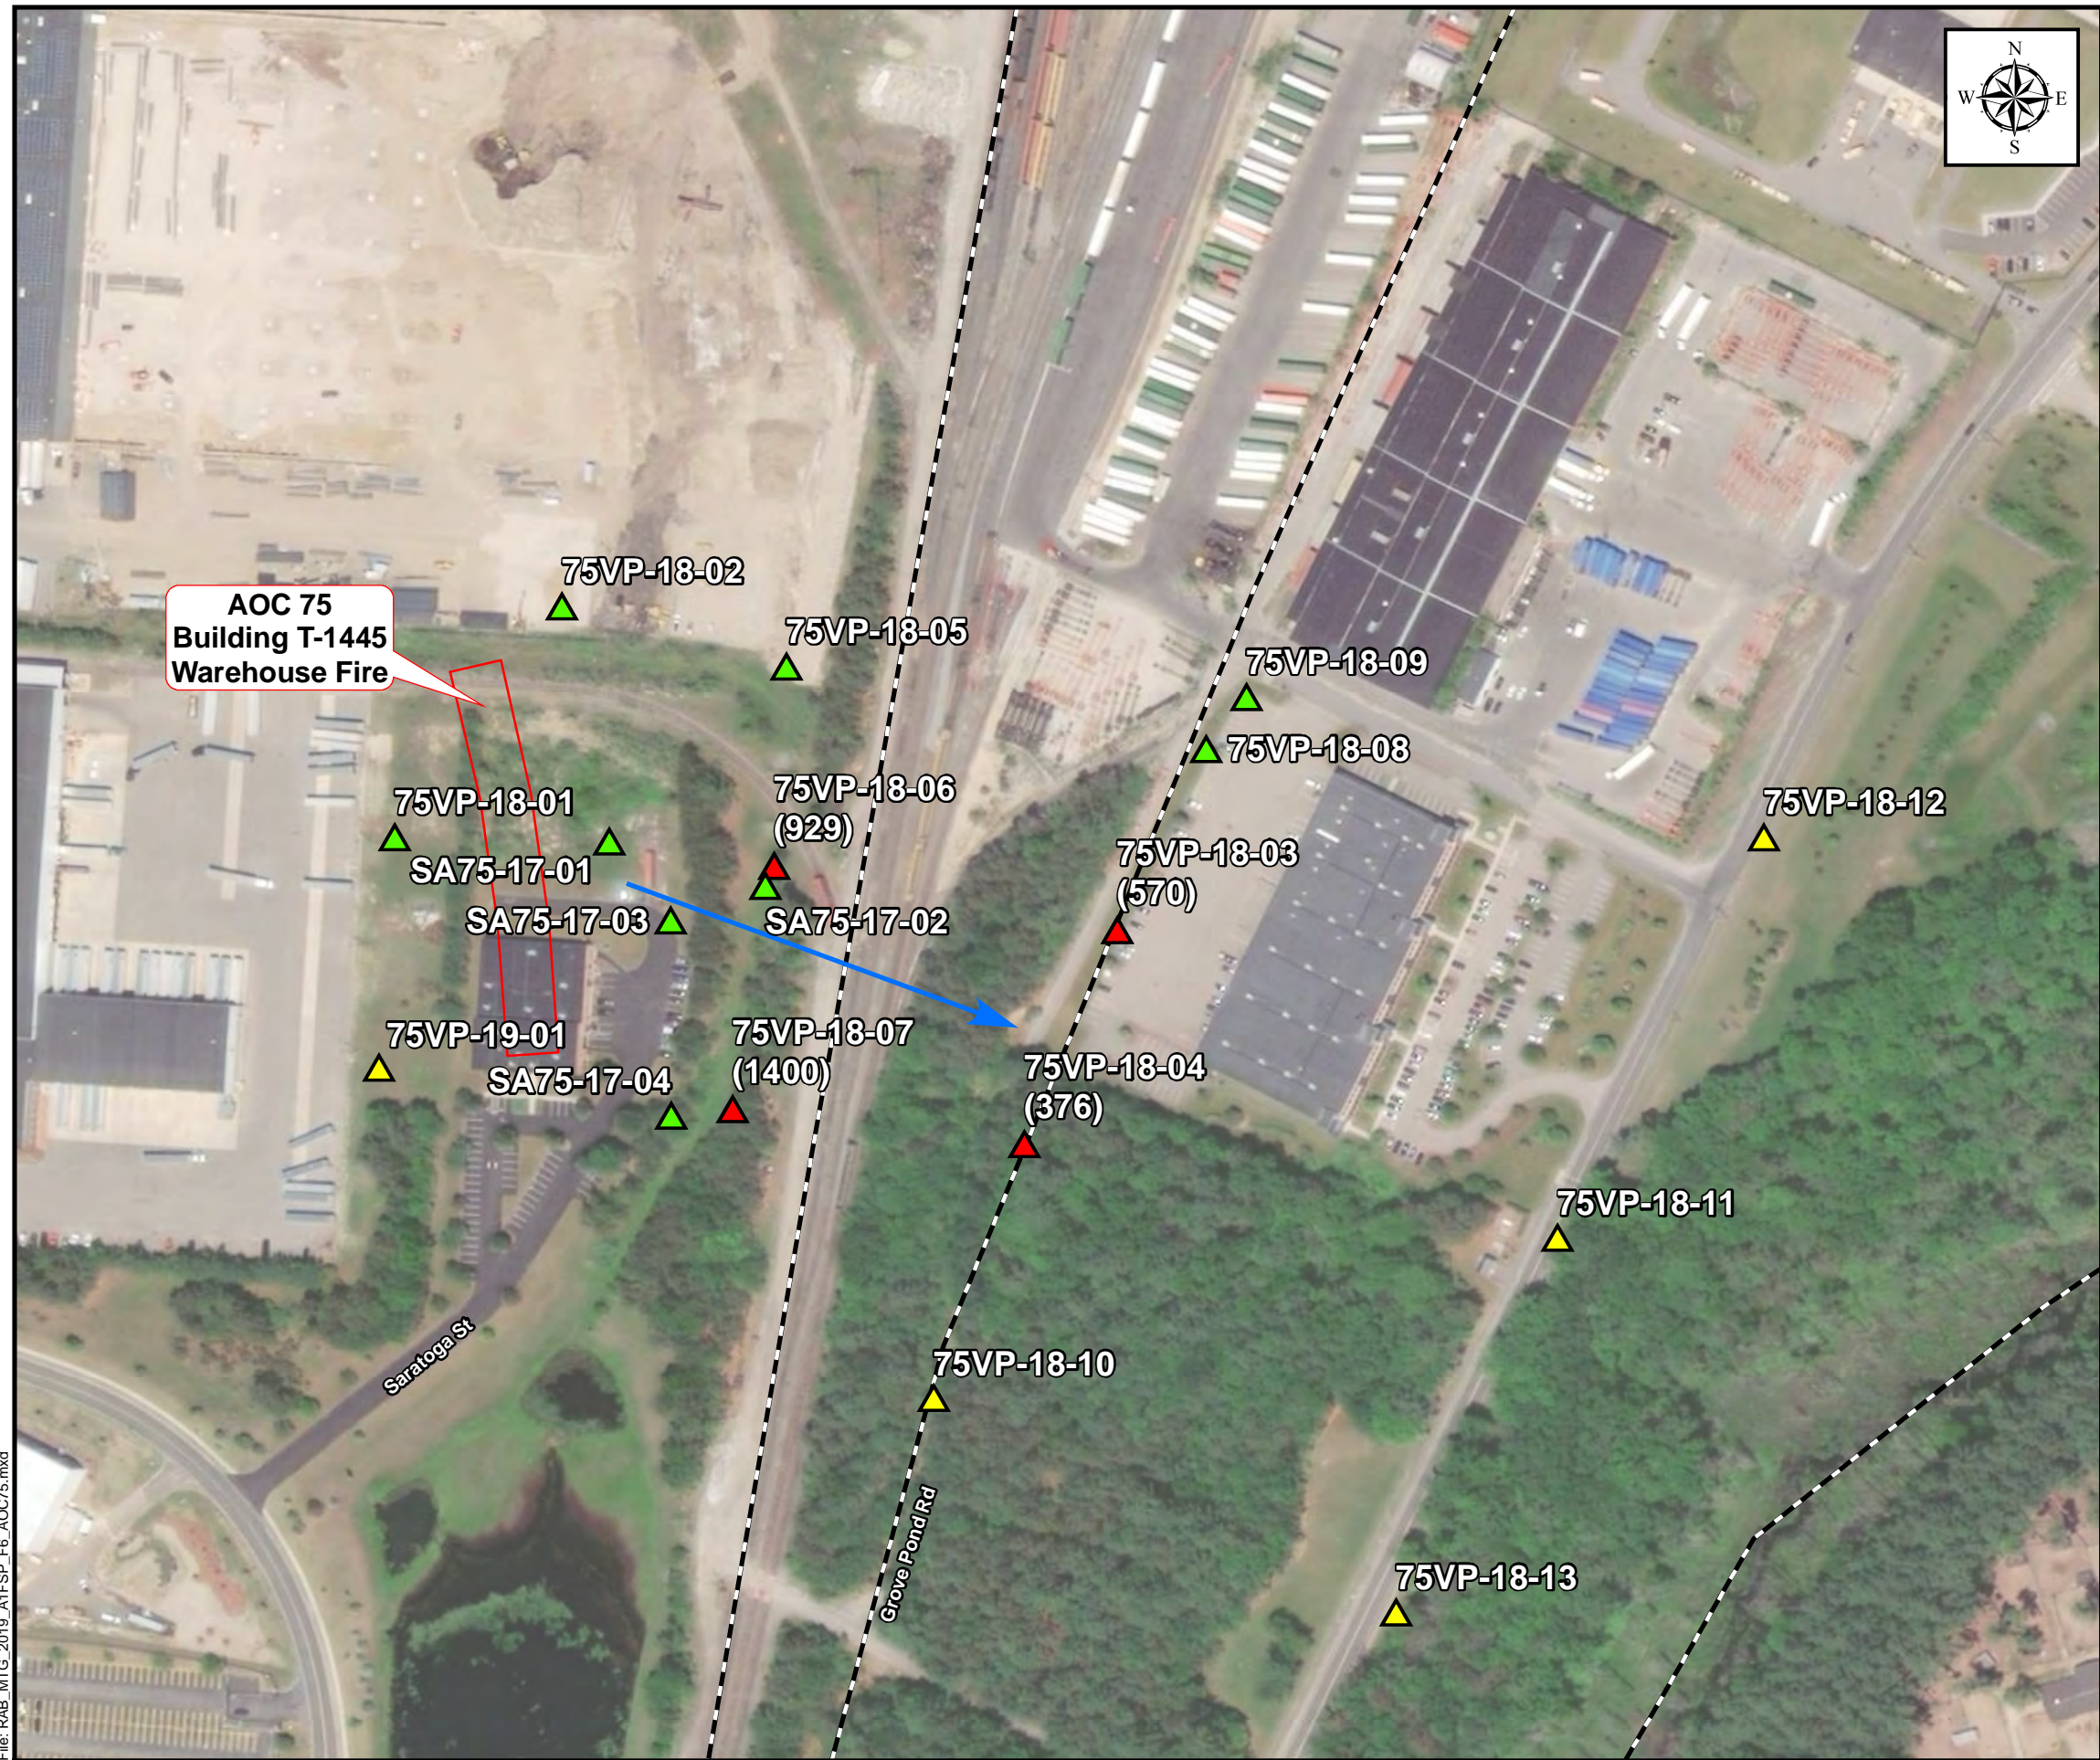
AOC 75 Preliminary Results Devens PFAS RI			
Former Fort Devens Army Installation Devens, Massachusetts			
KOMAN Government Solutions, LLC 293 Boston Post Road West, Suite 100, Marlborough, MA 01752			
0 100 200 Feet	Date: 01/17/2019	Figure .

- AOC 75
  - ▶ 7 soil borings complete (awaiting results)
  - ▶ 14 vertical profiles complete (awaiting results at 5 locations)
  - ▶ 9 locations with groundwater concentrations less than the EPA LHA
  - ▶ 4 locations with groundwater concentrations greater than the EPA LHA
  - ▶ Maximum PFOA+PFOS detection in groundwater is 1,400 ppt

- Legend
- PFOA+PFOS > 70 ng/l
  - PFOA+PFOS < 70 ng/l
  - Drilled, results pending
  - Yet to be Drilled
  - (120) Sum of PFOA and PFOS above 70 ng/L
  - △ Vertical Profiling Location
  - Groundwater Flow Direction
