REMOVAL ACTION COMPLETION REPORT

FOR RAILROAD ROUND HOUSE AND RED COVE

PLOW SHOP POND (AOC 72)

FORMER FORT DEVENS ARMY INSTALLATION, DEVENS, MA

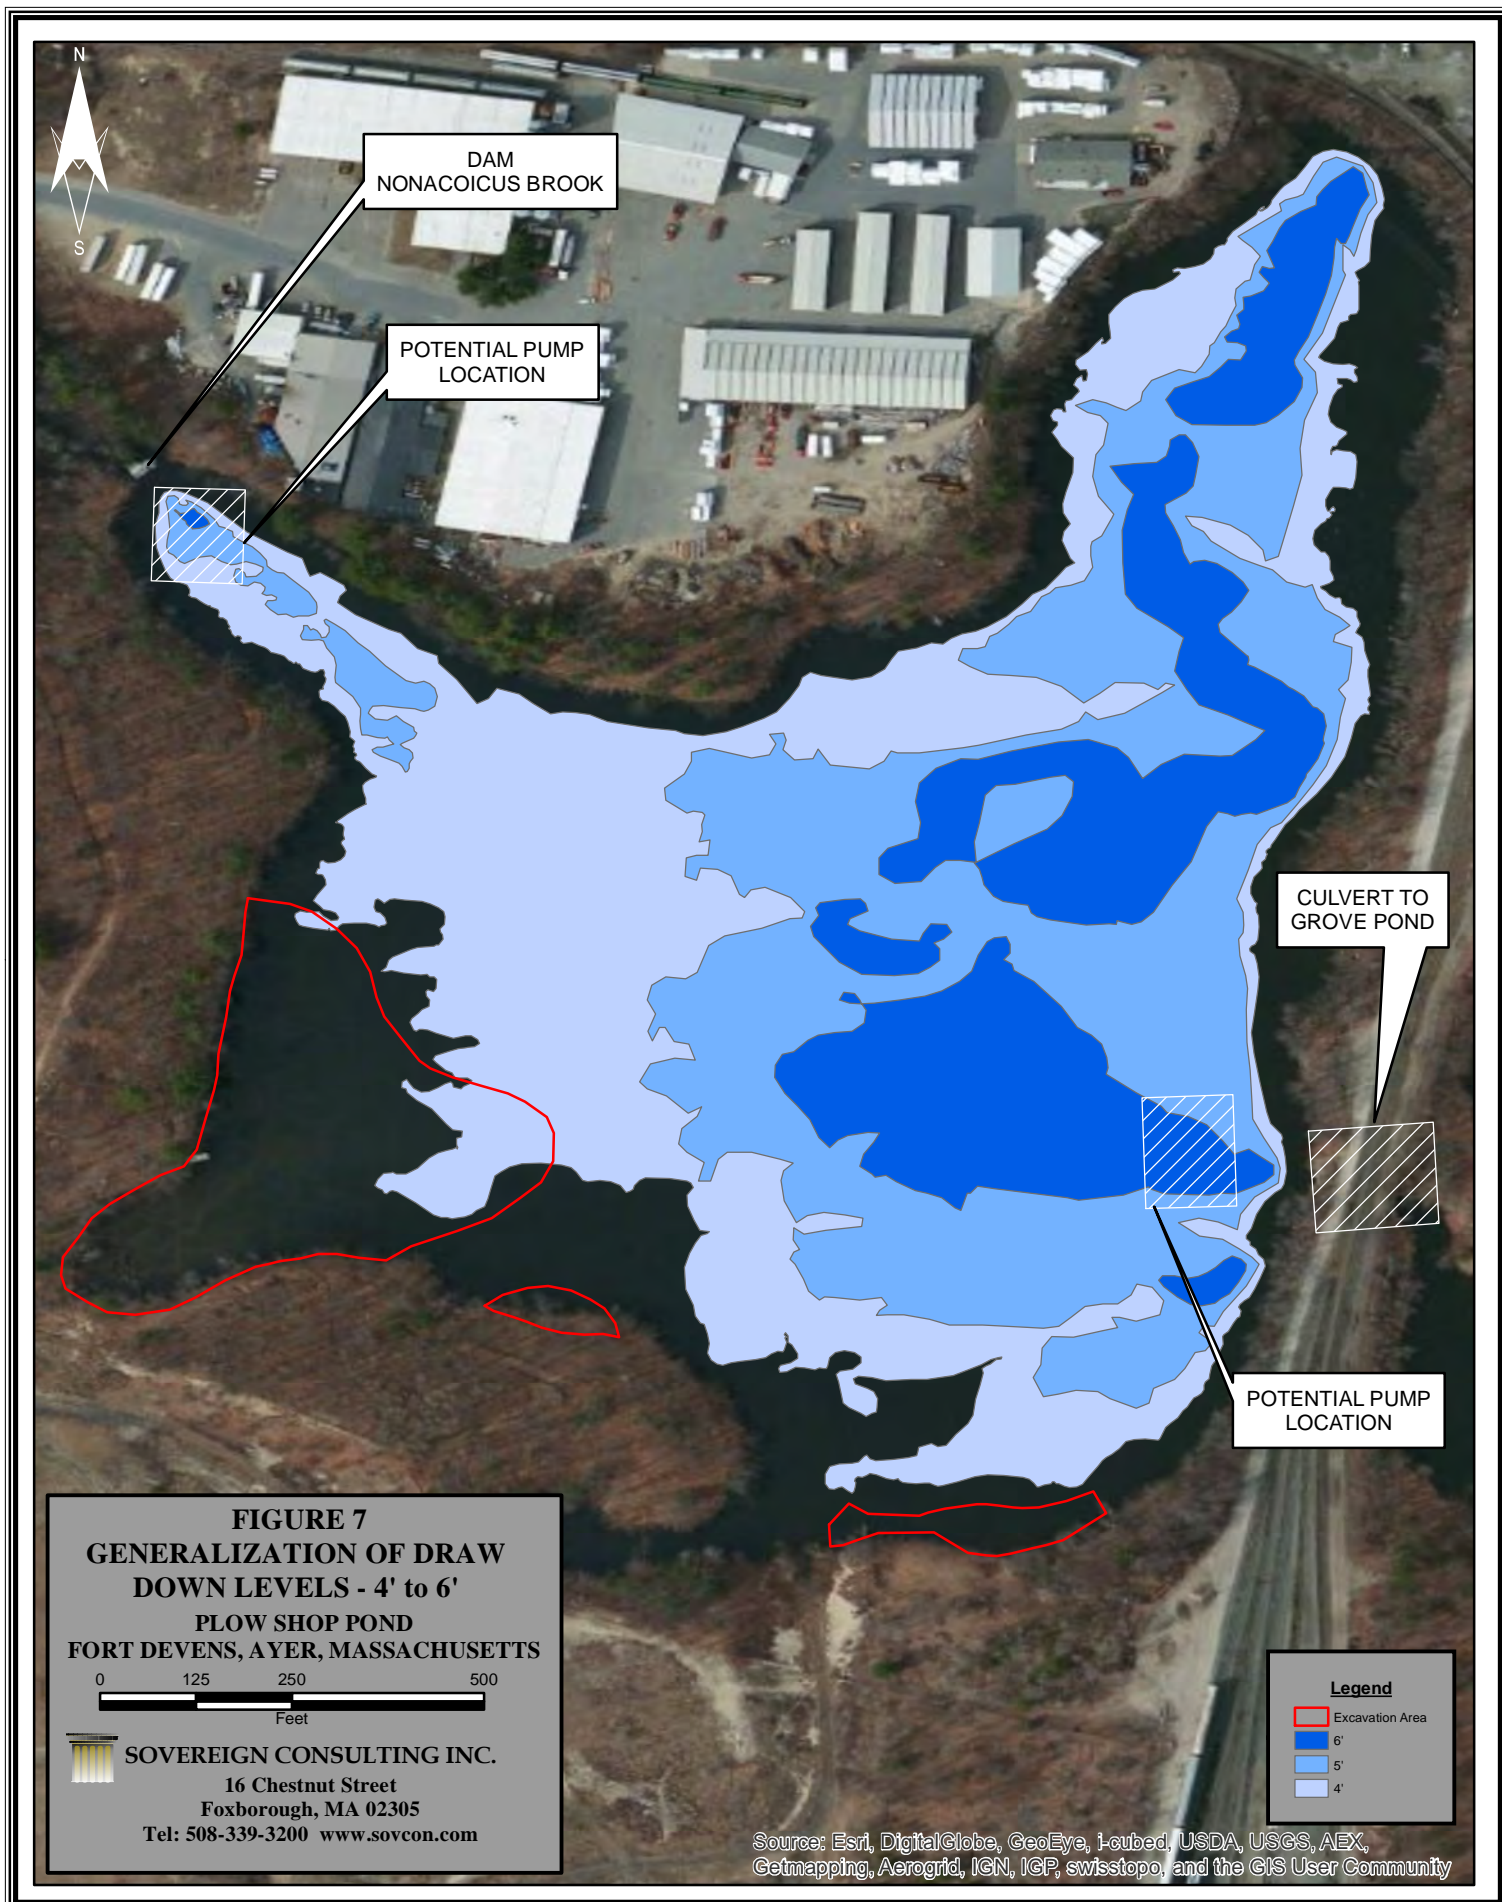
Note: 1. Bathymetric data collected and analyzed by Normandeau Environmental Consultants in December 2012.
 2. Remaining areas at respective draw down level are approximate.

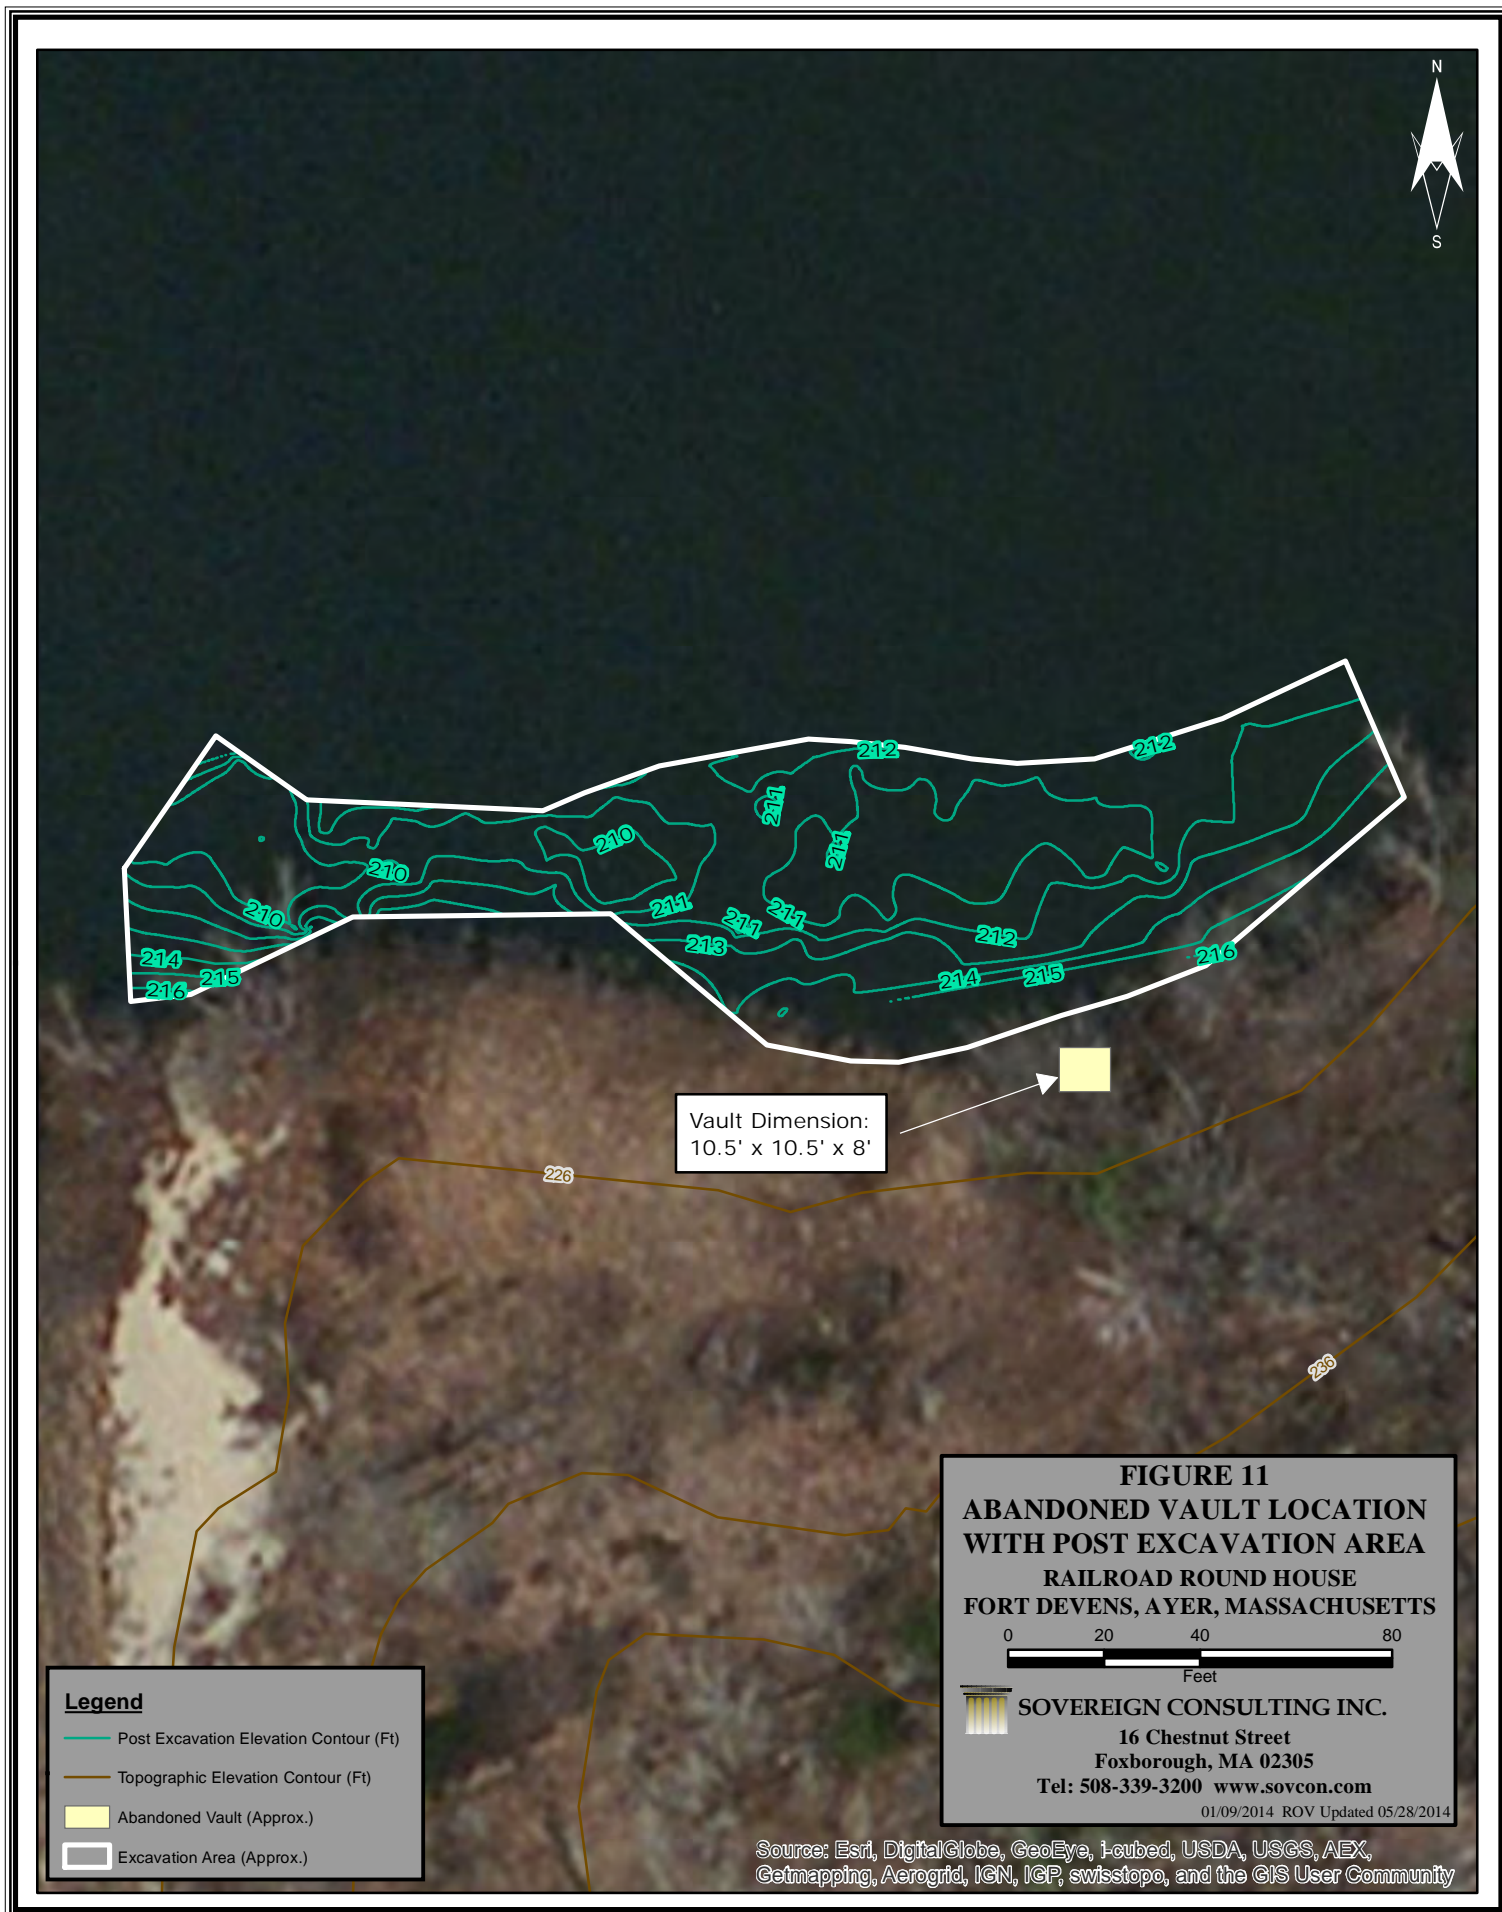
Source: Elevation Contours. 2003. Office of Geographic Information (MassGIS).
Note: The abandoned vault location is approximate.

During the shoreline excavation of Railroad Round House, a buried pre-cast concrete vault was discovered just below the ground surface on the eastern side of the excavation area (**Figure 11**). The vault was opened and sediment samples were taken from inside and outside of the vault for Total Petroleum Hydrocarbons (TPH). Sediments sampled from within the vault contained TPH concentrations of 5,670 ppm and TPH in soils outside the vault were detected at only 159 ppm. The debris and sediment found in the vaults interior was removed by a vacuum truck and hand cleaned with a shovel. The interior of the vault was inspected and all influent and effluent pipe openings were sealed with hydraulic cement. During the inspection of the vault, it was discovered that the vault's bottom was perforated. Following the cleaning, the concrete top was broken up and the vault back filled with clean gravel in accordance with the USACE tank abandonment requirements.
