## **Re: Ayer Ponds – 2022 Year End Report**

### **Summary Of 2022 Management Activities**

**James Lacasse**  
Project Manager  
Senior Environmental Scientist  
c: 774-276-6098  
o: 888-4WETLAN(D)  
[james@waterandwetland.com](mailto:james@waterandwetland.com)  
[www.waterandwetland.com](http://www.waterandwetland.com)

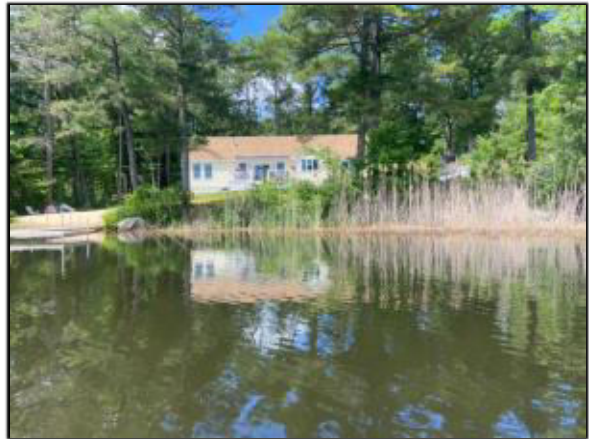
*Figure 1 Previously treated phragmites area*

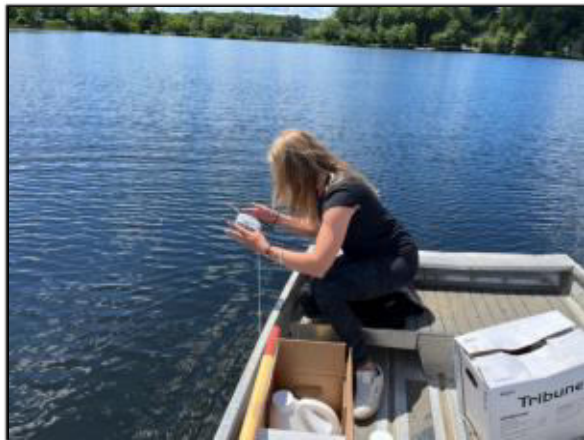
*Figure 2 Collection of Secchi disk data at Sandy Pond*

disappearance, called the Secchi depth, is a measure of the transparency of the water. The Secchi reading was 12ft 2in, which is indicative of excellent water clarity.

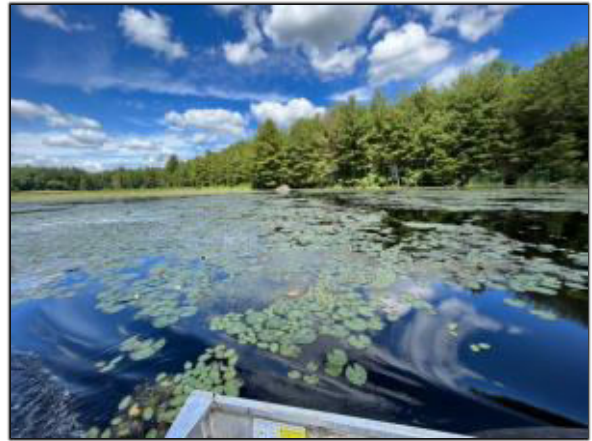
Upon arrival, a survey was conducted using visual observation. This was conducted to confirm the data that was collected during the pre-treatment survey and to further confirm the timing of the treatment. Throughout the pond there were dense densities of watershield and waterlilies, and in the water column there were sparse densities of ribbon leaf pondweed. In the northern end there were also dense populations of cattails. All target species were noted, which were variable milfoil and curly-leaf pondweed; no fanwort was observed. This was consistent with the pre-treatment survey (please refer to pre-treatment survey map noting locations of invasive variable milfoil and curly leaf pondweed).

*Figure 3 Dense waterlilies and watershield*

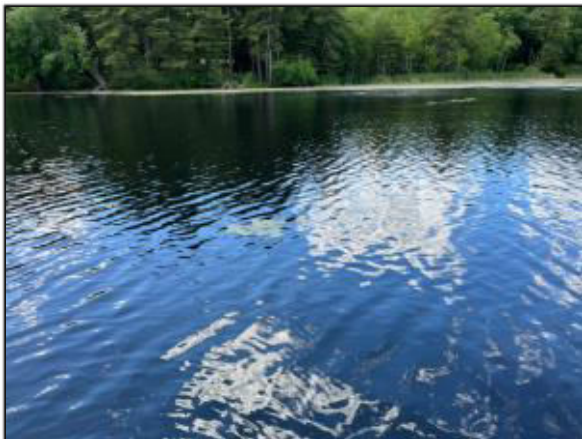
*Figure 4 Open water area in Pine Meadow Pond*

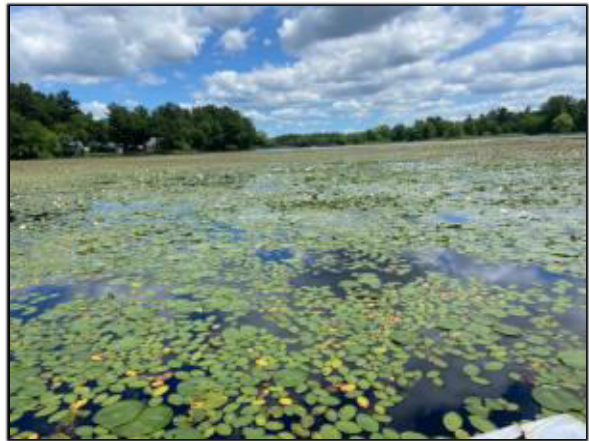
Upon arrival, a survey was conducted using visual observation paired with a standard throw-rake and handheld GPS/ArcGIS Field Maps, as applicable. Along the majority of the shoreline, as well as the coves of the Pond, there were trace to dense densities of waterlilies. The remainder of the waterlilies were scattered throughout the pond, on the surface, as well as in the water column. The target species, curly-leaf pondweed, fanwort, and variable milfoil were all treated, and ranged from trace to dense densities, scattered throughout the pond (see pre-treatment survey maps). The eastern basin in specific had dense densities of bladderwort, with some of it flowering. The fanwort in the eastern basin was observed in moderate to dense densities, also starting to flower. The curly-leaf had slightly decreased in density since the previous visit, as it is a colder water invasive species. Throughout the patches of waterlilies, there were also numerous floating islands, which is a result of the uprooting of the waterlilies. In addition, there were sparse densities of ribbon leaf

*Figure 5 Dense areas of lilies and watershield in Flannagan Pond*

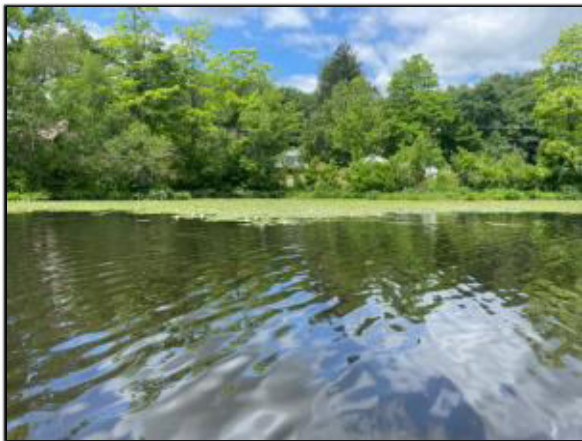
*Figure 6 Open water areas in Flannagan Pond resulting from 2021 Sonar program*

pondweed, a beneficial native plant. It is nice to see native plants like ribbon leaf starting to recolonize following the 2021 extensive Sonar treatment.

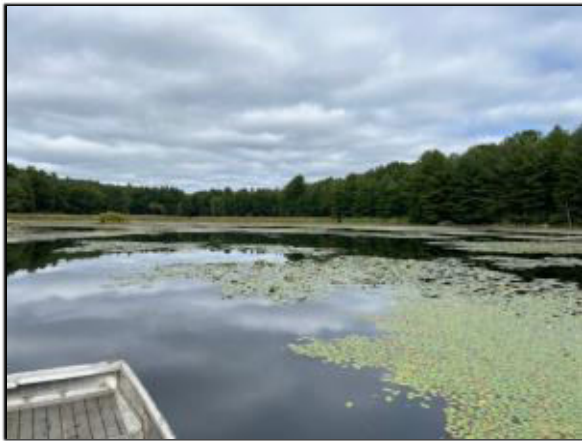
*Figure 7 Lilies on Pine Meadow Pond (South to North view)*

Upon arrival, a survey was conducted using visual observation paired with a standard throw-rake and handheld GPS/ArcGIS Field Maps, as applicable. Rake tosses were thrown regularly throughout the Pond, and information specific to vegetation species was collected using ArcGIS Field Maps application. The Pond looked great as all target species were controlled. Variable milfoil was documented in the southeastern corner but appeared very unhealthy and was covered in epiphytic algae. Epiphytic algae indicates that the plant is dying/decaying. Variable milfoil was only found in this one spot - no other invasive species were noted, including curly-leaf pondweed which was a target of the initial treatment. Watershield, waterlilies, callitriche, bladderwort, coontail, and duckweed were also documented throughout the survey, all native species. Bladderwort, watershield, and waterlilies were the most prominent species observed. Cattails surround the majority of the shoreline, specifically around the northern, western/northwestern, and eastern shorelines. Waterlilies and watershield were scattered in the southern half of the Pond, and more moderate to dense in the northern half.

As planned, a treatment was conducted for the control of waterlilies. The liquid herbicide (Rodeo) was applied using a treatment boat equipped with a calibrated pump system via foliar methodology. This application methodology allows for even coverage within the treatment areas. Posters stating the restrictions (no restrictions) were posted around the Pond several days prior to treatment. The focus of the waterlily treatment is by no means to eliminate waterlilies, but to scale them back to a more desirable density/cover. Due to the density and cover, this process will take several years to continually scale them back. Progress has already been made as open-water habitat has been increased through last year's lily treatment.

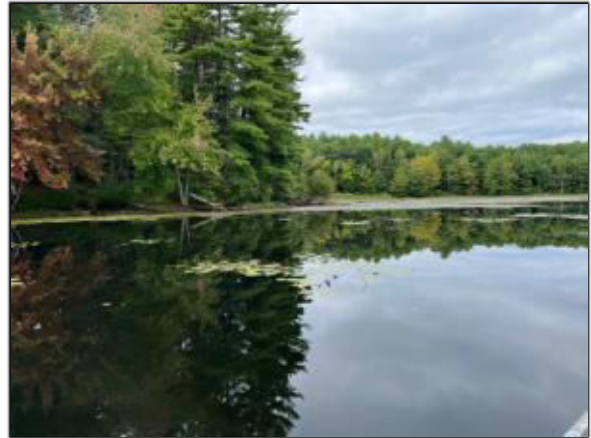
*Figure 8 Photo showing progress in creation of open-water habitat*

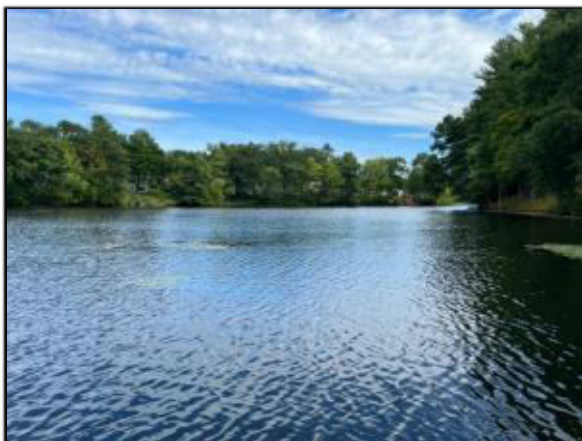
*Figure 9 Open water created at Flannagan Pond*

As planned, started on the 16th and finished on the 21st, a treatment was conducted for the control of waterlilies. The liquid herbicide (Rodeo) was paired with a non-ionic surfactant which acts as a sticking agent and increases uptake, was applied using a treatment boat equipped with a pump system via foliar methodology. This application methodology allows for even coverage within the treatment areas. Posters noting any affiliated water-use restrictions were posted several days ahead of each treatment, and the Conservation Commission was also notified in advance of both visits.

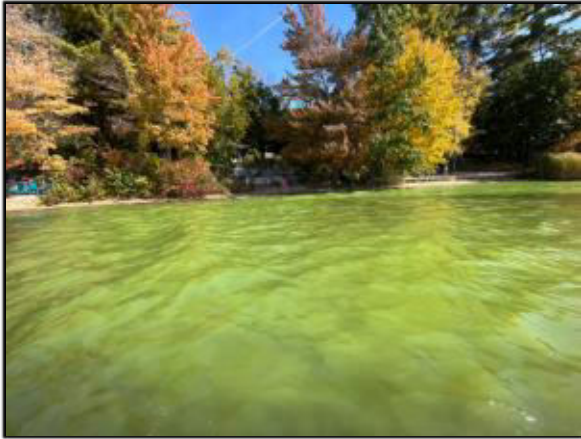
*Figure 11 Dense microscopic algae bloom in windblown areas*

microscopic algae bloom documented throughout the Pond, visible both on the surface and throughout the water column. It was especially dense in wind-blown areas of the Pond. This caused the color of the Pond to appear "green" and resulted in decreasing water clarity/quality. Because a public health advisory was in place, we were unable to treat waterlilies and/or phragmites this season. A special condition within MA-DEP WM04 permits prevents the licensed applicator from treating a pond when an advisory is in place. This treatment was not invoiced to the Town.

While on-site, basic water quality was collected using calibrated meters. The water temperature was consistent with other similar waterbodies we manage in the area, and the dissolved oxygen was sufficient to support fish and wildlife. Water clarity was also assessed using a Secchi disk. The Secchi reading was 2'10", which illustrated poor water clarity. This was due to the microscopic algae bloom.

Algae control is not part of the Ayer's management program, and the bloom came on late in the season, so no action was taken to resolve the issue. We take the bloom extremely seriously and have included information pertaining to both proactive and reactive control within the recommendations section below.

Ultimately, based on the above dialogue and analysis, the immediate recommendation for either just Sandy Pond, or all three Ayer Ponds would be collection of a baseline water quality sample which includes several basic parameters as well as a suite of nutrients. This may help us “predict” blooms. Aside from this, we are always available to either collect on-call samples for algae ID and enumeration, or if budget allows, set a regular program to monitor algae species and counts. By using this data, we can determine the need for an algaecide treatment prior to conditions shutting down the waterbody. The best approach to actual management in 2023 is on-call algaecide applications with copper-sulfate if needed based on either visual monitoring, or sampling. Copper sulfate is frequently used in drinking water reservoirs, so it is extremely safe. By applying copper sulfate at the early stages of a bloom, we can control it prior to it reaching a level which would warrant a pond shut down. Copper sulfate applications are limited to ½ of the waterbody at a time per the product label. We have provided copper sulfate application costs for all three ponds within our cost table. It is recommended to budget a small amount towards copper sulfate application if applications are necessary during the 2023 season.

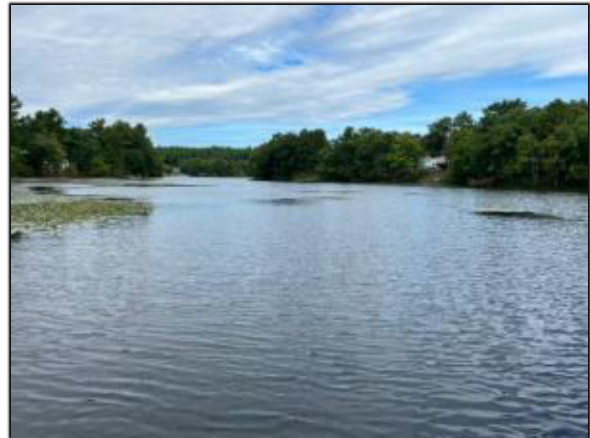
Figure 12 Flannagan Pond

Prior to the 2021 Sonar “reset” performed in Flannagan Pond, dense fanwort had taken over the majority of the Pond. A drastic reduction in fanwort was documented during the 2022 season, leading to much improved conditions. Despite this, we are still battling several invasives including areas where less multi-year fanwort control was achieved. These include higher flow areas, and an area that was avoided in 2021 due to the presence of a swan’s nest. Variable milfoil was also greatly reduced from the 2021 effort. Curly-leaf pondweed is a perennial plant that reproduces through turions. The turions typically germinate in the fall and the curly leaf pondweed plants typically grow extensively shortly after ice-out in the Spring. Given that CLP turions can survive at least five years of dormancy in ponds, annual control is recommended to gain extensive control over time.

Based on this information, the continued maintenance approach to invasive species control in Flannagan Pond is recommended. This includes use of diquat herbicide for the control of variable milfoil and curly-leaf pondweed regrowth. Unfortunately, diquat is not effective on fanwort so other options must be considered. There are only two MA/EPA approved herbicides which have efficacy on the invasive fanwort. The first is flumioxazin, commonly called by the brand name Clipper. Clipper is a contact herbicide, much like diquat. It provides seasonal fanwort control and must be repeated annually. Unfortunately, Clipper is not approved in the Ayer Ponds which only

Excessive waterlily growth has taken over much of Flannagan Pond, which is generally what most abutters ask us about when we are posting/treating. Waterlilies are a native species which provide valuable habitat and cover. Dense waterlily growth such as in Flannagan Pond can limit oxygen transfer and biodiversity. The waterlilies have been greatly reduced over the years, but there is still work to be done. Reduction was experienced from 2021 to 2022 and we anticipate further reduction in waterlily regrowth into 2023 (from the 2022 treatment). A similar treatment should be conducted during the 2023 season. We are able to save on costs by pairing this treatment with the post-management survey. Waterlily treatment is most effective late in the season, so this timing works extremely well. The goal will never be to eliminate lilies, but rather to scale them back to a more desirable and beneficial density and cover.

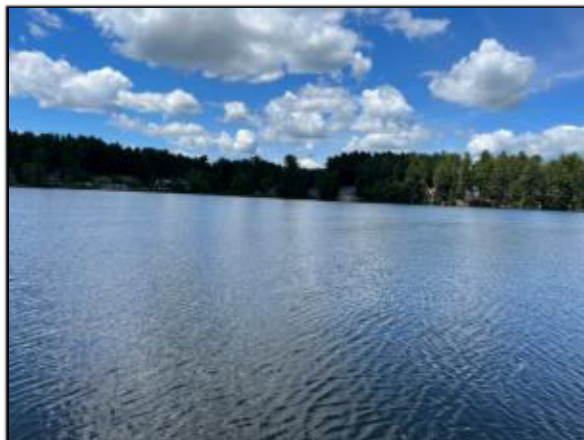
*Figure 13 Sandy Pond*

Sandy Pond has historically battled three invasive species: fanwort, variable milfoil, and curly-leaf pondweed. Luckily, Sandy Pond is deep, and these invasive species have stayed confined to only a few small areas. This allows for spot-management of curly-leaf pondweed and variable milfoil with diquat, and management of fanwort with Sonar One. This program should continue in 2023. It is important to ensure that treatments are timely. We recommend continuing with the initial Sonar treatment during the pre-management survey, with treatment areas to be based on 2021 maps. Additionally, the Sonar booster application can be applied with the mid-June diquat application. Sandy Pond has less issues with waterlilies than Flannagan Pond and Pine Meadow Pond, but waterlilies should continue to be monitored and scaled back as necessary. The several areas of invasive phragmites around the shoreline of Sandy Pond should also be monitored and treated as necessary as well. Drastic reduction in phragmites regrowth was achieved from the 2021 treatment, but they were unable to be treated in 2022 due to the public health advisory.
