## **Re: Ayer Ponds (Sandy Pond, Flannagan Pond, and Pine Meadow Pond) – 2023 Year End Report – DEP File #100-0293**

It is our pleasure to present a year end summary report regarding the 2023 Aquatic Management Programs at the Ayer Ponds (Flannagan Pond, Sandy Pond, and Pine Meadow Pond). The Town's objective of the aquatic management program is to manage invasive species and nuisance waterlilies within the three waterbodies. The purpose of the program is to restore and maintain habitat, public enjoyment, and recreation. These goals were met during the 2023 season through monitoring, reporting, communication, and treatments. Prior to the start of the program, a plan was developed for each individual Pond, based on its unique needs.

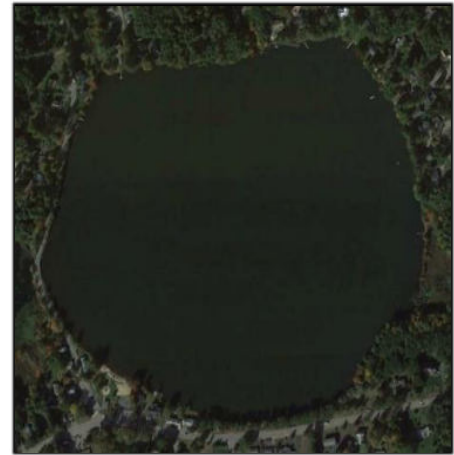
Figure 3: Sandy Pond - Ayer, MA

Sandy Pond (Figure 3) is the eastern most waterbody out of the three Ayer Ponds and is approximately 70 acres. The Pond is primarily surrounded by sparse woodlands and developed residential properties around the northern and southern shorelines. A small wetland area is located along the southeastern shoreline, which leads to Long Pond Brook. Sandy Pond Beach is found within the southwestern corner of the Pond, which is free to use for the residents of Ayer, and a small fee for non-residents. Sandy Pond Road (to the south), Snake Hill Road (to the west), and Wright Road (to the north and east) are the major roadways that border Sandy Pond. Access to the waterbody is granted through a pull-off on Snake Hill Road, or by navigating through the culvert that connects Sandy Pond and Flannagan Pond. Sandy Pond is a popular recreational waterbody for fishing, swimming, and boating.

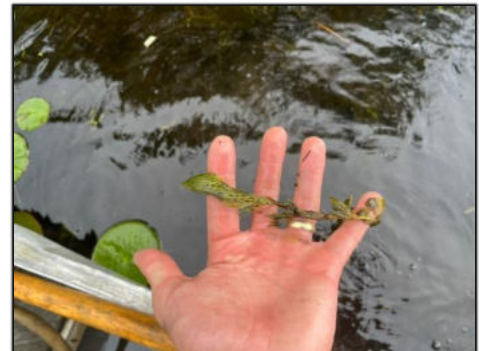
During the survey, four invasive species (invasive growth documented in Figure 4) were again observed in Sandy Pond, including fanwort (pictured in Figure 5 below), variable milfoil, curly-leaf pondweed, and phragmites. The phragmites were noted along the northern shoreline in a small number of separated populations. Fanwort, variable milfoil, and curly-leaf

Figure 5: Fanwort observed at Sandy Pond

The fanwort spots were treated with Sonar One, time released granular formulation, as planned. Sonar One allows for spot-treatment of fanwort, which is typically difficult with Sonar as it requires roughly 60+ days of contact exposure time at concentrations above 8+ parts per billion. The following planned diquat treatment would target the invasive milfoil and curly-leaf pondweed. At the same time as the next treatment, a “bump” Sonar treatment would be applied to the fanwort. Phragmites regrowth would be targeted during the later season treatment. The pH was documented at 7.0, which is within a standard range for freshwater and is considered neutral.

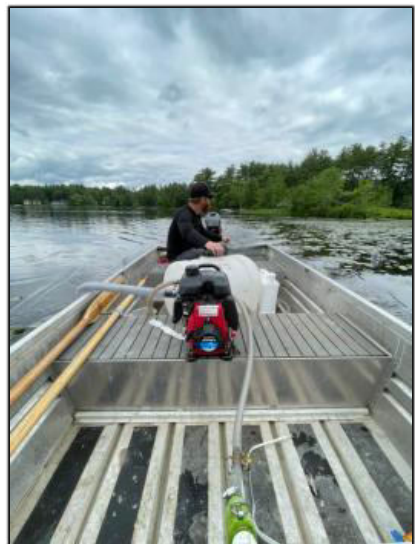
*Figure 7: Water and Wetland conducting a treatment at Sandy Pond*

Granular Sonar (fluridone) formulation was applied using a calibrated blower/spreading equipment. This was applied to the target fanwort growth as diquat does not impact fanwort. Sonar works best early in the season, as immature plants are most susceptible to low concentrations of fluridone. Sonar works by maintaining concentration of fluridone within the management areas, so this treatment was considered a “booster” to help maintain the fluridone concentration generated by the initial treatment applied several weeks ago. The granular time-released formulation of Sonar was again selected as it is the only possible way to maintain concentrations in small areas/spot-treat. In addition to the Sonar, diquat herbicide was applied for the control of curly-leaf pondweed and variable watermilfoil (see treatment application in Figure 7). The liquid contact herbicide was applied using a treatment boat equipped with a calibrated sub-surface injection system. This application methodology allows for even coverage within the treatment areas. The treatment was completed without issue. We anticipated die-off of curly-leaf pondweed and variable milfoil within just a few days to a few weeks; whereas the fanwort die-off would be slower given how Sonar works. Phragmites regrowth was noted in patches around the shoreline, this was targeted later in the season to allow for translocation of the systemic herbicide down into the rhizomes of the phragmites plants. Nuisance waterlilies were targeted at the same time. Generally, the management areas in Sandy Pond are small and were consistent with previous years in terms of locations.

Several days prior to the treatment, neon signs were posted around the shoreline noting the treatment, affiliated water-use restrictions, and Water & Wetland contact information. The treatment was performed late in the day so as not to interfere with recreation. We planned the phragmites/lily treatment for after the beach closes.

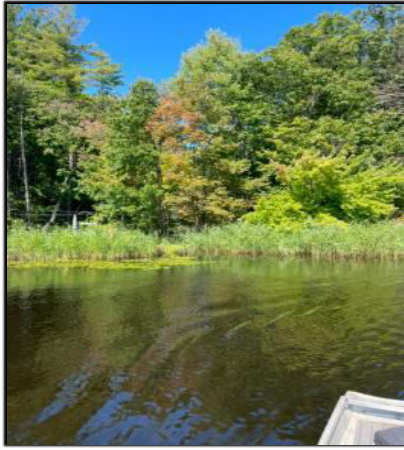
Figure 10: An area of phragmites documented at Sandy Pond

Two treatments were conducted during the site visit. The first treatment was a treatment conducted for the control of invasive phragmites (pictured in Figure 10). There were a handful of areas that contained phragmites, specifically along the northern shoreline, and a few smaller stands along the eastern and southern shorelines. The liquid herbicide was applied using foliar application methodology. Phragmites in low densities and/or phragmites plants in close proximity to non-target native species were individually hand-wiped to minimize/negate any non-target impacts. These methods allow for even and precise coverage. The phragmites were accessed via boat, as most applicable. Weather was also closely monitored prior to treatment to ensure a treatment date without rain or high winds.

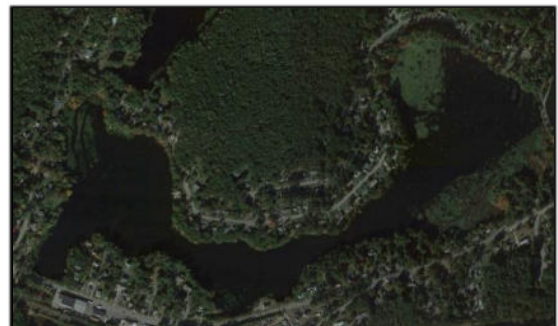
Figure 11: Flannagan Pond - Ayer, MA

Flannagan Pond (Figure 11) is found in the middle of Sandy Pond and Pine Meadow Pond and is approximately 87 acres. Flannagan Pond is surrounded by sparse woodlands and wetlands, with residential properties along the northern, western, and southern shorelines. The Pond is fairly shallow, as the entirety of the waterbody is considered a littoral zone. Access to the Pond was granted from the Ayer Water Department building located on the southern shoreline, off Central Avenue. The inlets at Flannagan Pond are found on the eastern shoreline (from Sandy Pond) and within the

northwestern cove (from Pine Meadow Pond). The outlet is located in the southwestern cove which feeds Balchs Pond. Flannagan Pond is a popular recreational waterbody for activities such as fishing and boating.

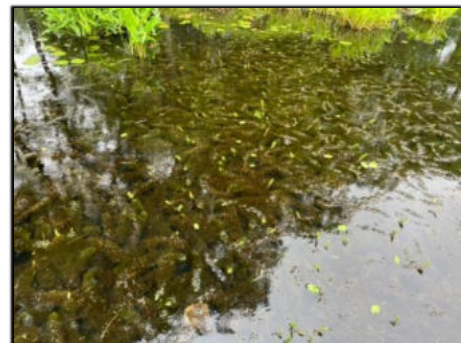
Four invasive species were documented within Flannagan Pond during the 2023 pre-treatment survey. These species included fanwort (Figure 12), variable milfoil (Figure 13), curly-leaf pondweed, and water chestnut (Figure 14). Curly-leaf pondweed was the most prominent invasive noted as it was found throughout the Pond in sparse to moderate densities. Fanwort was primarily found scattered along the southern shoreline, southwestern cove, northwestern cove with isolated densities along the northern cove. Fanwort was not found within the eastern basin; this was extremely encouraging. Variable milfoil

Figure 13: Variable milfoil surfacing, occasionally flowering at Flannagan Pond

was noted in the northwestern cove and within the eastern basin. Only a handful of water chestnut plants were identified within the eastern basin (scattered, isolated populations illustrated in Figure 14). To our knowledge, this is the first-time water chestnut has been documented in Flannagan Pond. While outside of the scope of our contract, we hand-pulled this species when encountered. Native species documented during the survey included bladderwort, ribbon-leaf pondweed, watershield, waterlilies, Robbins Pondweed, and thin-leaf pondweed (*Potamogeton pusillus*). Filamentous algae and epiphytic algae were also noted in varying densities. The densest filamentous algae was along the northern shoreline in the western basin.

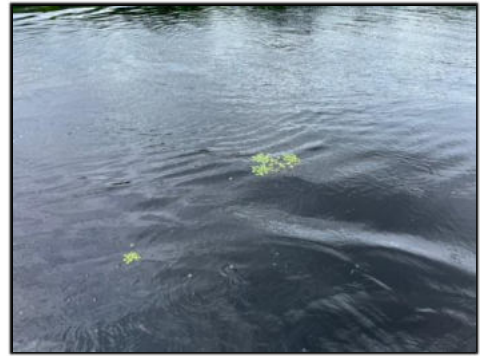
Figure 14: Water chestnut documented

This year, we found water chestnut in Flannagan Pond, albeit just a few plants. Luckily, this species was caught early, and we removed all plants prior to them setting seed. We will remain diligent about monitoring for water chestnut not only in Flannagan Pond, but in all three ponds. When encountered, we plan to hand-pull this species and to properly discard off-site.

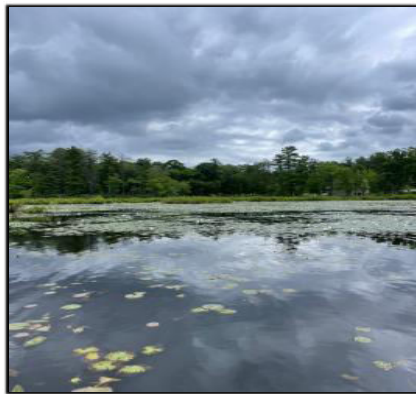
Figure 15: Overlooking dense pondweeds at Flannagan Pond

Upon arrival, a survey was conducted to evaluate the effectiveness of the previous treatment. Conditions were similar to those of the pre-management survey although the initial Sonar treatment was starting to show signs of fanwort control. The pH was measured at 7.5 which is within a standard range for freshwaters and is considered fairly neutral. Waterlilies were beginning to take over large areas of Flannagan Pond (pictured in Figure 15) and would be treated later in the season. Other species noted during the survey included curly-leaf pondweed, variable milfoil, ribbon-leaf pondweed, and coontail.

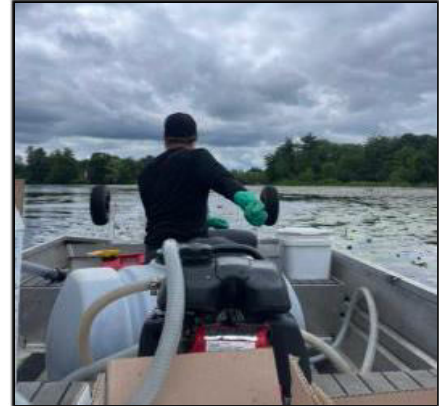
Figure 16: Water and Wetland conducting a treatment

Granular Sonar (fluridone) formulation was applied using a calibrated blower/spreading equipment. This was applied to the target fanwort growth as diquat does not impact fanwort. The application methodology allows for even coverage within the treatment areas. Sonar works best early in the season, as immature plants are most susceptible to low concentrations of fluridone. In addition to the Sonar, diquat herbicide was applied for the control of curly-leaf pondweed and variable watermilfoil. The liquid contact herbicide was applied using a treatment boat equipped with a calibrated sub-surface injection system (illustrated in Figure 16). The treatment was completed without issue. We anticipated die-off of curly-leaf pondweed and variable milfoil within just a few days to a few weeks; whereas the fanwort die-off would be slower given how Sonar works. This treatment would only have minimal effects on nuisance waterlilies, only within the Sonar treatment areas. Treatment specific to waterlilies occurred later in the season (September). Several days prior to the treatment, neon signs were posted around the shoreline noting the treatment, affiliated water-use restrictions, and Water & Wetland contact information.

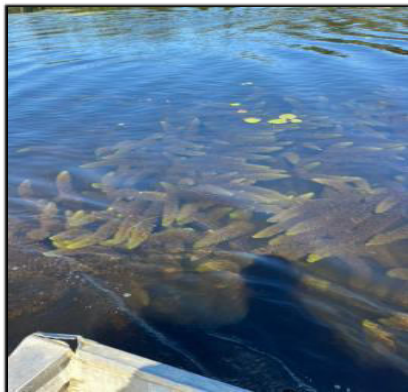
Figure 17: Variable milfoil documented during the survey

Two invasive species were noted during the survey, fanwort (see Figure 18), and variable milfoil (Figure 17). Curly-leaf pondweed was not documented during the survey. Variable milfoil was very much scattered in low densities when found (See small patch in Figure 17). Fanwort was only targeted in select areas based on the 2022 post-management survey. In these treatment areas, fanwort growth was greatly

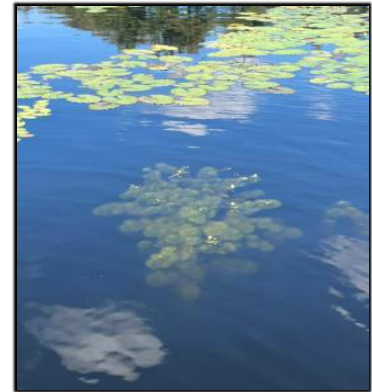
reduced (>90%). Unfortunately, fanwort was again spreading to additional areas which should be addressed in 2024, if budget allows. In these areas it was documented in varying densities, ranging from just trace to moderate. It did not reach dense densities in any location, as the Sonar within the treatment areas likely still had some impacts outside the management areas. Other species noted during the survey included cattails, Robbin's Pondweed, ribbon-leaf pondweed, tapegrass, watershield, and duckweed.

Figure 18: Fanwort flowering

Looking forward to 2024, we recommend that Flannagan Pond be prioritized as ultimately another whole-pond Sonar treatment would highly benefit the Pond. This would target all target species in Flannagan Pond, so diquat would not be needed if this approach is taken. Sonar would provide some reduction to waterlilies; however much higher rates of fluridone would be needed to fully control lilies. Given this, we recommend the rate appropriate for control of the other species, paired with a follow-up foliar waterlily treatment.

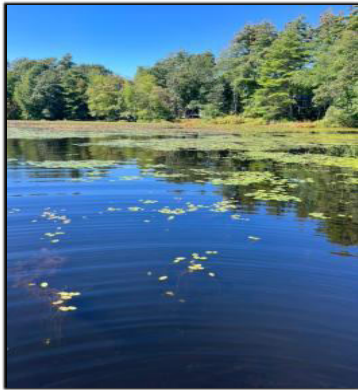
Figure 19: Dense waterlilies and pondweeds within Flannagan Pond

A treatment was conducted for the control of nuisance level waterlilies. The liquid herbicide was applied using the most appropriate boat, equipped with a calibrated pump, which is used to target the nuisance lilies via foliar application methodology. This method allows for even and precise coverage. Weather was also closely monitored prior to treatment to ensure a treatment date without rain or high winds. Waterlilies are a native species, so the goal of the program was to scale back nuisance level lilies, but not eliminate all waterlily growth. Lilies provide valuable habitat and cover; however, dense lilies covering large areas have the ability to limit oxygen transfer and biodiversity. Although, given the density and cover of lilies in Flannagan Pond, it is worth considering an initial and a follow-up treatment in Flannagan Pond in 2024. These treatments would be spaced approximately two-four weeks apart from

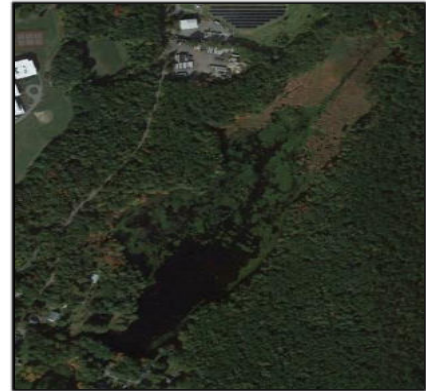
Figure 20: Pine Meadow Pond - Ayer, MA

Pine Meadow Pond (pictured in Figure 20) is found north of Flannagan Pond, as this waterbody is also called "Upper Flannagan Pond". Pine Meadow Pond is approximately 34 acres and is fairly shallow throughout the entirety of the Pond as the whole Pond would be considered a littoral zone. The Pond is primarily surrounded by woodlands and wetlands, with a few residential properties along the southern and southwestern shorelines. Groton-Harvard Road borders the western shoreline (through the woods) and Oak Ridge Drive is found along the southern shoreline. Ayer Conservation hiking trails are located through the woods along the western shoreline (off Groton-Harvard Road). The Pond receives flow from

Rock Meadow Pond as the flow within the Pond moves from north to south. The outlet is found along the southern shoreline, with flows into Flannagan Pond. Access to Pine Meadow Pond was granted off Oak Ridge Drive.

Historically, Pine Meadow Pond has battled several invasive species including fanwort, variable milfoil, water chestnut (*Trapa natans*), and curly-leaf pondweed, in addition to nuisance densities of pondweeds, specifically waterlilies. The goal of the 2023 program was to manage the invasive species and waterlily population while examining basic water quality through a proactive monitoring schedule. This would be accomplished by implementing an aquatic management program that focused around performing all applicable tasks, including planning, permitting, surveys, treatments, and reporting.

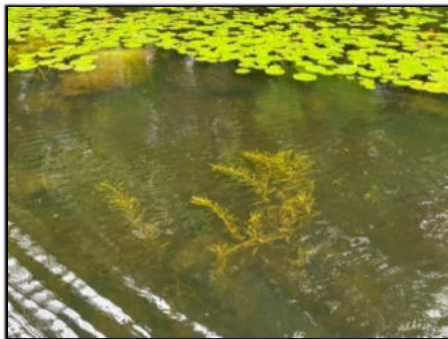
Figure 21: Curly-leaf pondweed documented during the survey

The pre-management survey was consistent with the 2021 and 2022 pre-treatment surveys. Two invasive species were documented throughout the survey, which included curly-leaf pondweed and variable milfoil. Curly-leaf pondweed was the more dominant invasive noted as it was observed throughout the majority of the Pond ranging from sparse to dense densities

(Figure 21). The densest curly-leaf pondweed and variable milfoil was documented in the northern half of the Pond. Native species (See Figure 23 below) observed included waterlilies, watershield, bladderwort, duckweed, and thin-leaf pondweed. Various forms of algae were noted as there were moderate to dense densities of filamentous algae and macro-algae, with small amounts of epiphytic algae. Filamentous algae

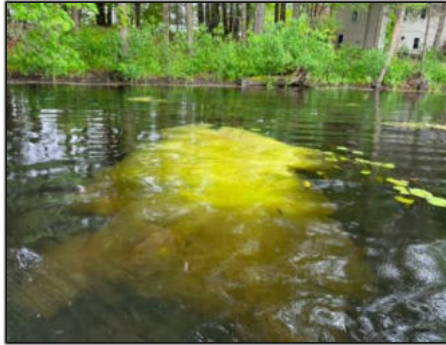
*Figure 22: Filamentous algae seen growing throughout the water column and surfacing*

was noted on the bottom, in the water column, and surfacing (reference Figure 22). Macro-algae was noted throughout much of the Pond along the bottom, occasionally growing through the water column. Epiphytic algae was noted on roughly 5-10% of the vegetation, specifically variable milfoil. Pollen was noted on the surface especially against windblown shorelines. A handful of floating islands were observed throughout the dense populations of waterlilies and watershield. Native cattails (cattails visible in the background of Figure 23 below) surrounded the eastern, northern, and portions of the western shoreline. Curly-leaf pondweed was found in the middle to western half of the Pond, with scattered variable milfoil mixed in. Milfoil was found mixed within the open areas of waterlilies. Fanwort was not found in Pine Meadow Pond, which is consistent with previous years. The waterlily population was notably reduced from last year's treatment – which helps promote open water habitat. The surface dissolved oxygen collected during the survey was 7.66 mg/l, which is sufficient to support fish and wildlife. The pH was documented at 6.6, which is within a standard range for freshwater, and is considered fairly neutral. The planned diquat treatment would target the areas of variable milfoil and curly-leaf pondweed. Diquat is highly effective at providing seasonal control of both species.

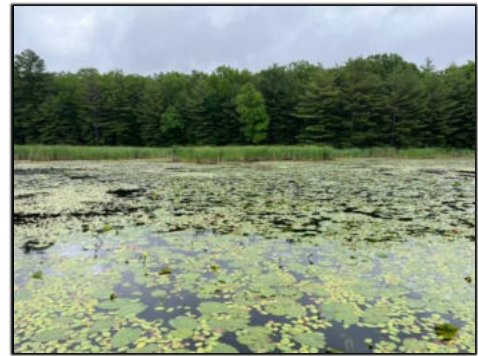
*Figure 23: Dense native pondweeds, specifically waterlilies and watershield, surfacing at Pine Meadow Pond*

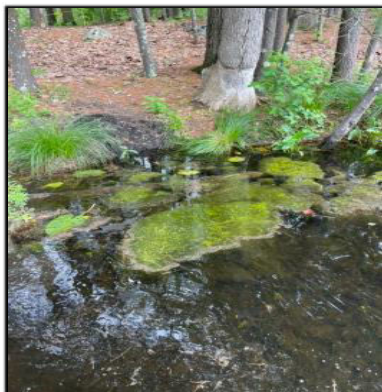
*Figure 24: Filamentous algae noted during the site visit*

Upon arrival, a brief survey was conducted in order to confirm potential treatment areas. Filamentous algae was noted on the surface during this visit (illustrated against a wind-blown shoreline in Figure 24). Variable milfoil was mature at the time of the treatment. Curly-leaf pondweed was still present at the time of treatment. Waterlilies had begun to take over the middle and perimeter of the Pond (pictured in Figure 25 below), which would be targeted later in the season. Other species noted during the survey included cattails, benthic algae, and watershield.

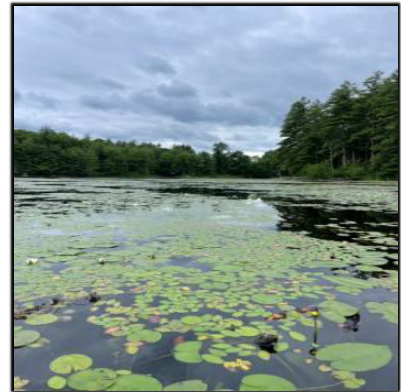
*Figure 25: Waterlilies and watershield growing to nuisance densities*

As planned, a treatment with diquat was conducted for the control of target nuisance/invasive plant growth including curly-leaf pondweed and variable milfoil. The liquid contact herbicide was applied using a treatment boat equipped with a calibrated sub-surface injection system. This application methodology allows for even coverage within the treatment areas. The treatment was completed without issue. We anticipated plant die-off within just a few days to a few weeks. Days prior to the treatment, the shoreline was posted with neon pink signs noting the treatment, affiliated water use restrictions, and Water & Wetland contact information. The signs fulfill the permit obligation for shoreline posting.

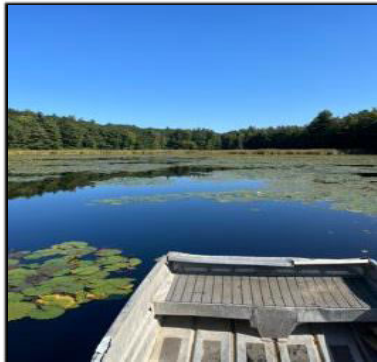
*Figure 26: Water and Wetland treating the waterlilies*

Overall, Pine Meadow Pond looked great as the 2023 treatment program has been a success. Waterlilies were noted encroaching towards the middle of the Pond (see Figure 26). Besides waterlilies and watershield, minimal vegetation was noted. When noted, the vegetation was either black/brown or covered in epiphytic algae (which indicates that the plant is decaying/dying). Variable milfoil was found in trace densities, scattered within the northern third of the Pond. All variable milfoil populations appeared dead/discolored (illustrated in Figure 28 below).

A treatment was conducted for the control of nuisance level waterlilies, specifically focusing on patches of waterlilies within the middle of the Pond and trimming the patches along the shorelines and northern point. The liquid herbicide was applied using a small jon boat, equipped with a calibrated pump, which is used to target the nuisance lilies via foliar application methodology. This method allows for even and precise coverage. Weather was also closely monitored prior to treatment to ensure a treatment date without rain or high

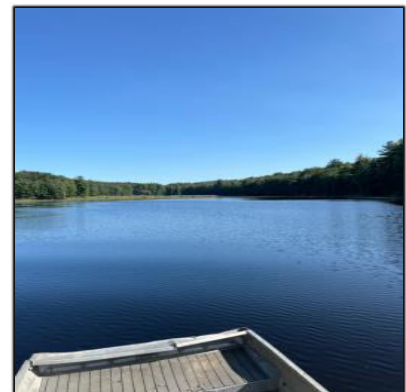
*Figure 27: Open water habitat and much improved conditions created from years of waterlily treatments*

The previous years of treatment targeting waterlilies have worked great as more and more open water habitat has been created each year (illustrated in Figure 27). Overall, >90% control of the target invasive species (variable milfoil and curly-leaf pondweed) was achieved during the 2023 program.

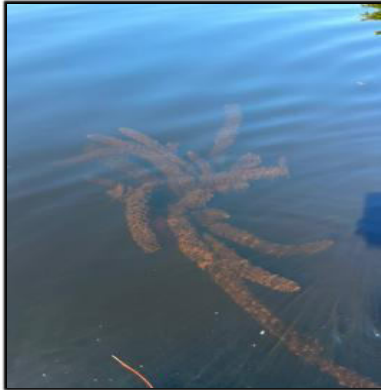
Figure 28: Dead variable milfoil covered in epiphytic algae

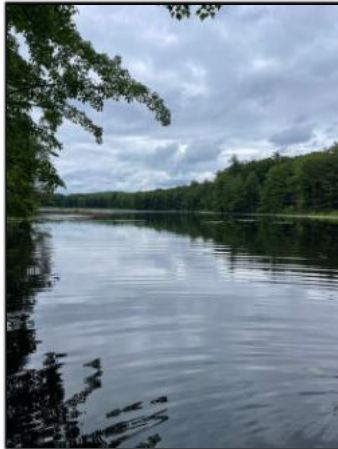
*Figure 29: Overlooking Pine Meadow Pond*

Conditions in Pine Meadow Pond in 2023 were consistent with previous years. Luckily, fanwort has not been introduced into Pine Meadow Pond. If it does find its way into the Pond, ideally it will be caught early through the regular surveys being conducted. Water & Wetland staff is diligent about cleaning and inspecting our boats in between each pond we visit to help limit the spread of invasives. The Town may want to consider signage at any access points to the ponds, noting the importance of cleaning and inspecting boats. Water chestnut was also found in Flannagan Pond this year and is present in other Ayer Ponds. We aim to keep this species out of Pine Meadow Pond through diligent monitoring, although signage would also help limit introduction of new invasive species (specifically fanwort and water chestnut).

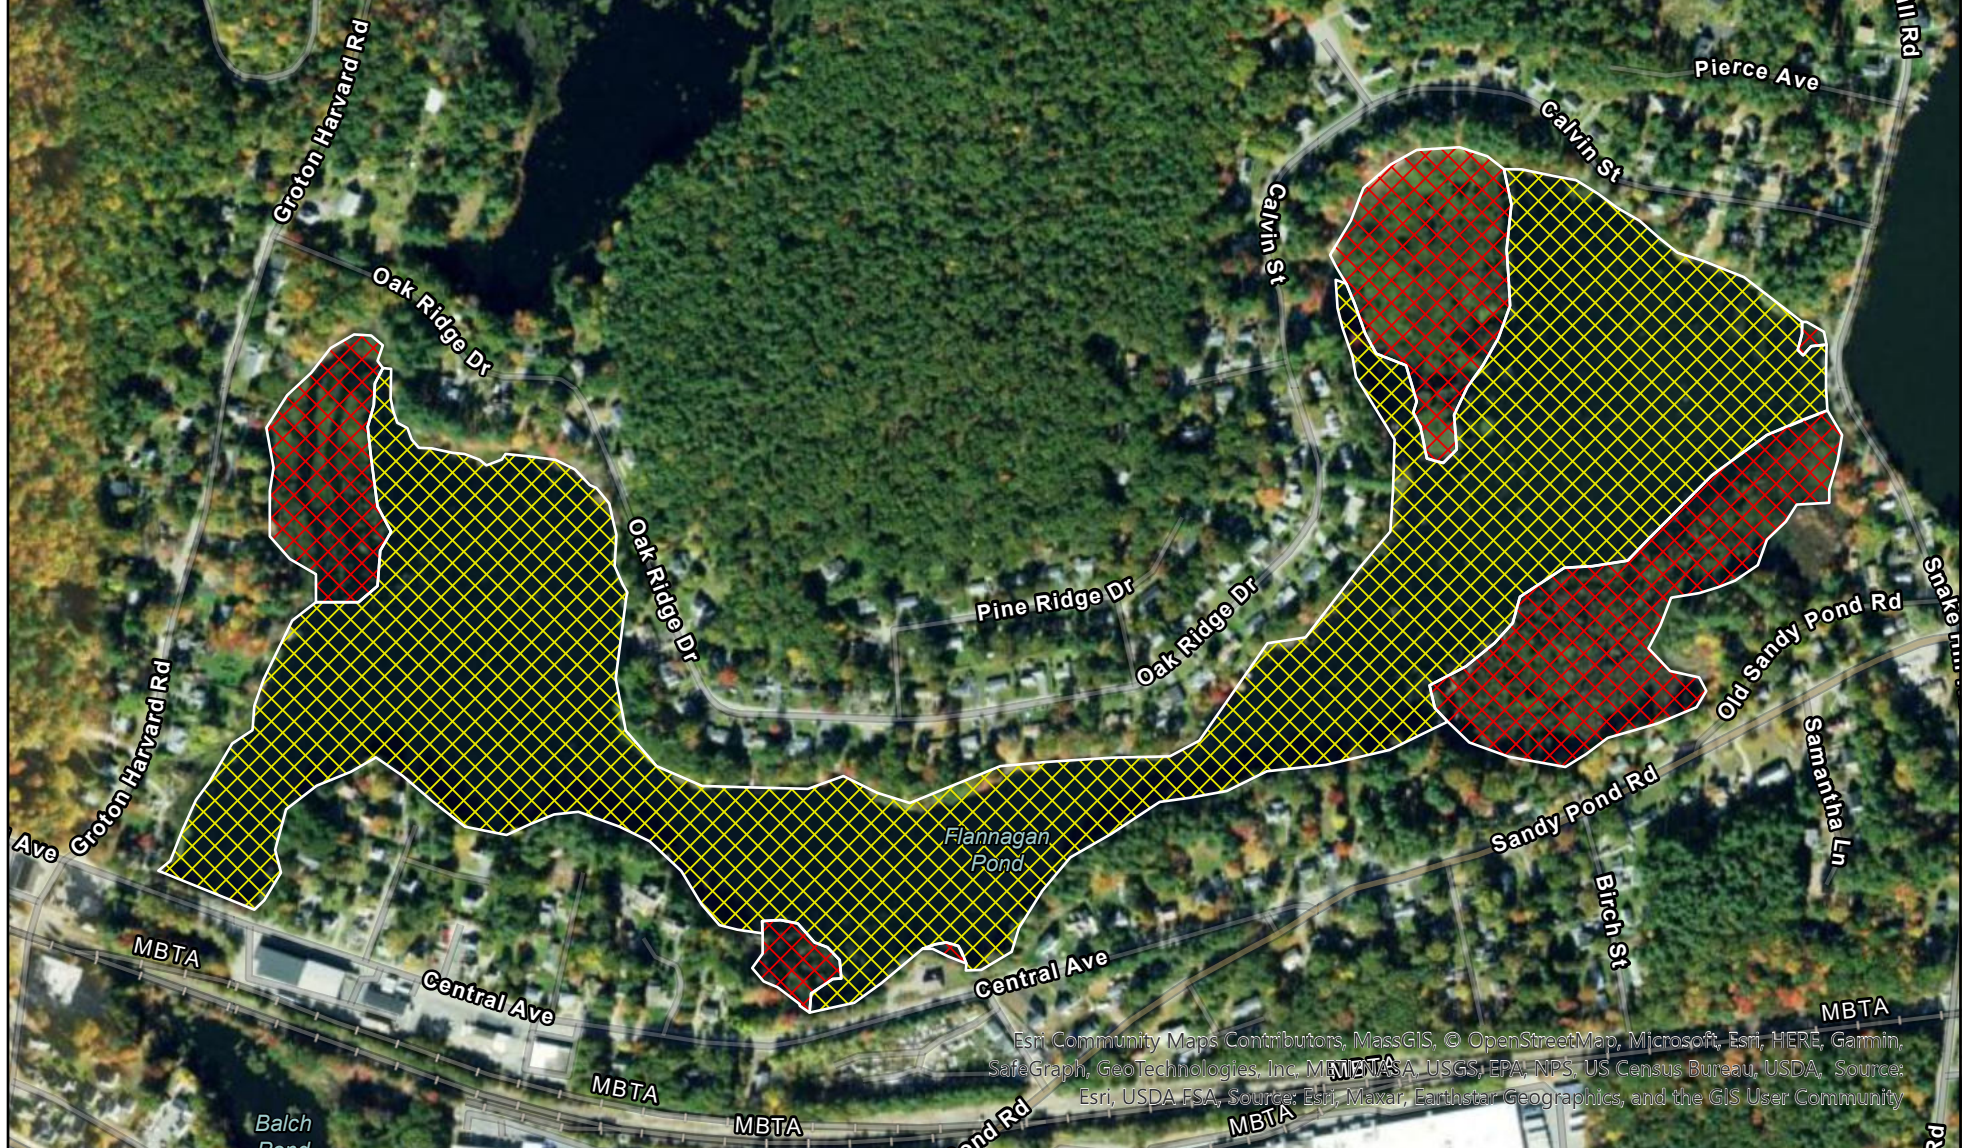
↗ Moderate to Dense Waterlilies and Watershield

✕ Primarily Bladderwort with Mixed Densities of Waterlilies, Watershield, Ribbon-leaf, Tape Grass, and Robbin's Pondweed

- xx Sparse to Dense Waterlilies and Watershield
- yy Scattered Bladderwort, Watershield, and Waterlilies
