Biological Survey, Assessment and Management Recommendations for Ayer's Ponds

Final Report
May 2016

Prepared for:
Ayer Conservation Commission
Town Hall – One Main Street
Ayer, MA 01432

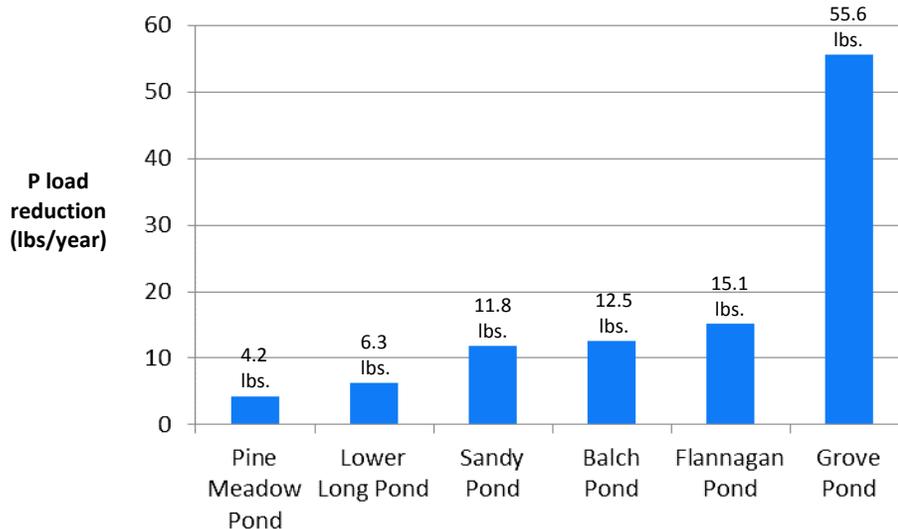
Estimated P Load Reductions Needed to Reduce Pond Total P Concentration by 1 ug/L

The Vollenweider model relationship between flushing rate, external phosphorus load, and in-lake phosphorus concentration has implications for pond management strategies. The model estimates the external phosphorus load reduction required to reduce in-lake phosphorus concentration by a given amount. The figure below shows this relationship for the six ponds, to allow for a comparison of the relative level of effort required to reduce P concentrations in each pond by an equal amount. Pine Meadow Pond would require the least amount of external P load reduction to lower its in-pond concentration by 1 ug/L (4.2 lb/yr), whereas Grove Pond would require over 13 times that load reduction (55.6 lb/yr) to achieve the same in-pond P concentration reduction. Watershed management strategies that target nutrient load reduction will be most effective for ponds with lower ratios of external load to in-pond concentration.

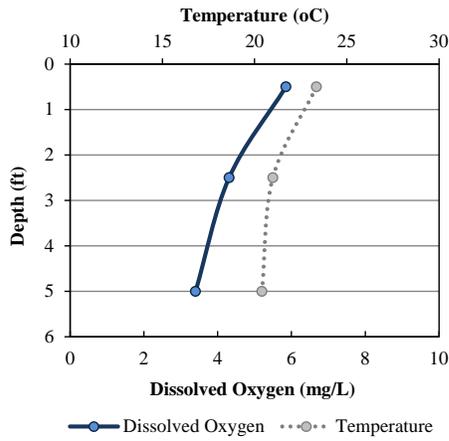
a) Pine Meadow Pond (08/25/2014)

Figure 1.2 shows the dissolved oxygen and temperature profiles for the six Ayer Ponds. Pine Meadow Pond, Flannagan Pond, Balch Pond, and Grove Pond are shallow and did not exhibit significant thermal stratification. Despite its shallow depth, Grove Pond exhibited very low DO levels that are likely indicative of high oxygen demand from biological processes in its bottom sediments. Lower Long Pond and Sandy Pond, which are both over 20 feet deep, exhibited highly stratified conditions and associated hypolimnetic oxygen depletion that are typical of the late summer period when these measurements were conducted.

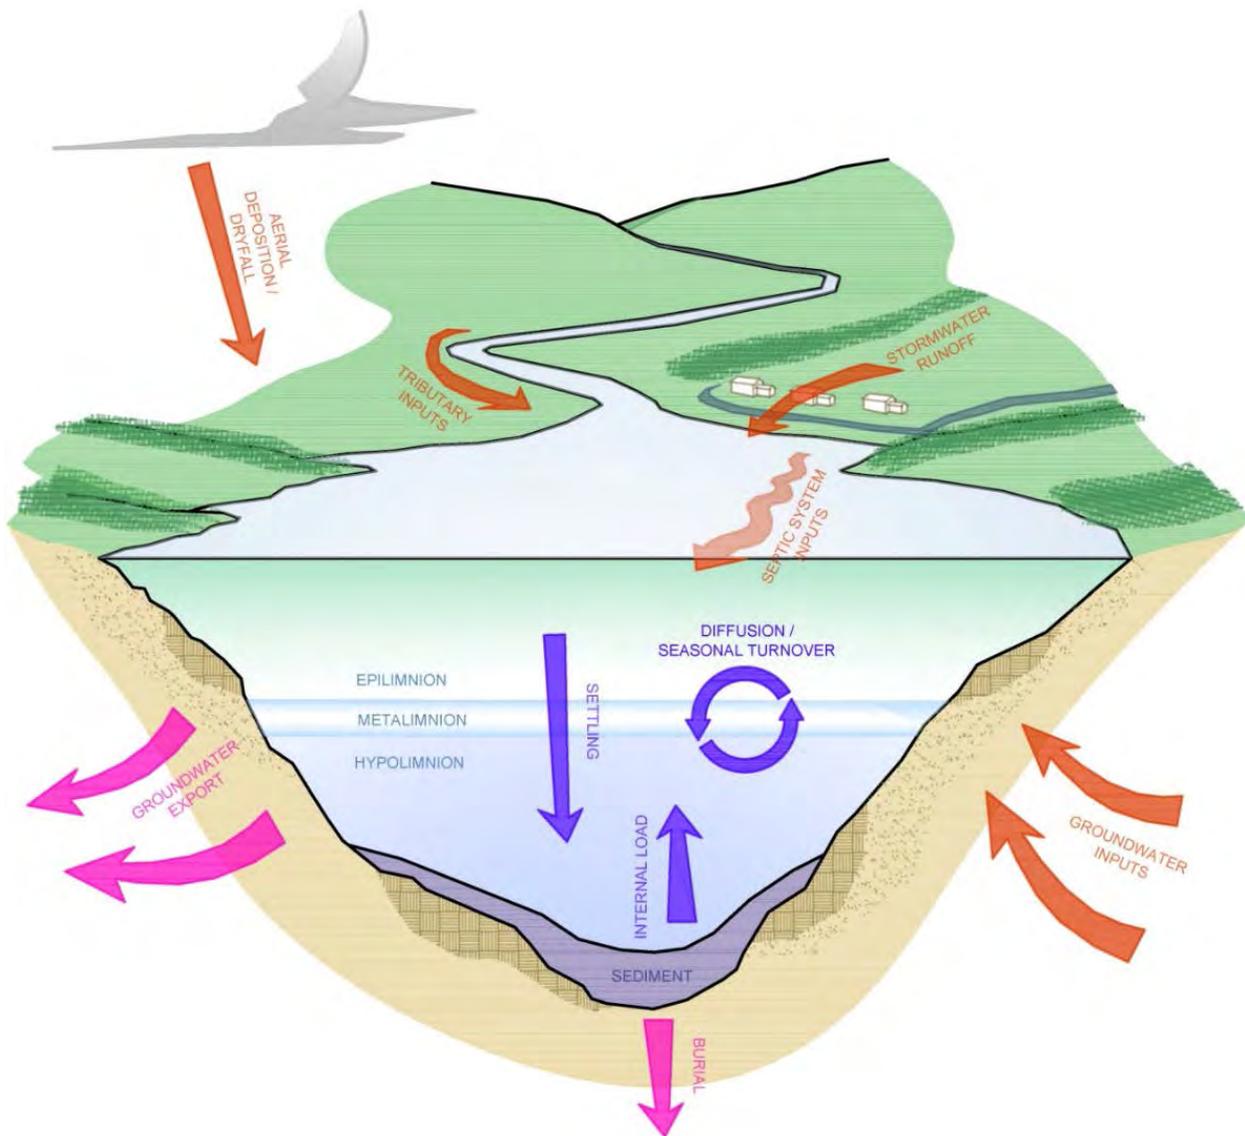
Figure 2.1 Conceptual Pond Phosphorus Dynamics

Eutrophication is the gradual process of nutrient enrichment in aquatic ecosystems such as lakes. Eutrophication occurs naturally as lakes become more biologically productive over geological time, but this process is often accelerated by human activities in the watershed. As shown in Figure 2.1, nutrients that contribute to eutrophication can come from many natural and anthropogenic sources, such as fertilizers applied to residential lawns and agricultural land, septic systems, deposition of nitrogen from the atmosphere, erosion of soil containing nutrients, and sewage treatment plant discharges. Land development not only increases the sources of nutrients, but also decreases opportunities for natural attenuation (e.g., uptake by vegetation) of such nutrients before they can reach a water body.

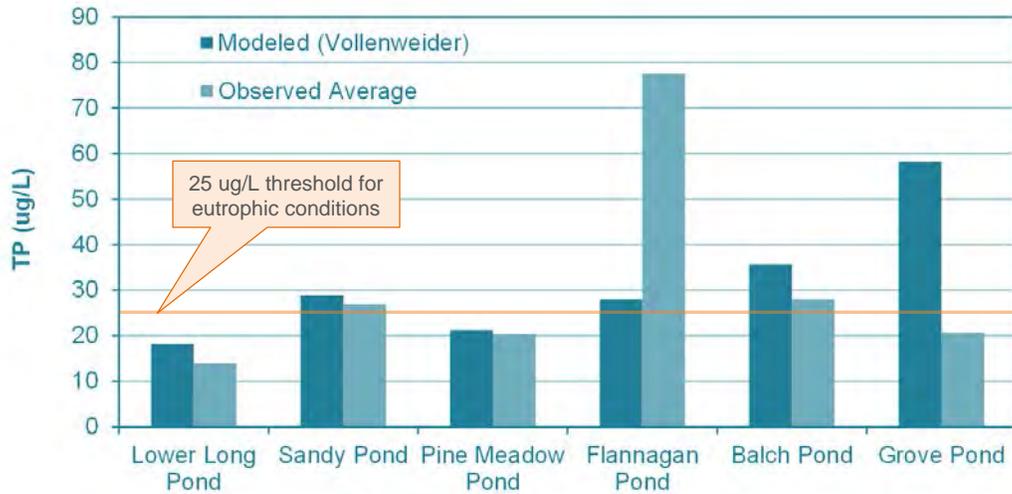
Figure 2.16 Comparison of Modeled and Observed Phosphorus Concentrations in Ayer Ponds

The Vollenweider model results appear to compare reasonably well to the observed results for Lower Long Pond, Sandy Pond, Pine Meadow Pond, and Balch Pond, given the limited sampling data available.

uptake by the dense community of macrophytes in Grove Pond may result in temporary reduction in observed in-lake phosphorus concentrations. The reasons for Flannagan Pond's observed phosphorus concentrations greatly exceeding the model estimate are unclear based on the limited available data. As previously stated, discretion should be used when comparing results from a single summer sampling event to model results meant to represent year-long averages (as well as fully-mixed conditions in stratified lakes). A more robust sampling program which obtains measurements throughout the spring-fall season could provide better data with which to compare the model results in the future.

The Vollenweider model predicts in-lake phosphorus (P) concentrations as a function of annual P loading, mean lake depth, and hydraulic residence time. The Vollenweider model results compare reasonably well to the August 2014 sampling results for Lower Long Pond, Sandy Pond, Pine Meadow Pond, and Balch Pond. The Vollenweider results did not match well with the observed conditions for Flannagan Pond and Grove Pond. Discretion should be used when comparing results from a single summer sampling event to model results meant to represent year-long averages. A more robust sampling program could provide better data with which to compare the model results in the future.

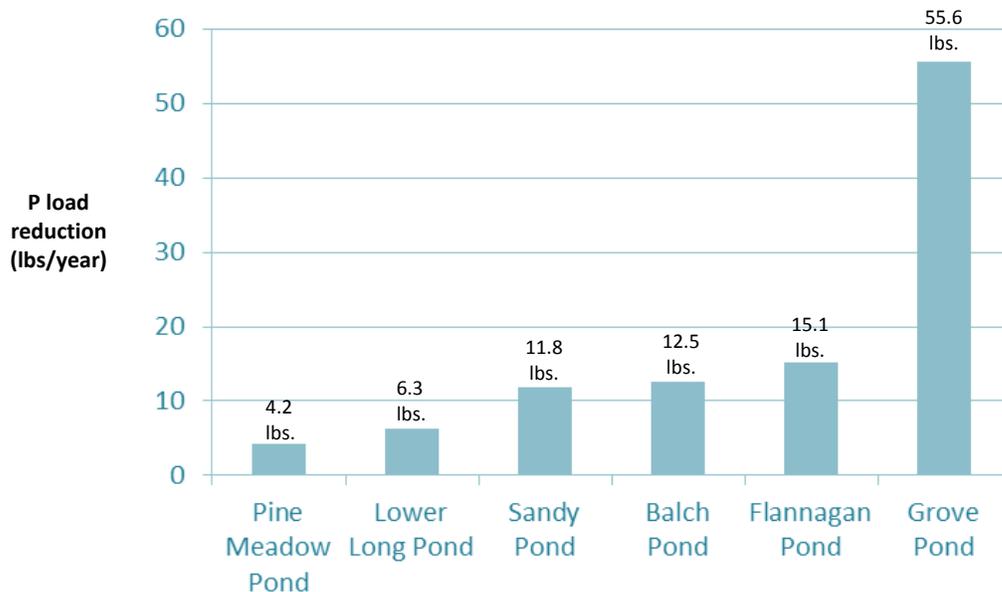
Figure 2.17 Estimated Phosphorus Load Reductions Needed to Reduce Pond TP Concentration by 1 ug/L

The relationship between flushing rate, external phosphorus load, and in-lake phosphorus concentration presented by the Vollenweider model also has implications for pond management. The relationships predict the amount of load reduction required to reduce in-lake phosphorus concentration by a given amount. Table 2.15 and Figure 2.17 shows this relationship for the 6 ponds. Pine Meadow Pond requires the least amount of phosphorus load reduction to lower its in-pond concentration by 1 ug/L (4.2 lb/yr), whereas Grove Pond would require over thirteen times that load reduction (55.6 lb/yr) to lower in-pond concentration by the same amount. Watershed management strategies that target nutrient load reduction would therefore be most effective for ponds with lower ratios of external load to in-pond concentration.

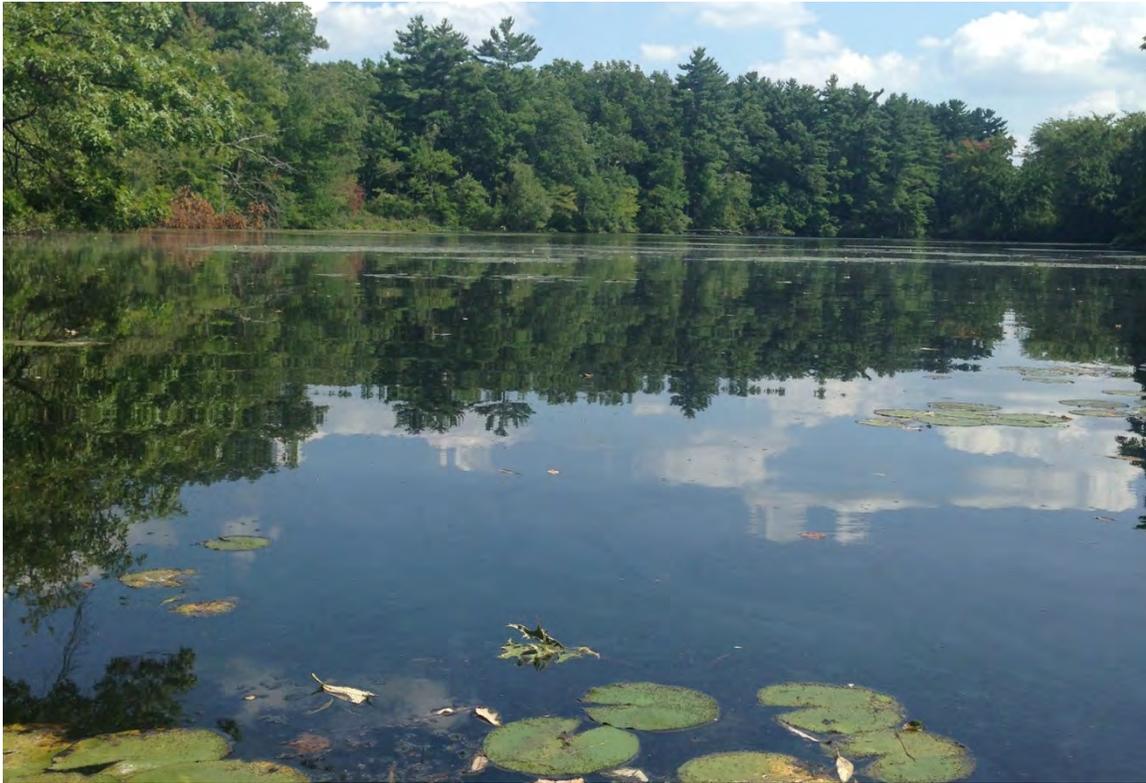
Photo 1: View across Balch Pond towards its northern shoreline. Plant abundance in the central portions of the pond was generally sparse and dominated by low growth of Robbin's pondweed near the pond bottom.

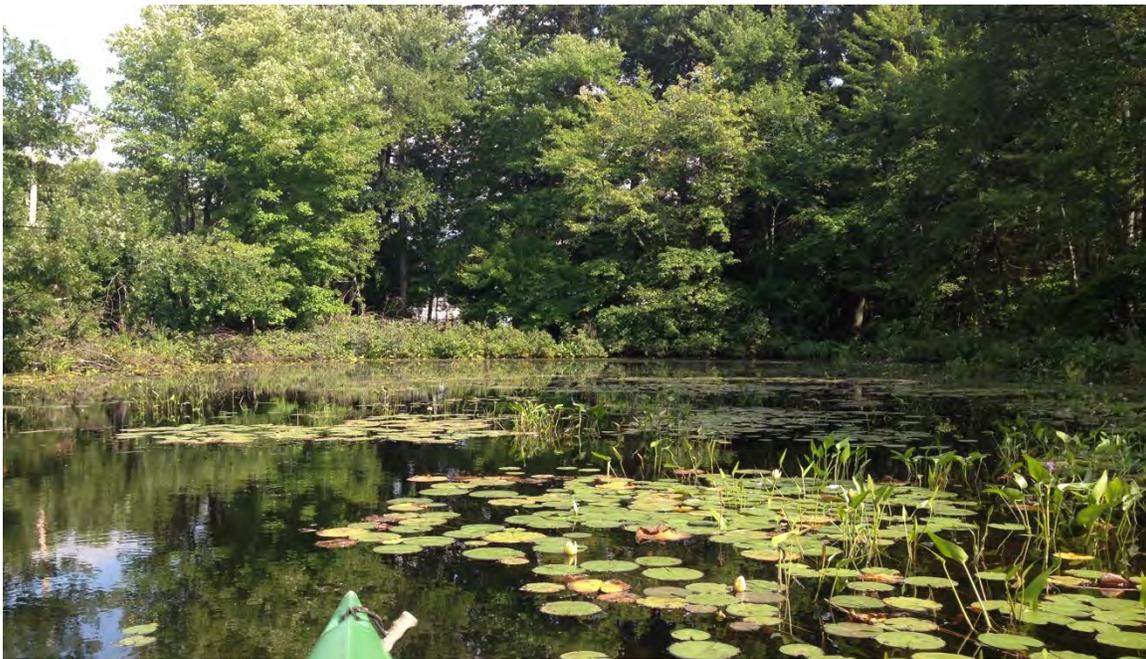
Photo 2: The eastern end of Balch Pond had moderate to very dense plant growth, dominated by surface growth of white water lily and submerged growth of Robbin's pondweed and eastern purple bladderwort.

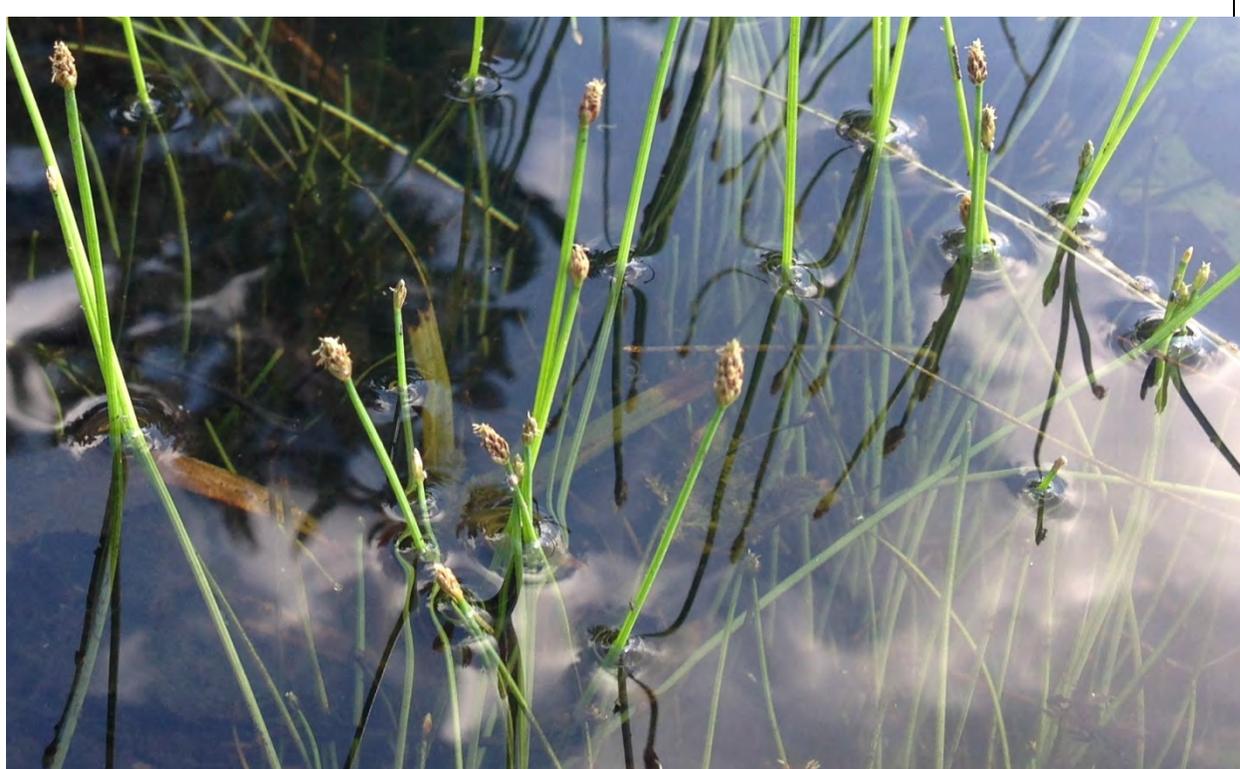
Photo 3: Blunt spike rush growing in the shallow cove area to the north of the main body of Balch Pond.

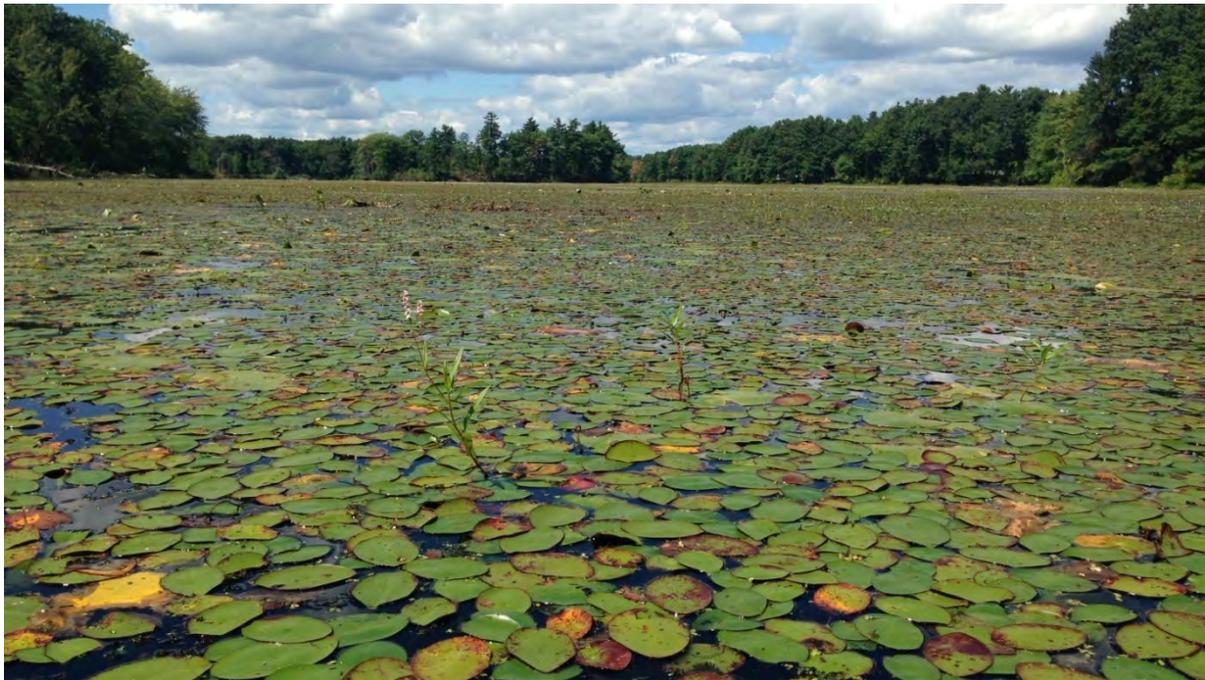
Photo 5: View across Grove Pond to the west, from an area in the eastern end of the pond dominated by native watershield. Very dense floating-leaf and submerged vegetation was present over the vast majority of Grove Pond.

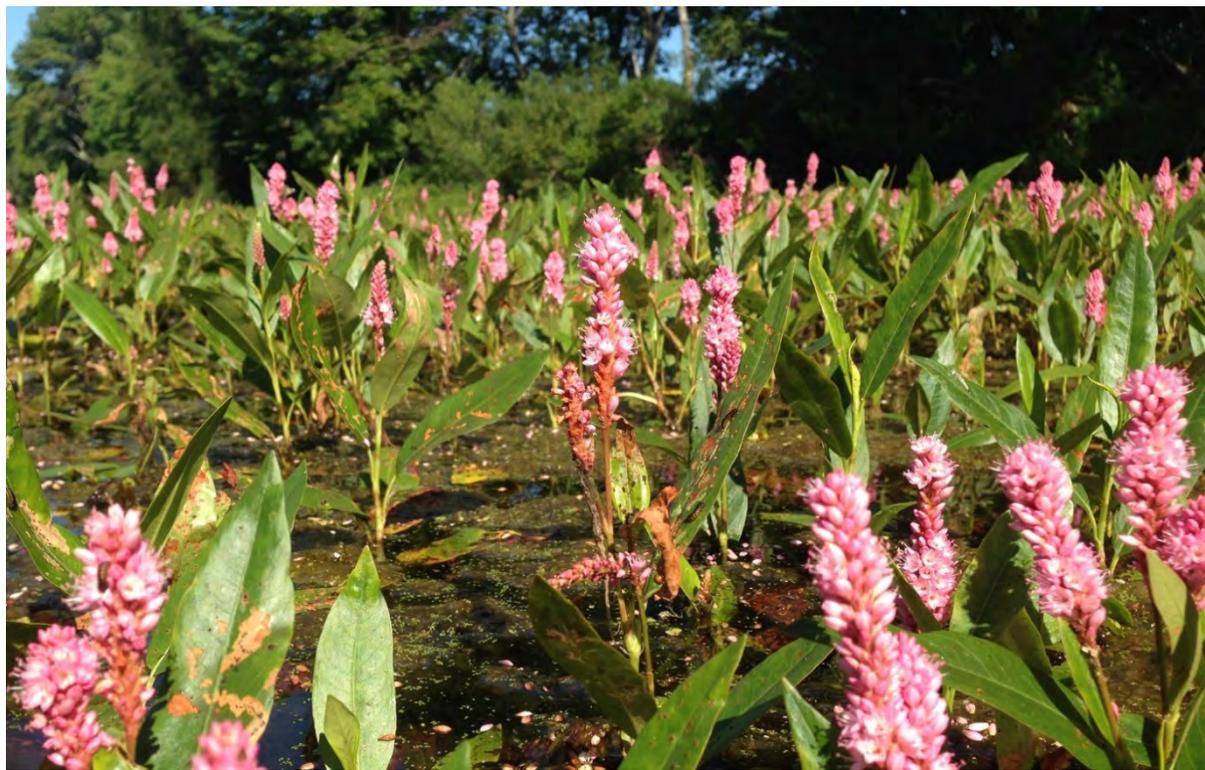
Photo 6: A stand of native water smartweed in flower along the southern perimeter of Grove Pond.

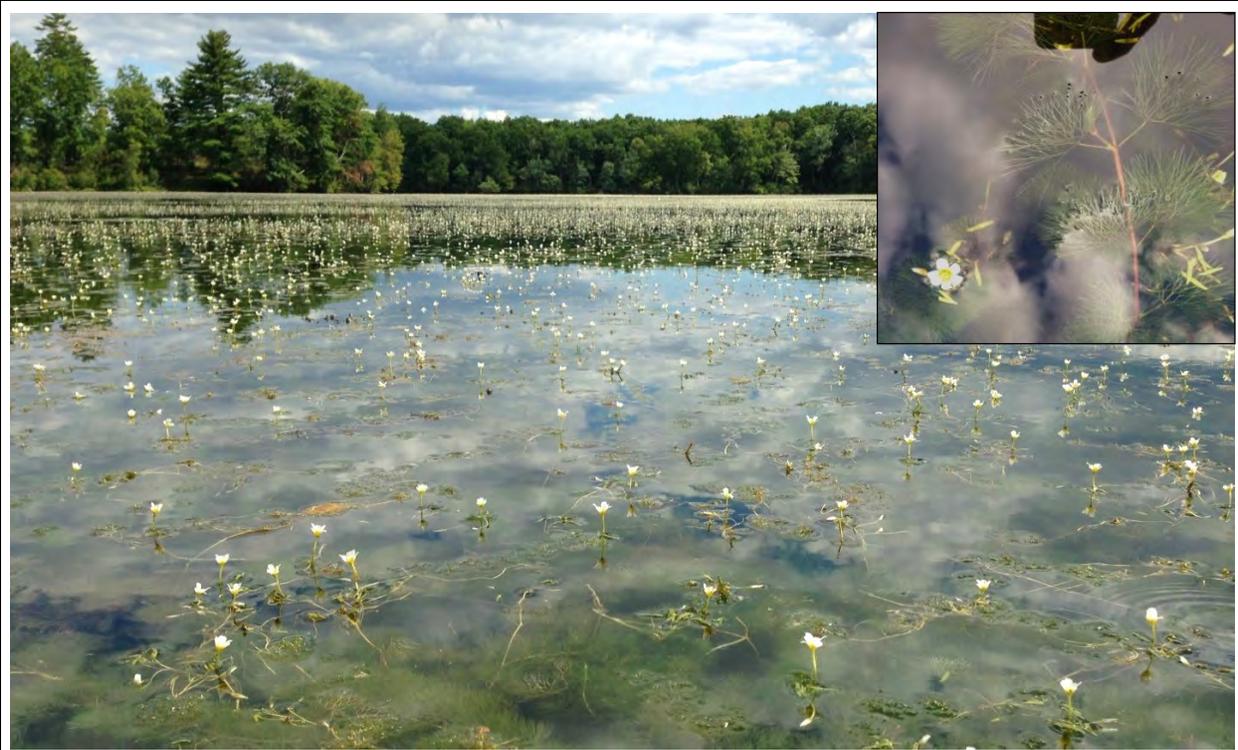
Photo 7: A large, near-monoculture stand of fanwort was observed in the western/central portion of Grove Pond. As shown in the photo, fanwort has small white flowers that typically appear at the water surface in late summer.

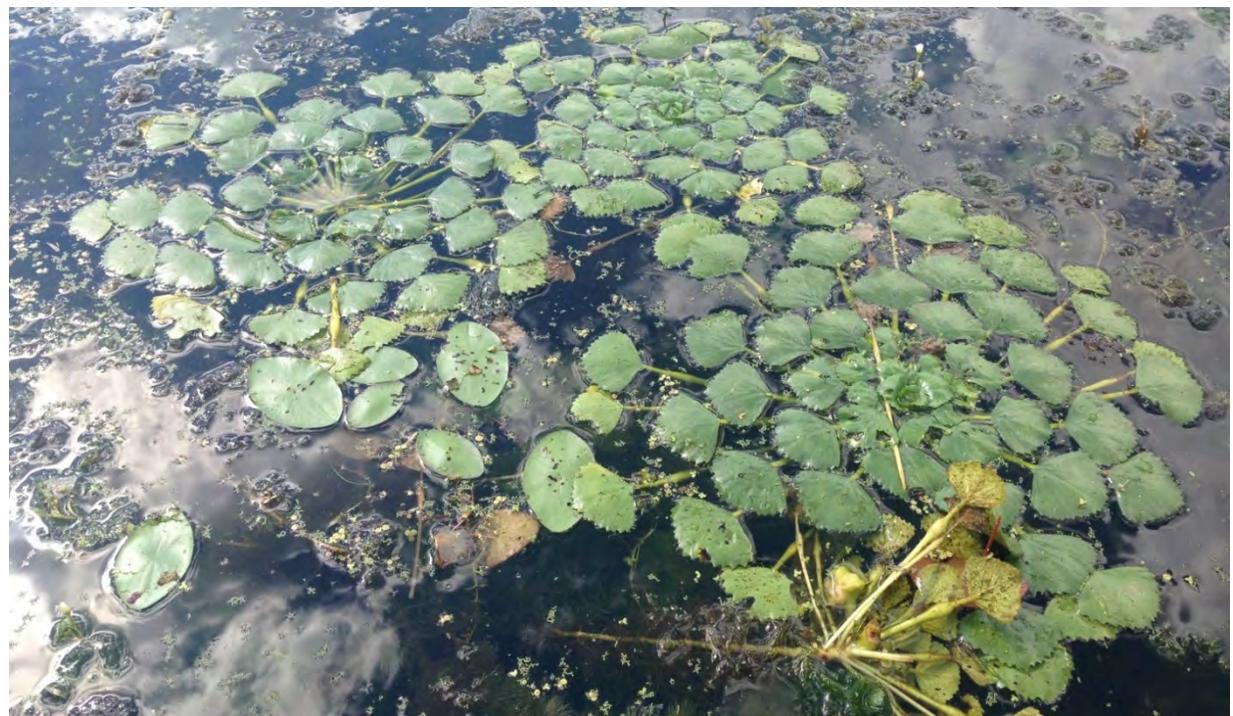
Photo 8: Small to moderately sized clusters of invasive water chestnut were observed at locations in the eastern end of Grove Pond. This annual plant can spread prolifically by seed, and has the potential to spread aggressively once introduced to a waterbody.

The relatively modest infestation of water chestnut in the eastern end of the pond has the potential to spread rapidly if control actions are not taken. Immediately following the August 2014 vegetation survey, Geosyntec reported the water chestnut infestation to the Ayer Conservation Agent, and discussed the potential for volunteers to hand harvest this plant from canoes or

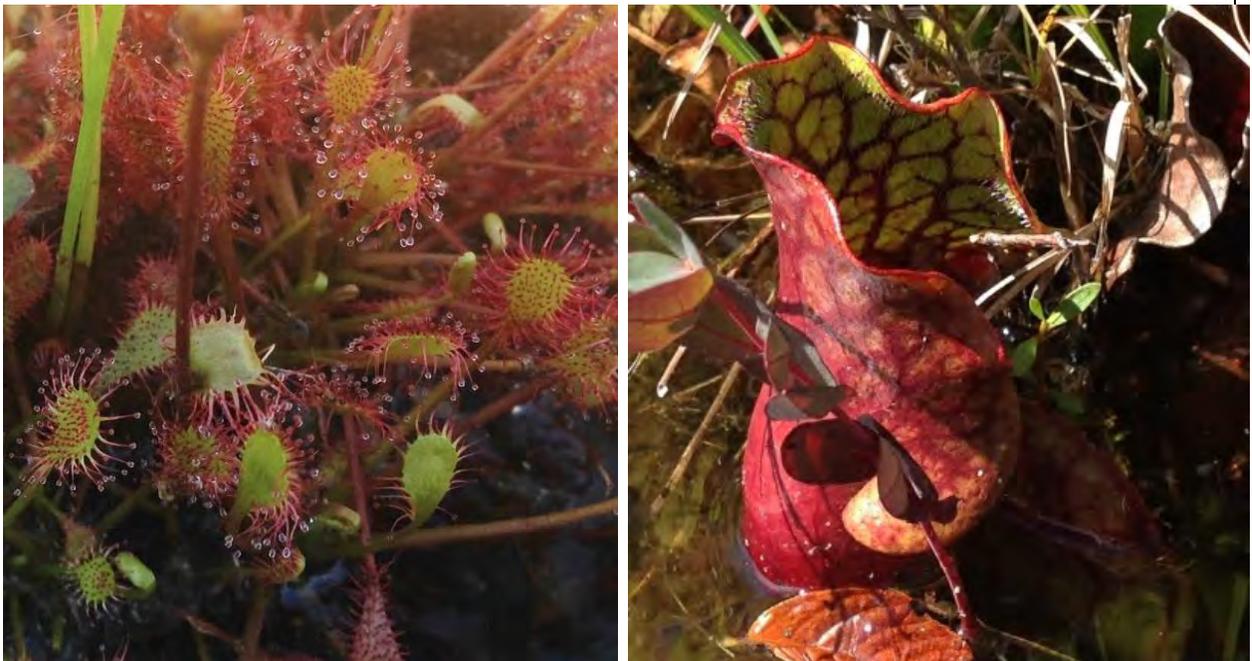
Photo 10: Bog species found observed in the northern end of Lower Long Pond included spatulate-leaved sundew (left photo) and pitcher plant (right photo). Both of these species are carnivorous plants that capture invertebrates and digest them to supplement their nutrient uptake.

- The pond provides a relatively wide range of high-quality aquatic habitats including areas characterized by sparsely vegetated open water, emergent marsh, floating-leaf community, and submerged aquatic bed community. The northern end of the pond has significant areas of floating bog mats supporting scrub-shrub vegetation and carnivorous herbaceous species such as spatulate-leaved sundew and pitcher plant (see photo 10).

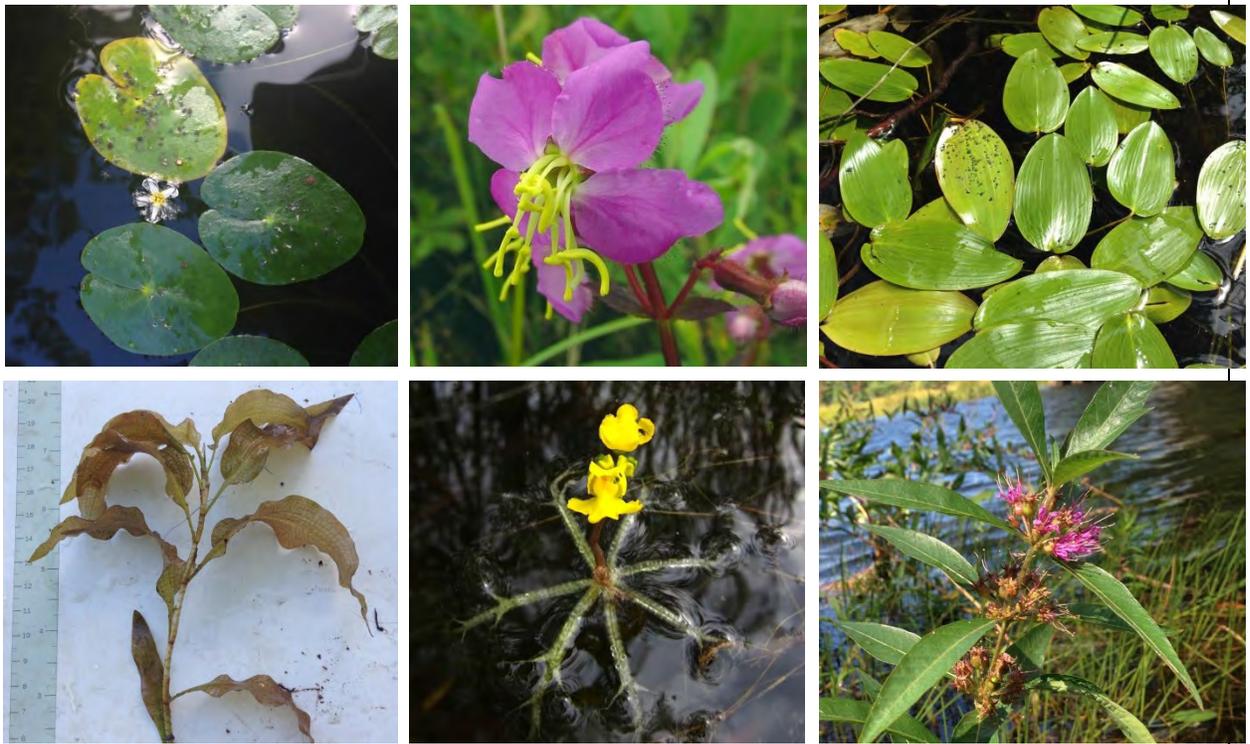
Photo 11: The diverse native plant assemblage at Lower Long Pond included (clockwise from the upper left): little floating-heart, Virginia meadow beauty, floating-leaf pondweed, spotted pondweed, little floating bladderwort, and water willow.

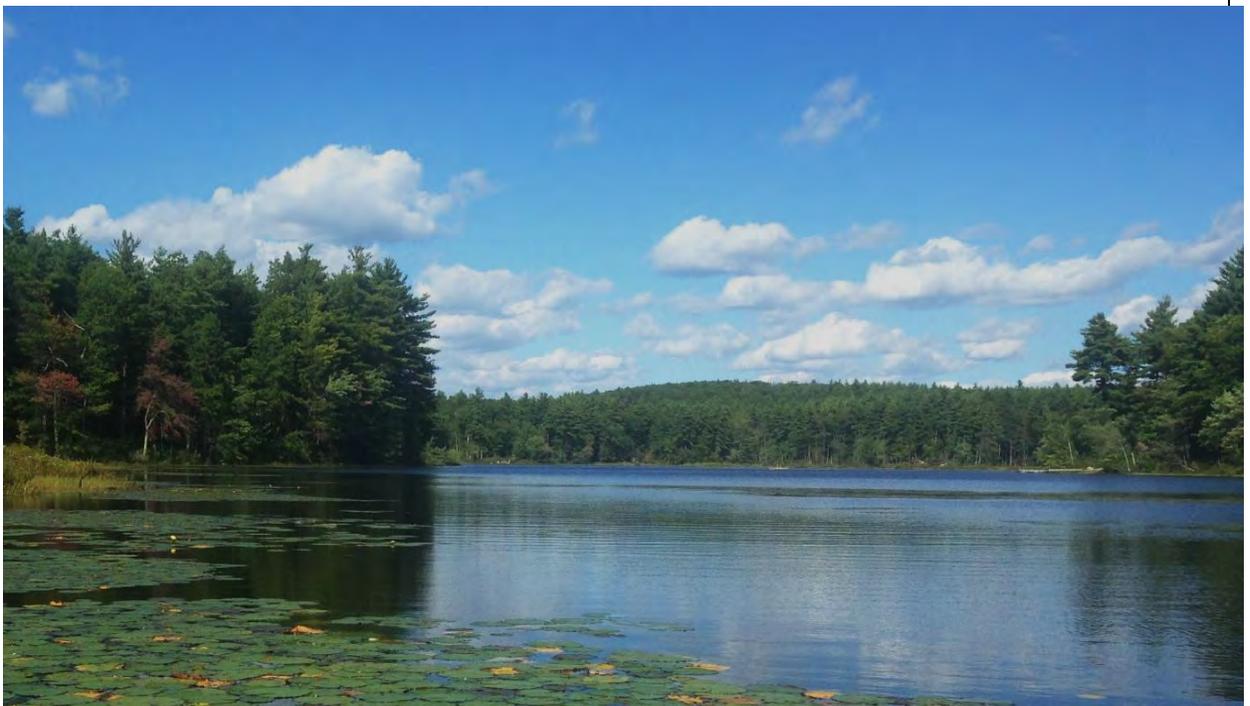
Photo 12: View to the north across Lower Long Pond. In general, the pond had very dense growth throughout its shallow perimeter and coves, with sparse growth throughout the deeper central area.

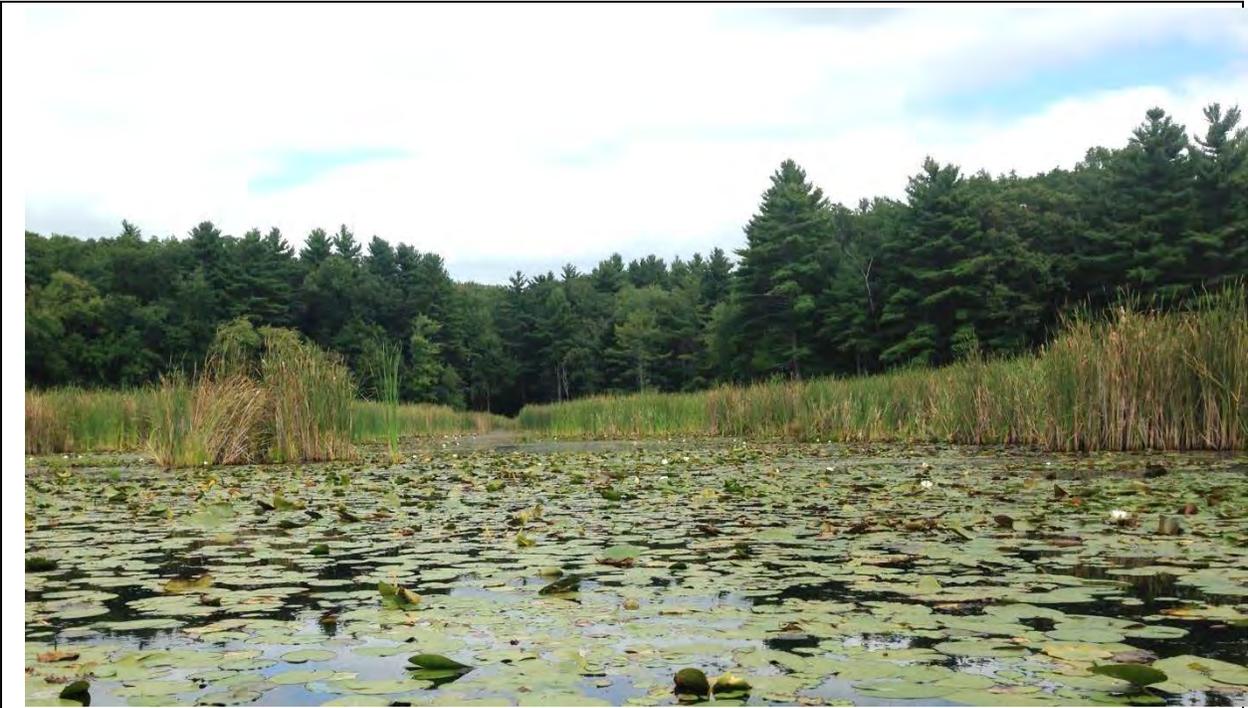
Photo 13: Most of Pine Meadow Pond was comprised of a very dense assemblage of native floating-leaf and submerged species. As shown in the photo, aquatic plant growth was densest at the shallow northern end of the pond, where the pond gradually transitions to wet meadow/emergent marsh community

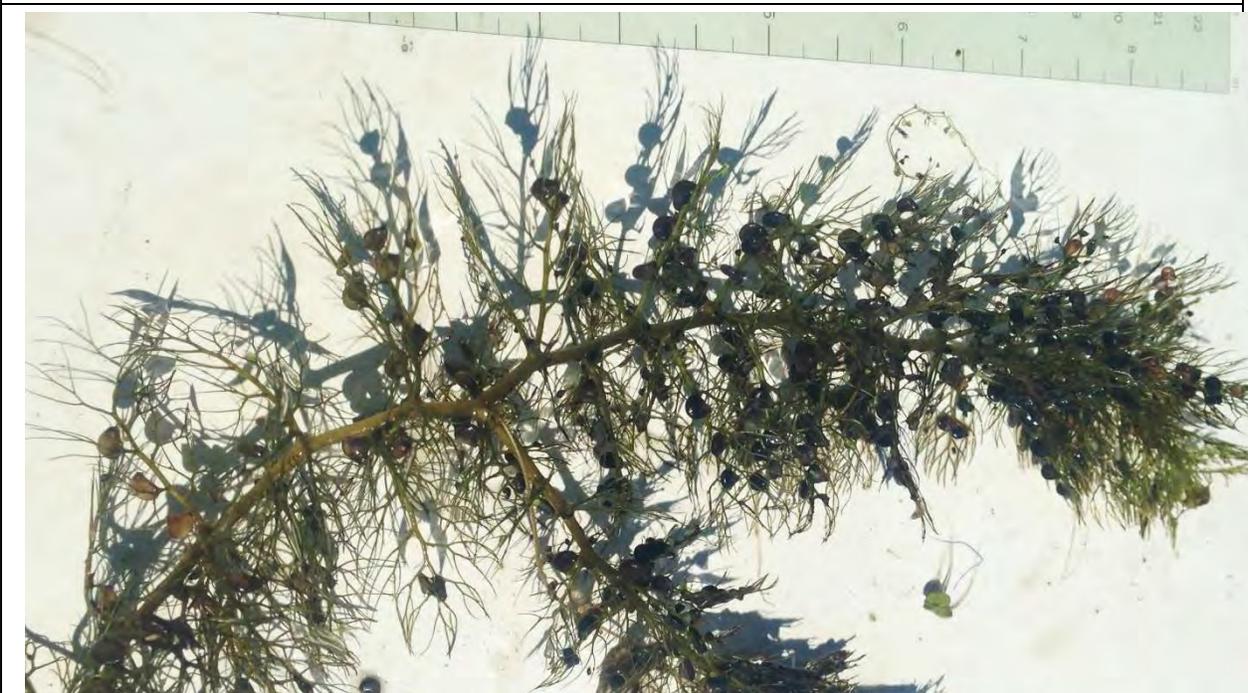
Photo 14: Common bladderwort, a carnivorous plant that captures its prey in sophisticated bladder-like traps, was a common species throughout most of Pine Meadow Pond.

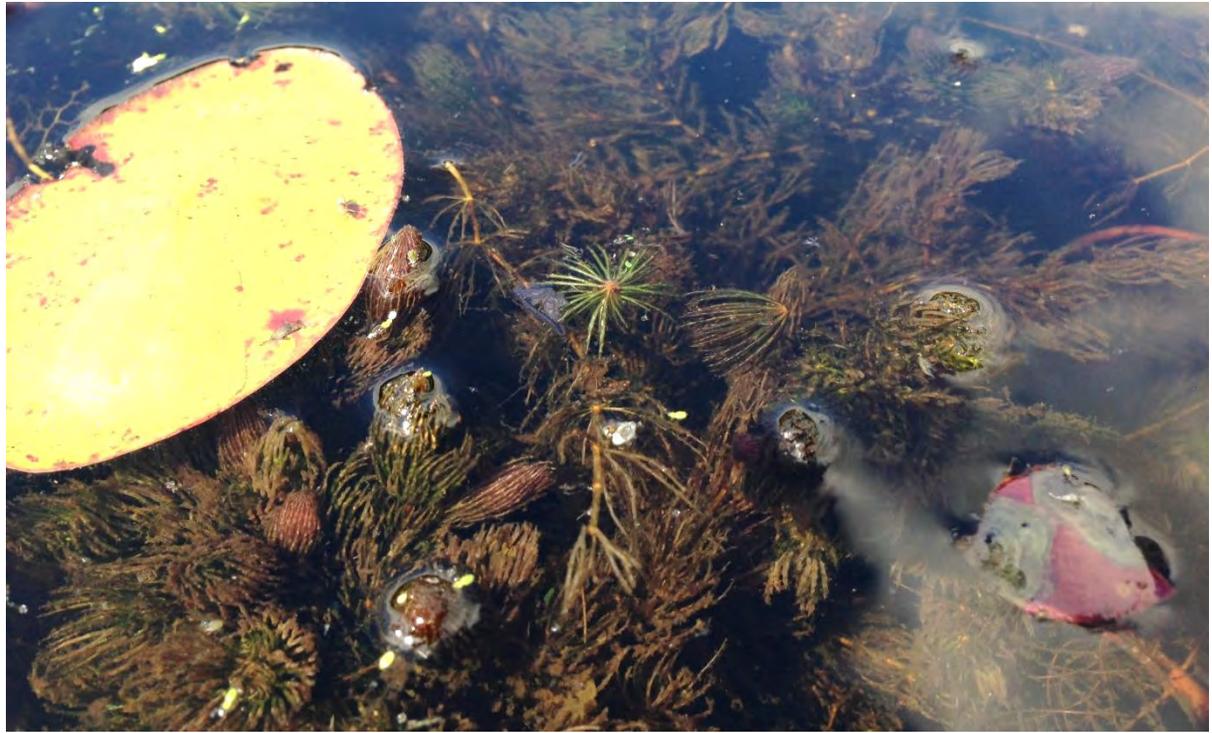
Photo 15: Coontail, a free floating submerged species, was dominant plant at three sampling stations in the northern end of Pine Meadow Pond.

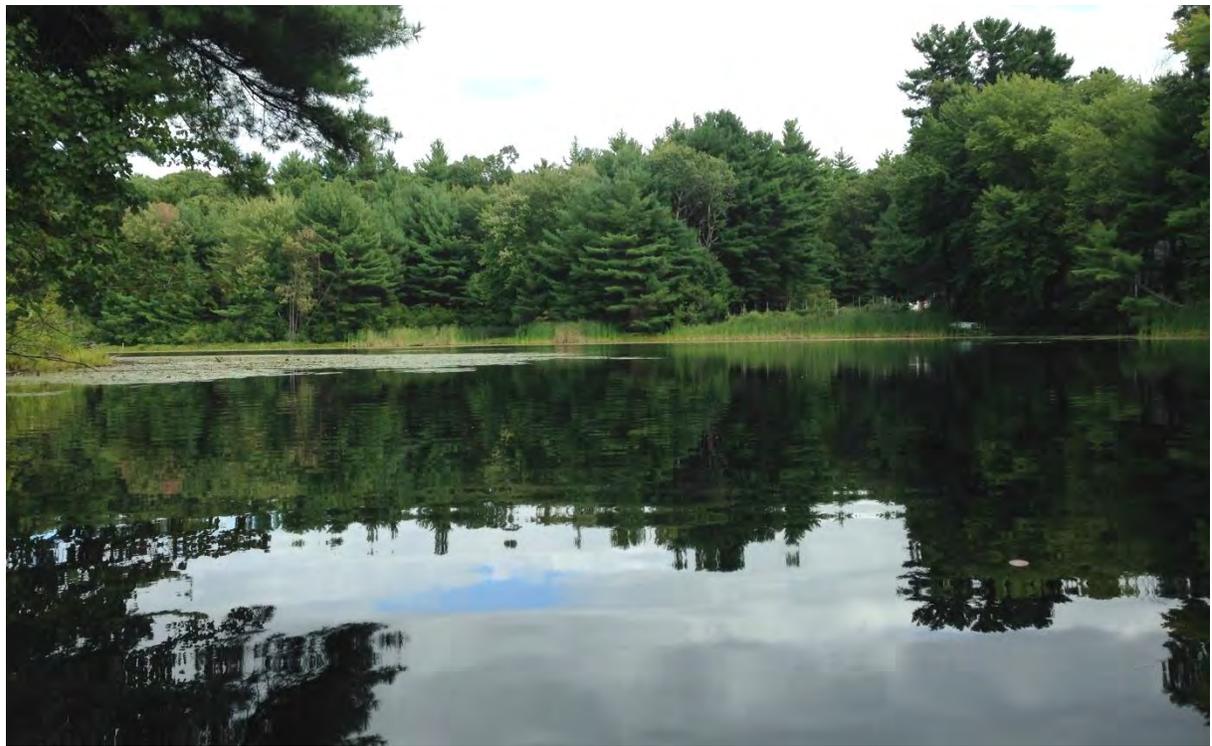
Photo 16: The southern end of the pond ranges from very dense growth at the shallow near-shore areas to sparse growth in the deeper central area.

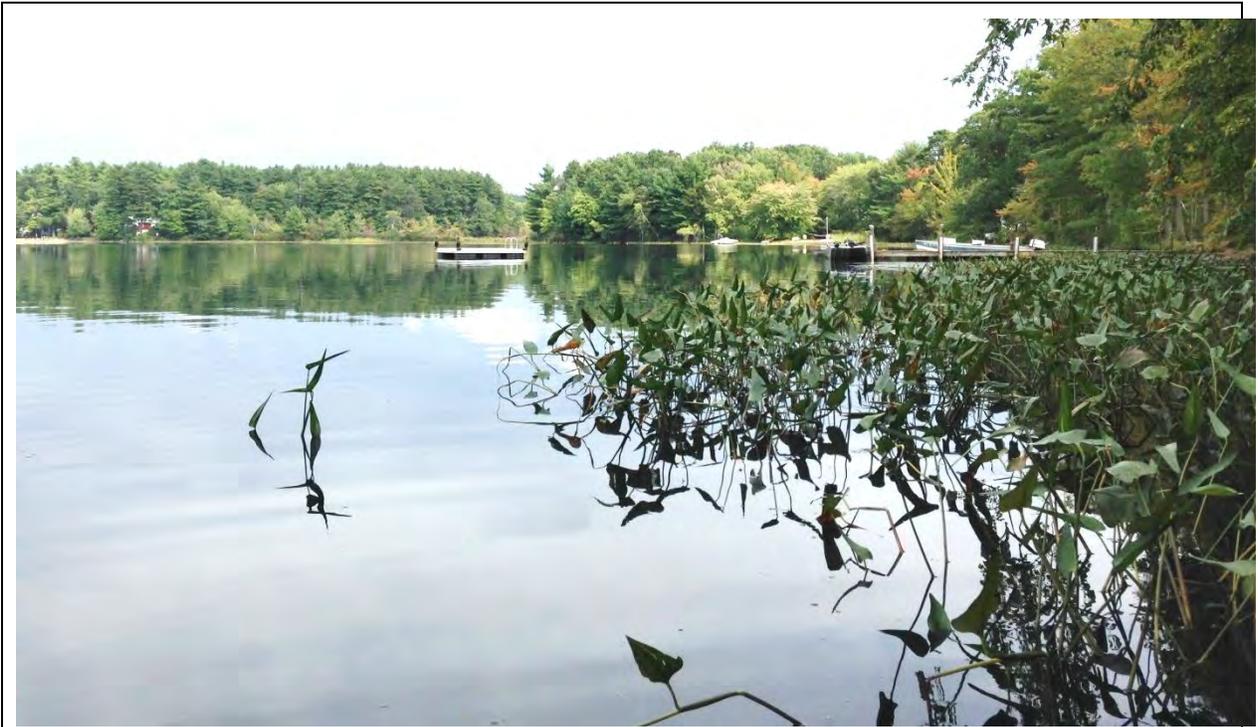
Photo 17: Pickerelweed was a common emergent plant along Sandy Pond's southern near-shore area. Most of the Pond's open water area exhibited sparse growth of aquatic plants.

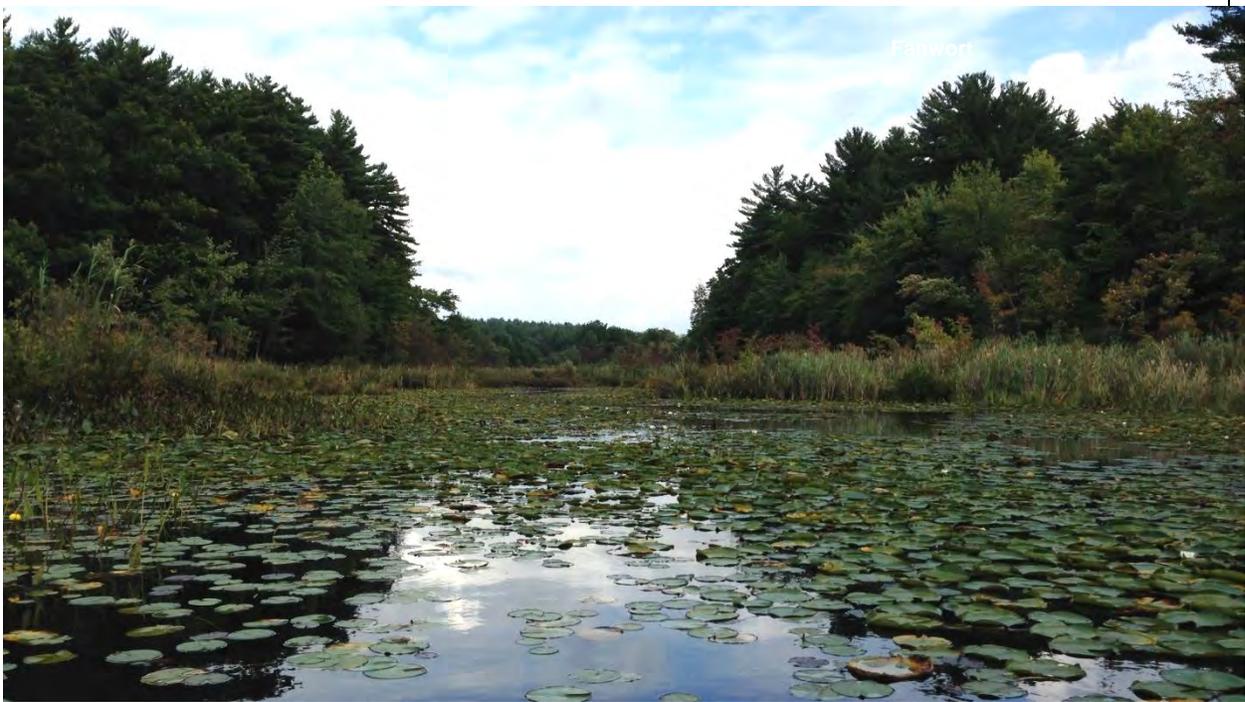
Photo 18: Very dense growth was observed at the Pond's eastern inlet cove, including surface growth of white water lily and dense submerged growth of invasive fanwort.

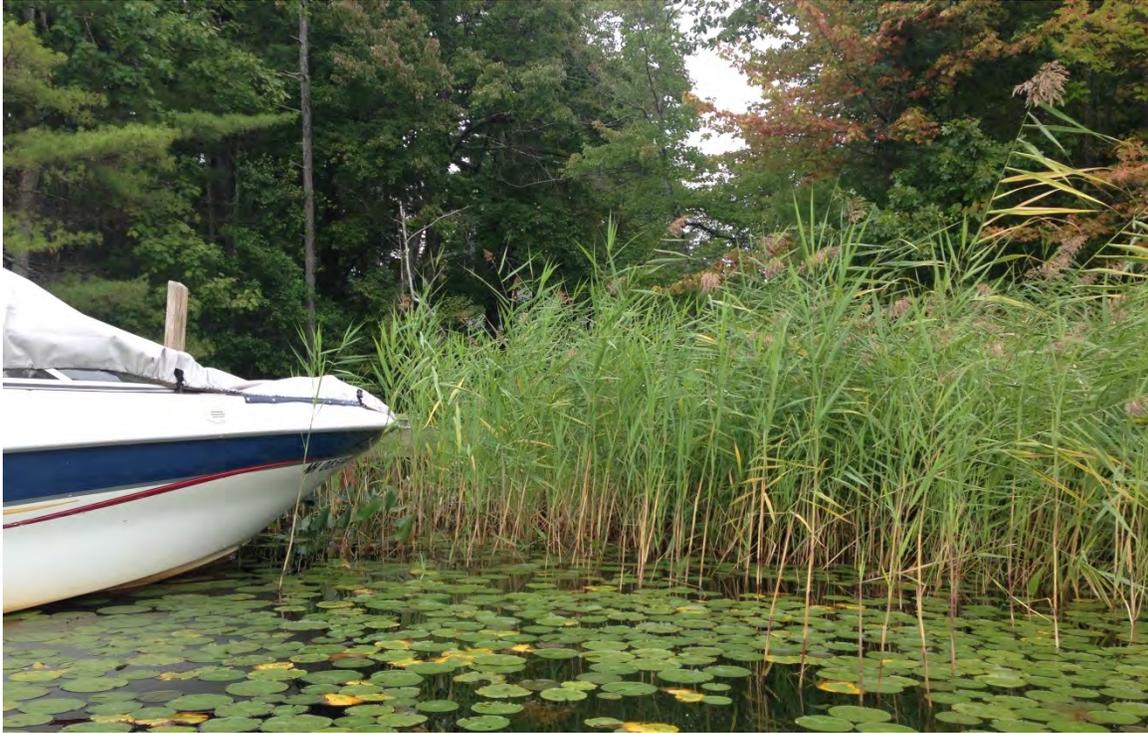
Photo 19: A small stand of Common Reed along the Pond's northern shoreline, near monitoring station #10.

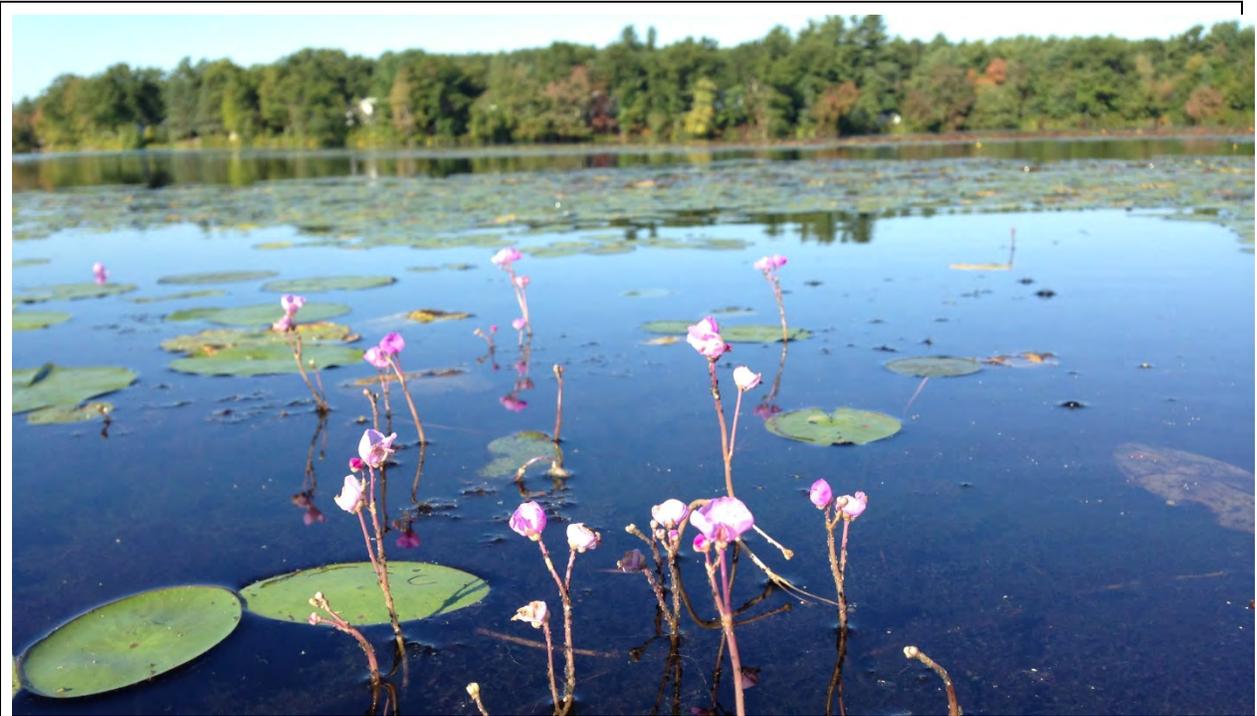
Photo 21: Watershield and eastern purple bladderwort (in flower) at the eastern end of Flannagan Pond.

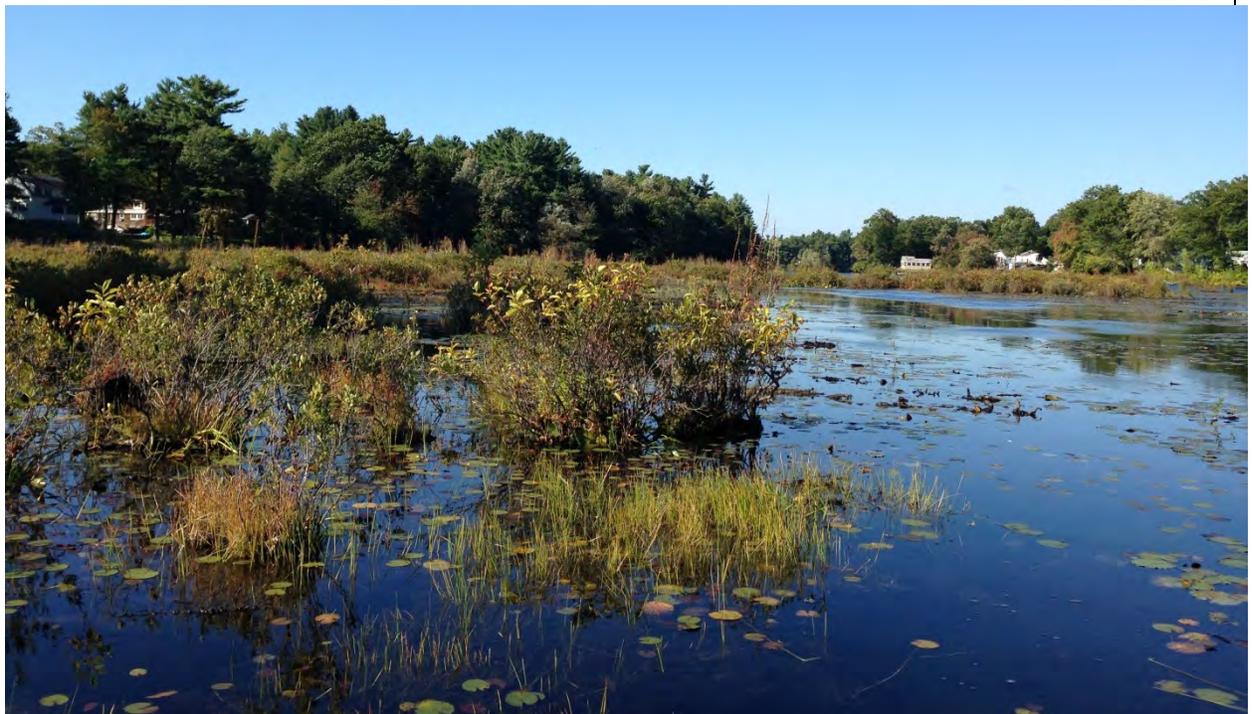
Photo 22: At Flannagan Pond's southeastern perimeter, aquatic vegetation transitions to a shrub swamp community.
