Biological Survey, Assessment and Management Recommendations for Ayer's Ponds

Final Report
May 2016

Prepared for:
Ayer Conservation Commission
Town Hall – One Main Street
Ayer, MA 01432

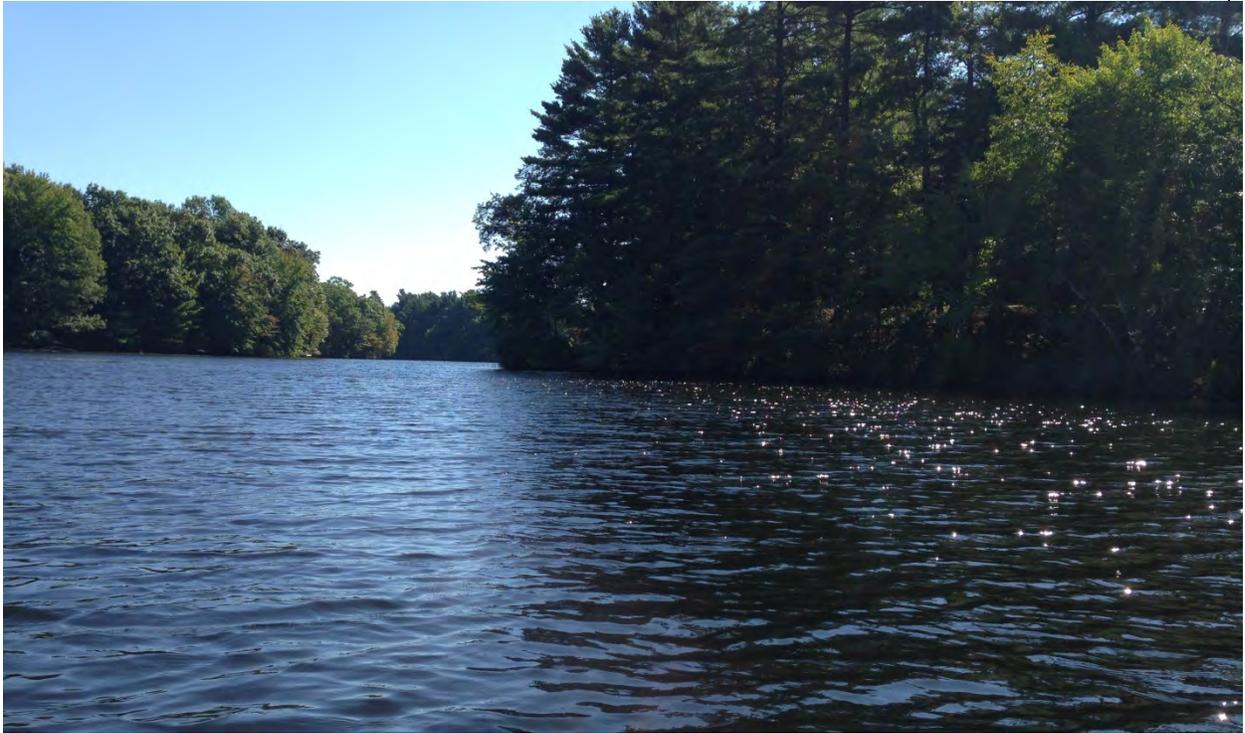
Photo 23: View to the east from sampling station #7, towards the narrow central portion of Flannagan Pond. Aquatic vegetation was typically sparse in this area, with some narrow bands of moderate growth near the shoreline.

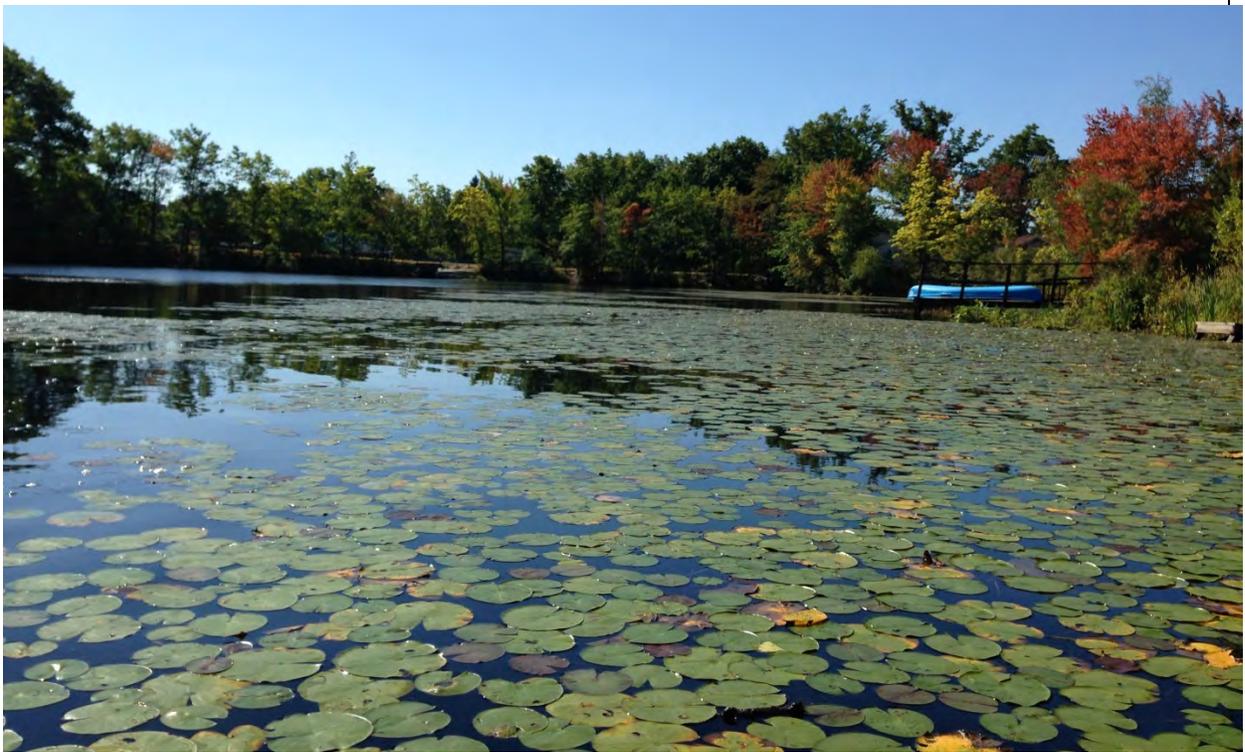
Photo 24: Dense growth of white water lily along the northwestern shore of Flannagan Pond.

- Periodic thinning of dense water lilies may also be necessary in some areas to allow for boat access and open water recreation. Given the pond's shallow depths and history with fanwort and variable milfoil (which can be spread by fragmentation), mechanical methods are not recommended for control of water lilies. Spot treatments with glyphosate are recommended when conditions prevent boat access to shoreline properties in these areas.

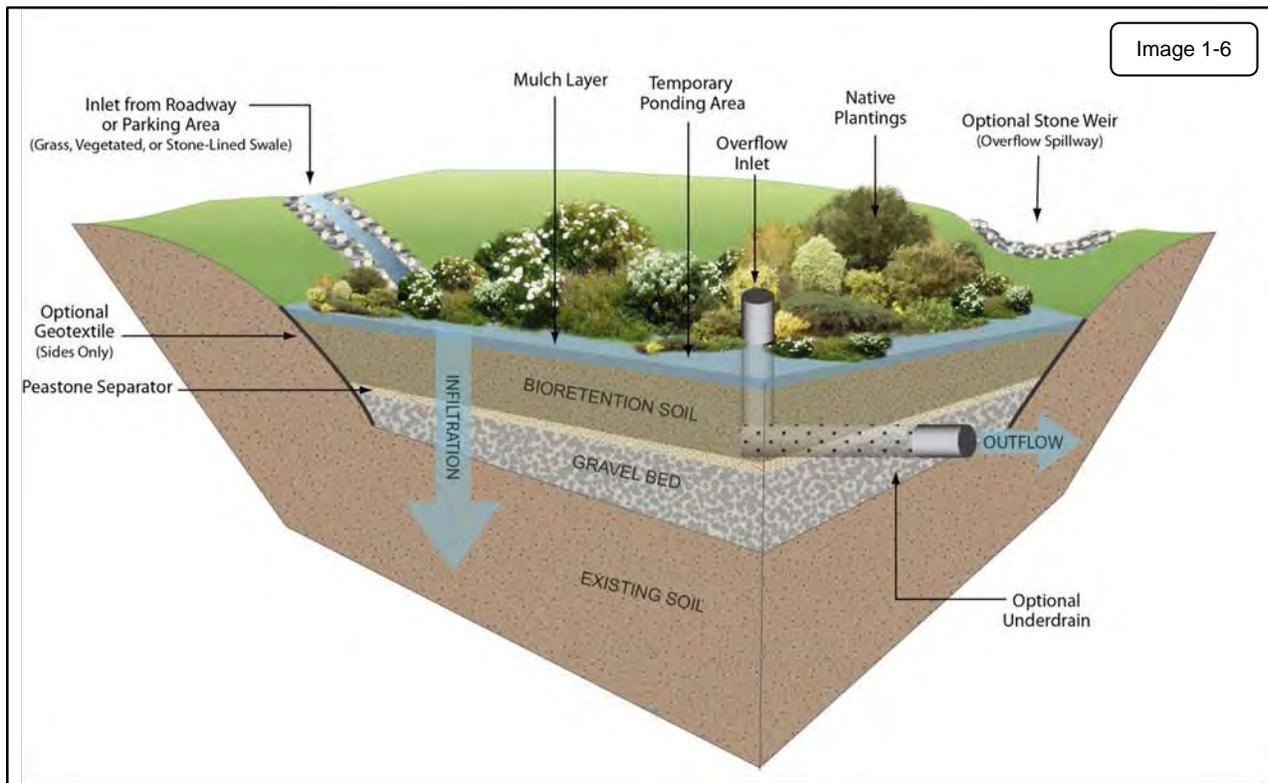
Image 1-6 is a cross section schematic of a typical bioretention cell. Bioretention cells are shallow landscaped depressions that incorporate plantings and engineered soil with a high porosity and infiltration capacity. Bioretention cells control stormwater runoff volume by providing storage, reducing peak discharge, and removing pollutants through physical, chemical, and biological processes occurring in plants and soil.

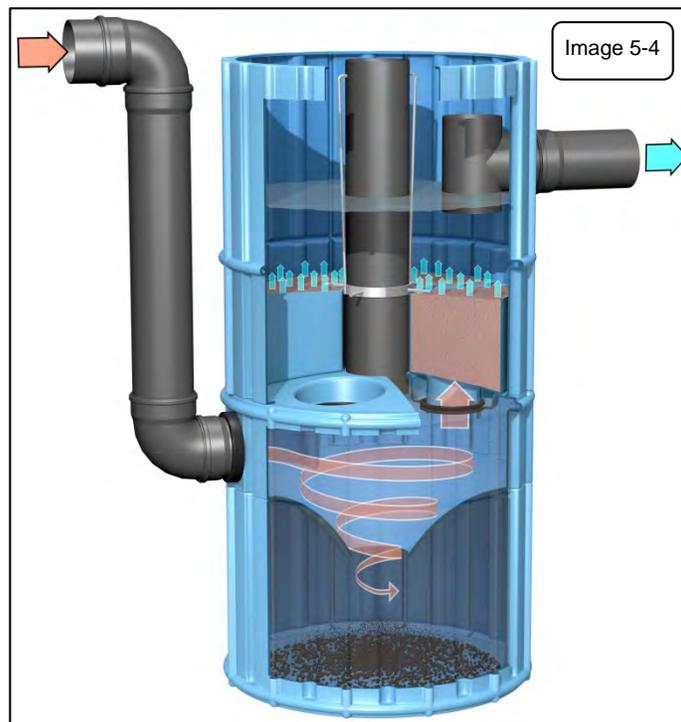
Image 5-4 is a schematic of a typical hydrodynamic separator. A hydrodynamic separator is a stormwater management technology that treats stormwater primarily by using gravity to remove particles and phase separation to remove materials such as oil and grease from the water matrix.

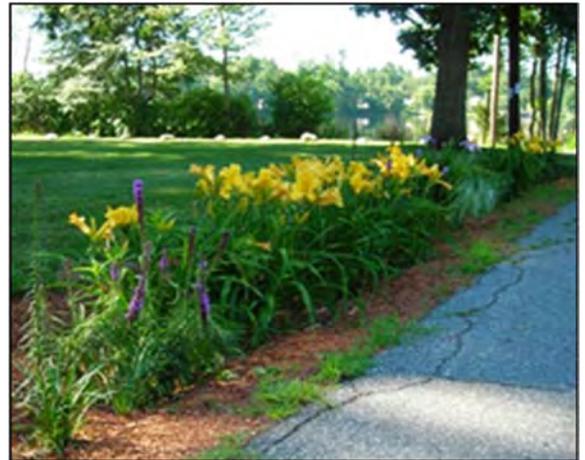
Typical rain garden installation along road shoulder (Silver Lake watershed, Wilmington, MA)

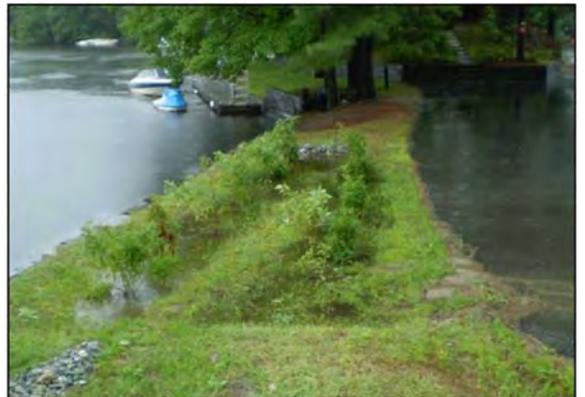
Lakeside rain garden providing storage during a rain storm (Lake Shirley, Lunenburg, MA).

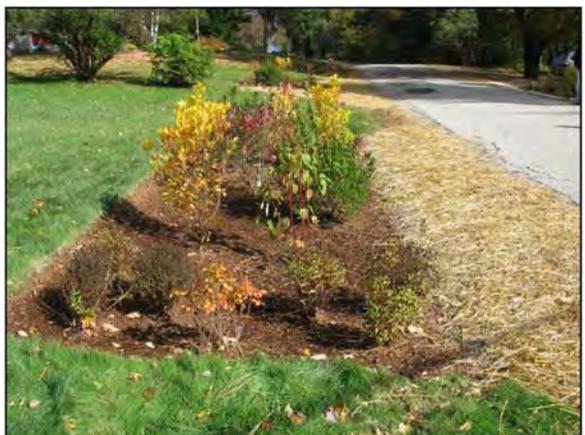
Newly planted rain garden with shrub planting scheme (Mirror Lake watershed, Tuftonboro, NH).
