CONSERVATION ANALYSIS
PURSUANT TO 10.1 OF THE AYER ZONING BYLAW

STRATTON HILL

STRATTON HILL ROAD
MAP 6, PARCELS 1, 2, 3, 7, 8 & 11 THROUGH 55

AYER,
MASSACHUSETTS

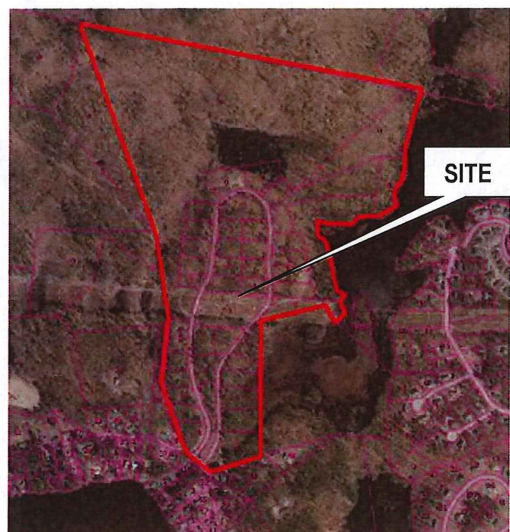
Massachusetts GIS Map

The property (referred to herein as “the site”) is located on the northerly side of Wright Road with access approximately 2000-feet east of Snake Hill Road. The site extends from Wright Road to the Groton Town Line at the northerly boundary of the property. The site contains Stratton Hill Road with the lots created by the subdivision (see Middlesex Registry of Deeds plan 829 of 2005). The subdivision was partially completed, and the site can be accessed through the graded roadway associated with the subdivision. Utilities for the subdivision were also partially installed with the development area cleared of trees and portions of the stormwater and sewer infrastructure installed. The site is identified as Ayer Assessor’s Map 6, Parcels 1, 2, 3, 7, 8, and 11 through 55.

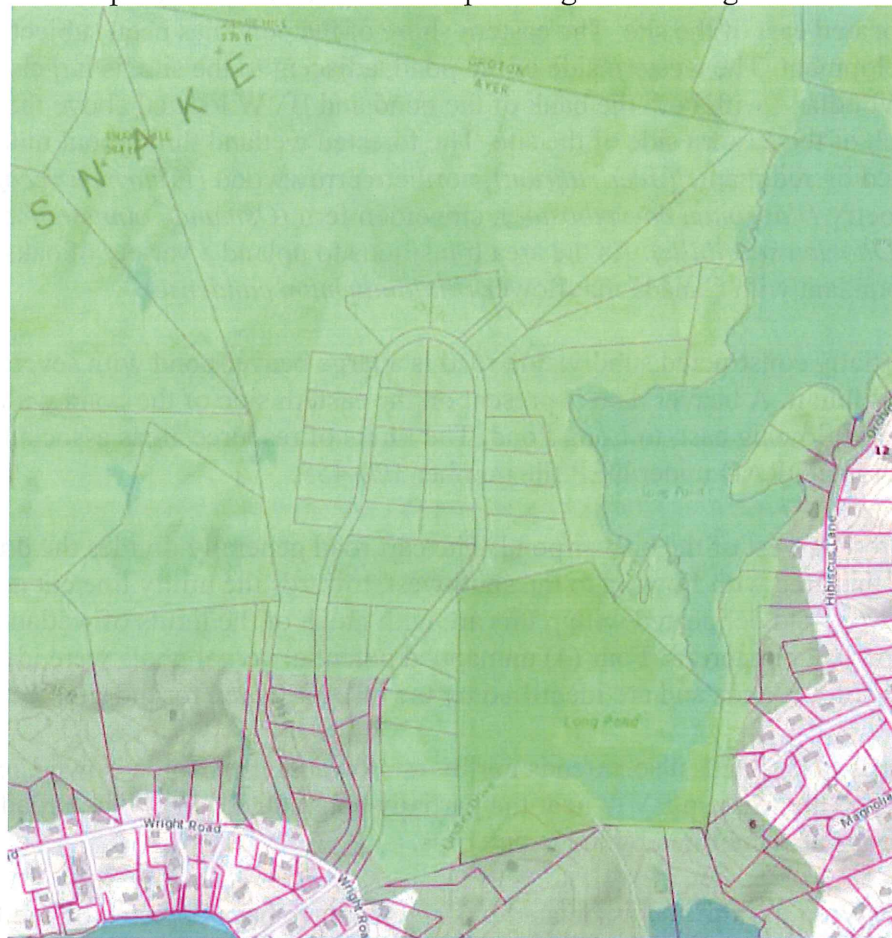
BioMap2 Habitat per MassGIS Oliver

The entirety of the site is located within the Petapawag ACEC. This ACEC extends from the New Hampshire state line to Sandy Pond Road, south of the site. NHESP data shows The entirety of the site is located within BioMap2 Core Habitat with a portion of the site being located within BioMap2 Critical Natural Landscape. A figure detailing this is below:

BioMap2 Critical Natural Landscape

BioMap2 Core Habitat

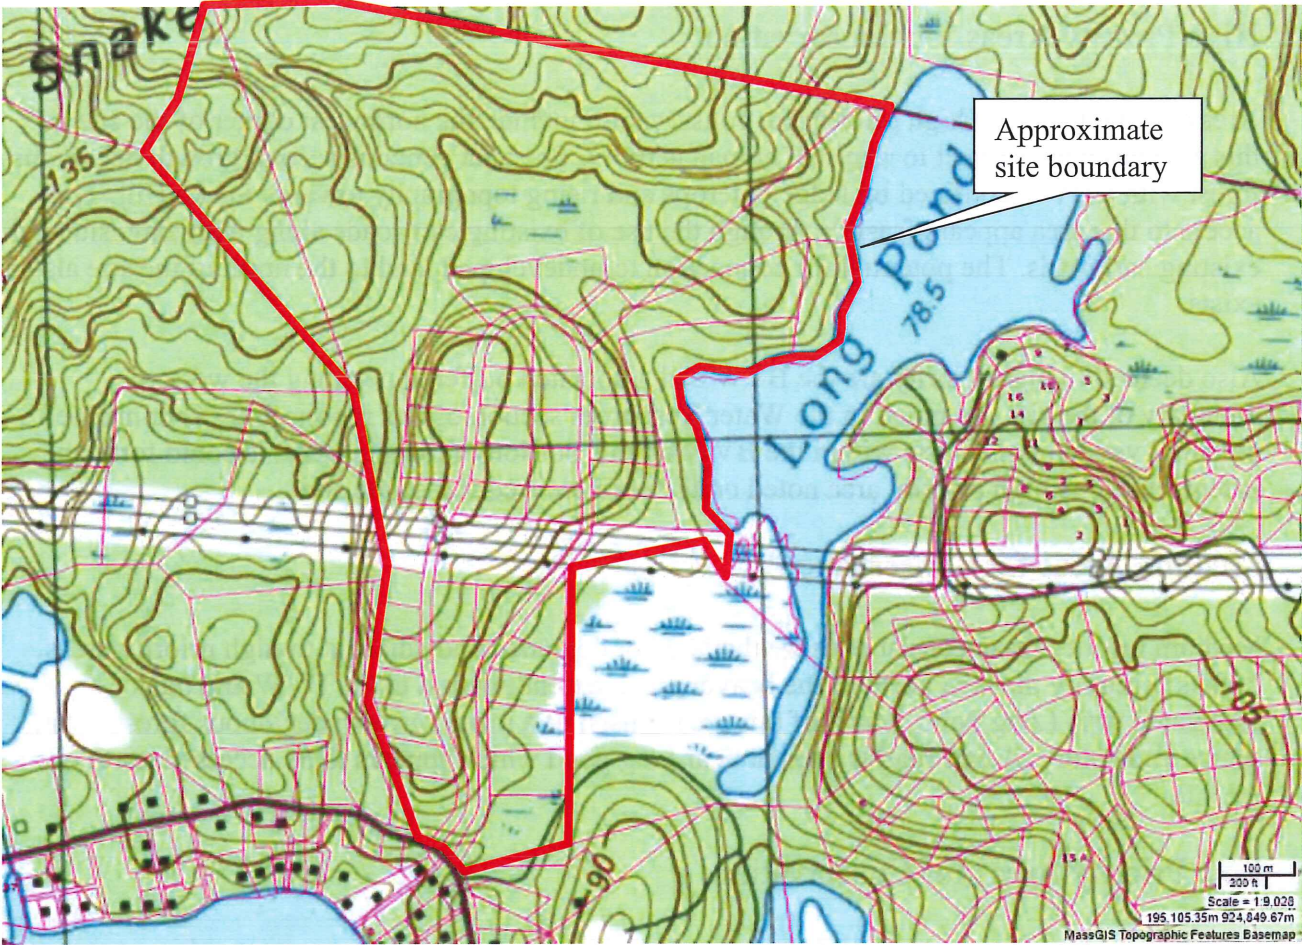
USGS Map

1988 USGS Ayer Quadrangle with tax parcel overlay
Source: MassGIS

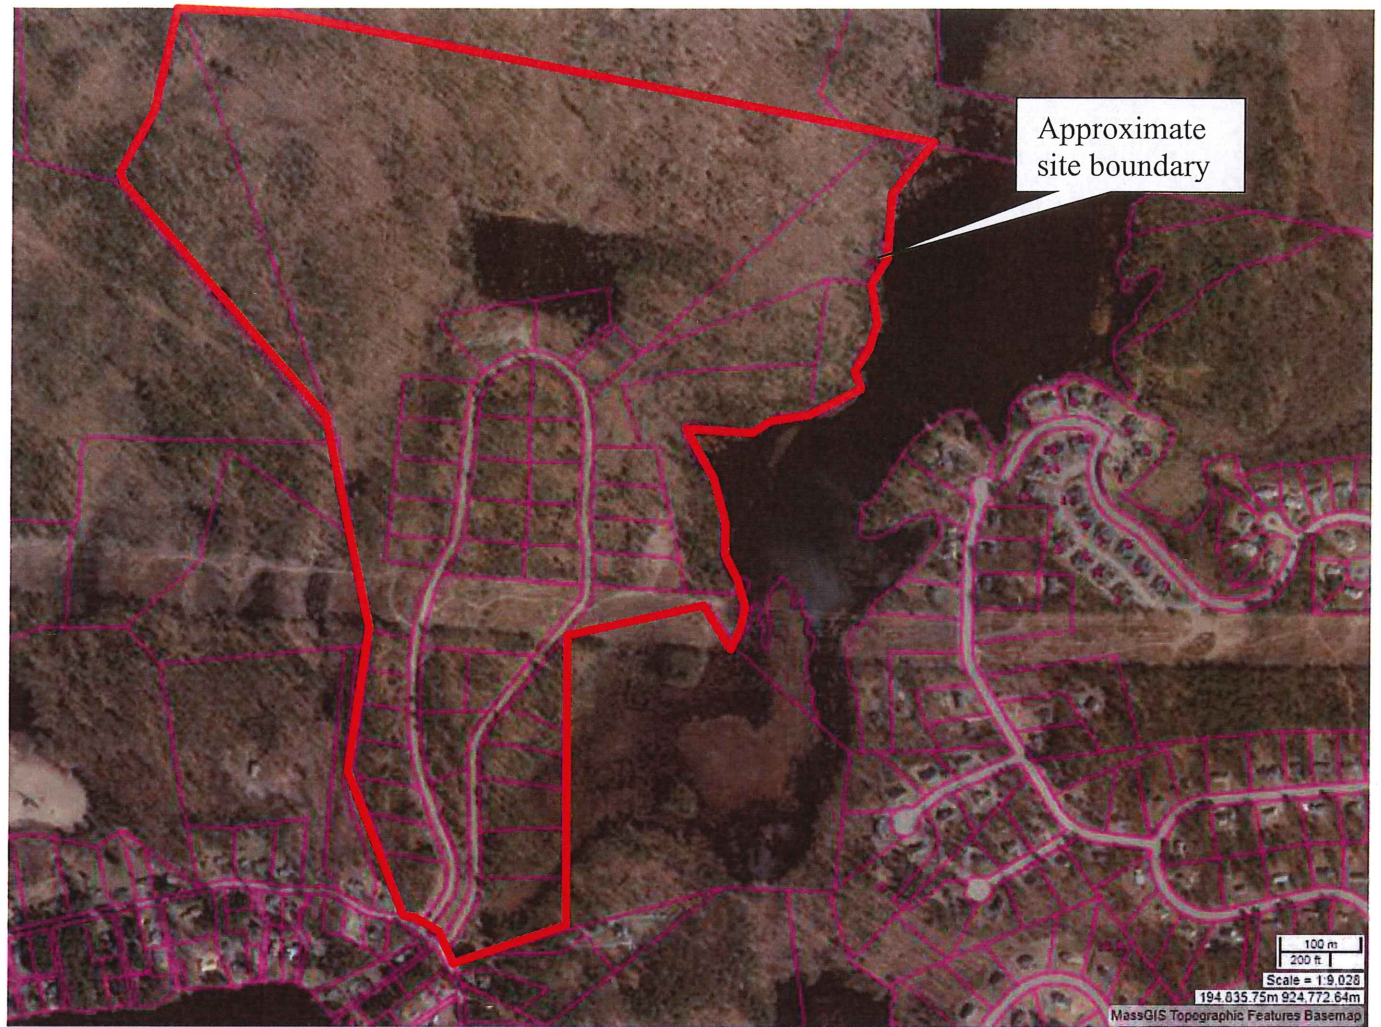
2019 Orthophoto

2019 USGS orthophoto with tax parcel overlay
Source: MassGIS

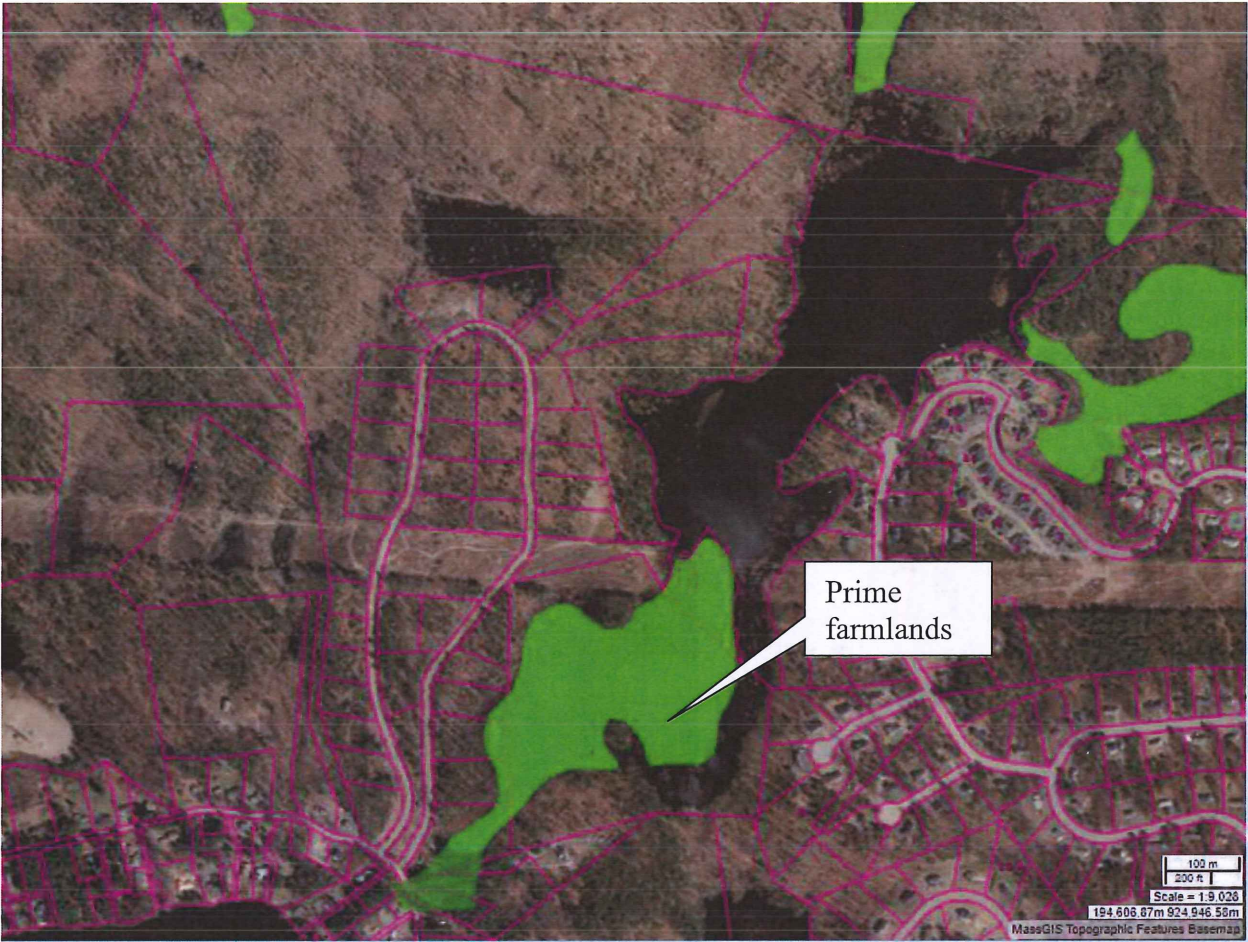
Prime Farmlands Map

2019 USGS orthophoto with prime farmland indicated in green
Source: MassGIS

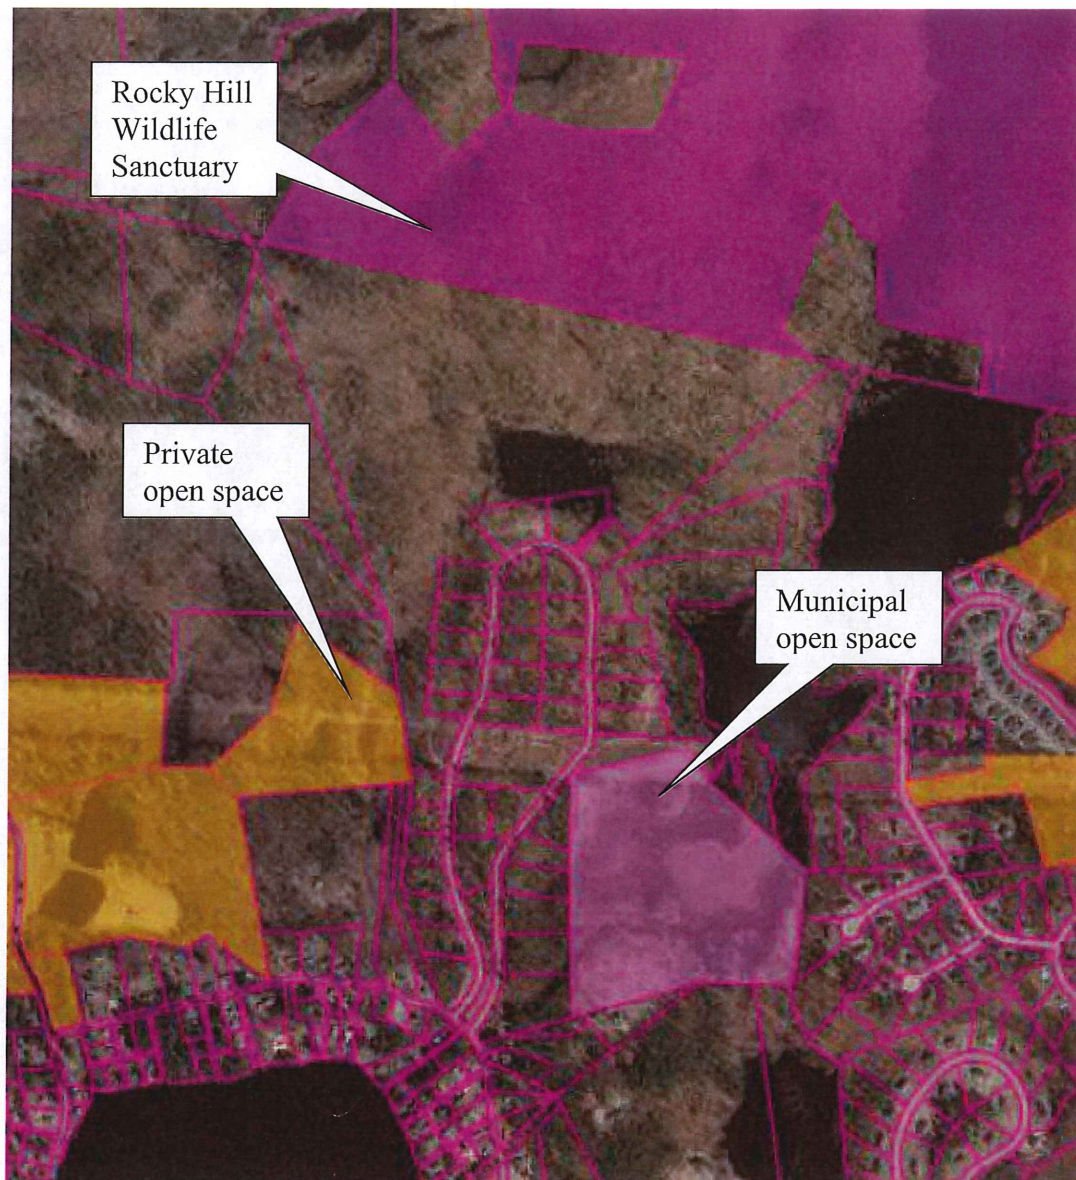
Open Space Map

The site abuts three (3) separate open space areas. Specifically, the Ayer Rod and Gun property west of the site, the Rocky Hill Wildlife Sanctuary (387 acres) north of the site, and Town of Ayer land (30.2 acres) at the southerly end of Long Pond.

2019 USGS orthophoto with existing open space
Source: MassGIS

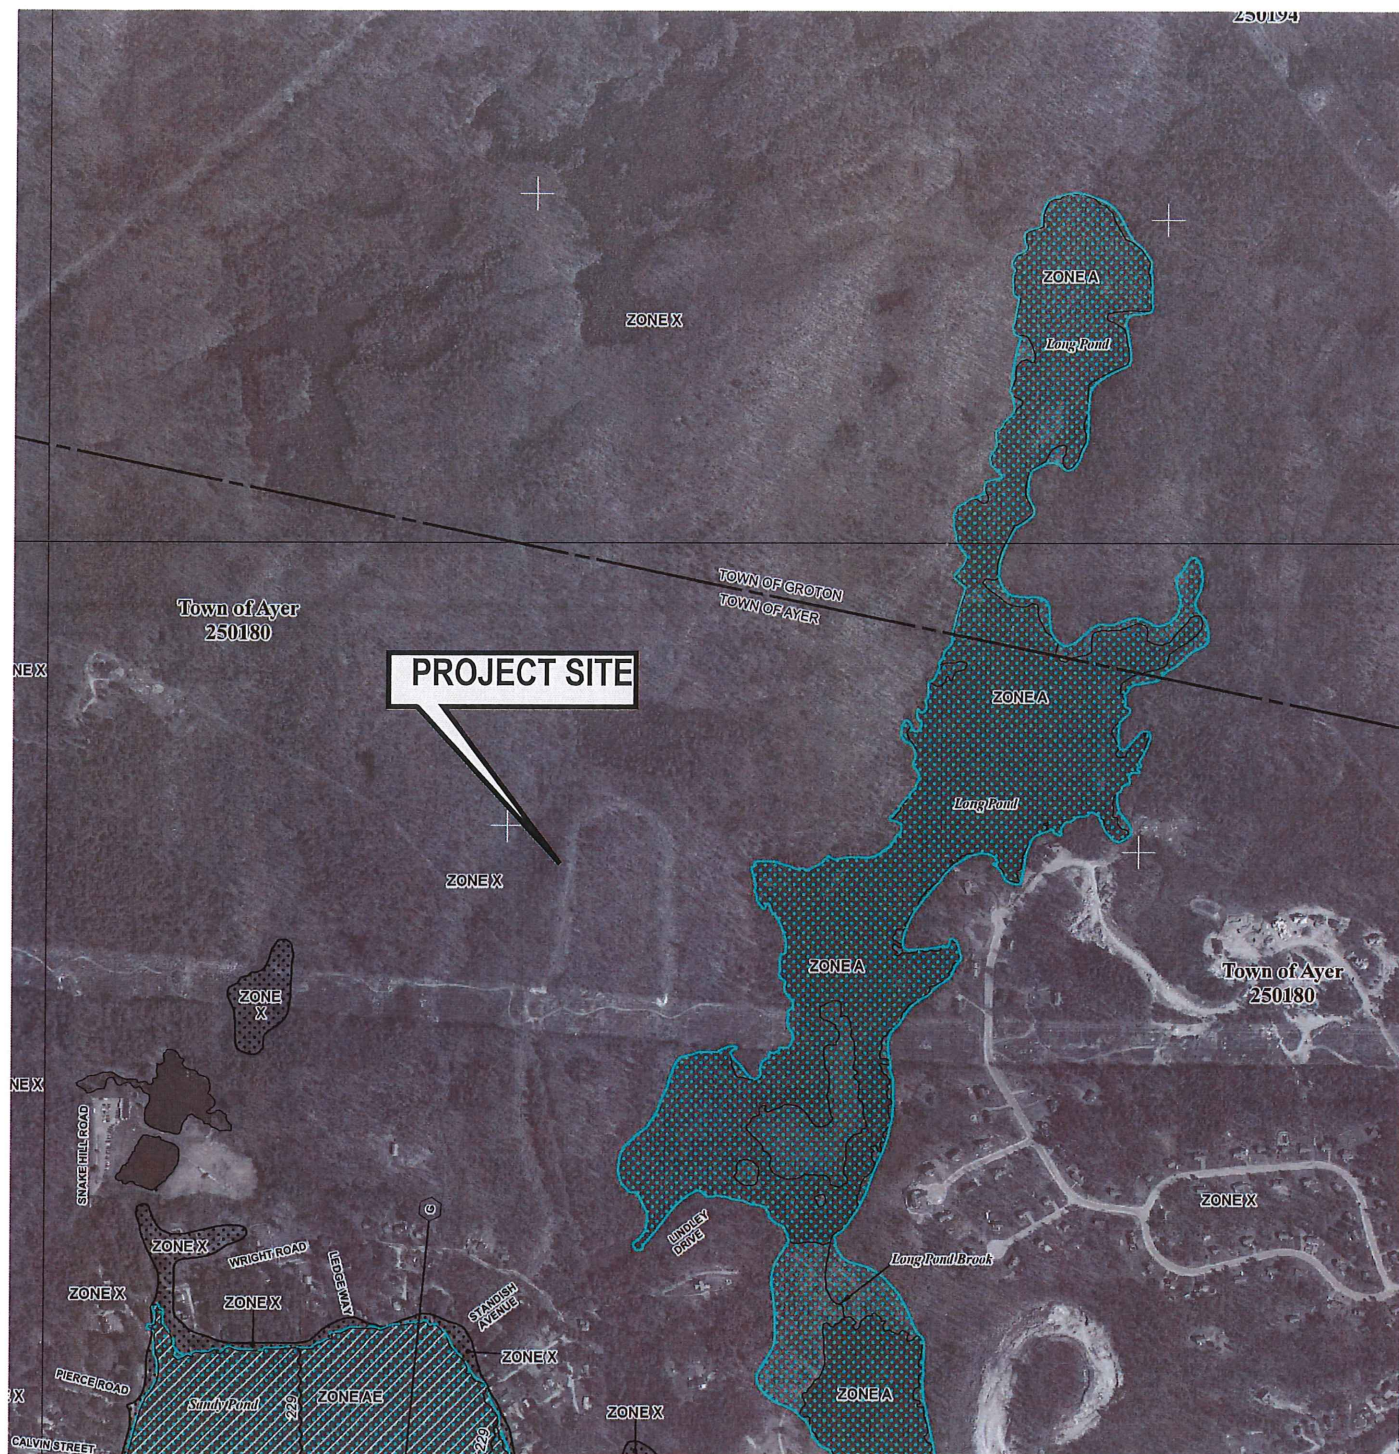
FLOOD MAP

References: FIRM - Flood Insurance Rate Map
Community-Panel Number: 25017C0208E

The proposed project site falls within a few environmentally protected areas. The site contains some wetland areas which all have an associated buffer zone. The entire site falls within the Natural Heritage and Endangered Species Program (NHESP) Priority Habitat of Rare Species and is sited as and Area of Critical Environmental Concern (ACEC). Lastly, a portion of the site falls within a FEMA Zone A from Long Pond.
