CONSERVATION ANALYSIS
PURSUANT TO 10.1 OF THE AYER ZONING BYLAW

STRATTON HILL

STRATTON HILL ROAD
MAP 6, PARCELS 1, 2, 3, 7, 8 & 11 THROUGH 55

AYER,
MASSACHUSETTS

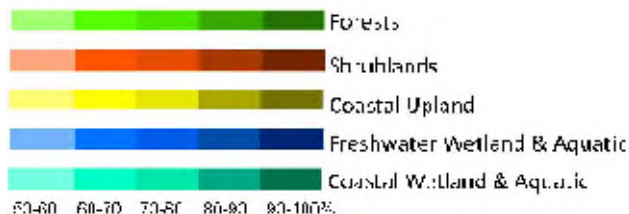
A portion of the site has been mapped by the University of Massachusetts Conservation Assessment and Prioritization System (CAPS) as an area with higher ecological integrity. The existing wetland system provides a primary environmental corridor through the site and connection to areas mapped as higher ecological integrity. Specifically, the northwest corner of the site indicated in a darker green color on the CAPS map. Below is an image of the CAPS map with the current Town of Ayer Assessor parcels for reference:

IEI, Index of Ecological Integrity
Top 50% of the Landscape

UMASS CAPS Index of Ecological Integrity (IEI) Town of Ayer, MA with Town of Ayer Assessor Parcels

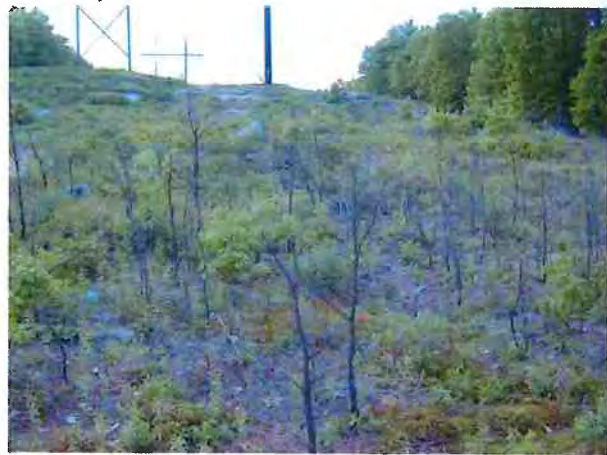
Figure 3. Utility easement, view to the north from the PWP (June 2, 2003)

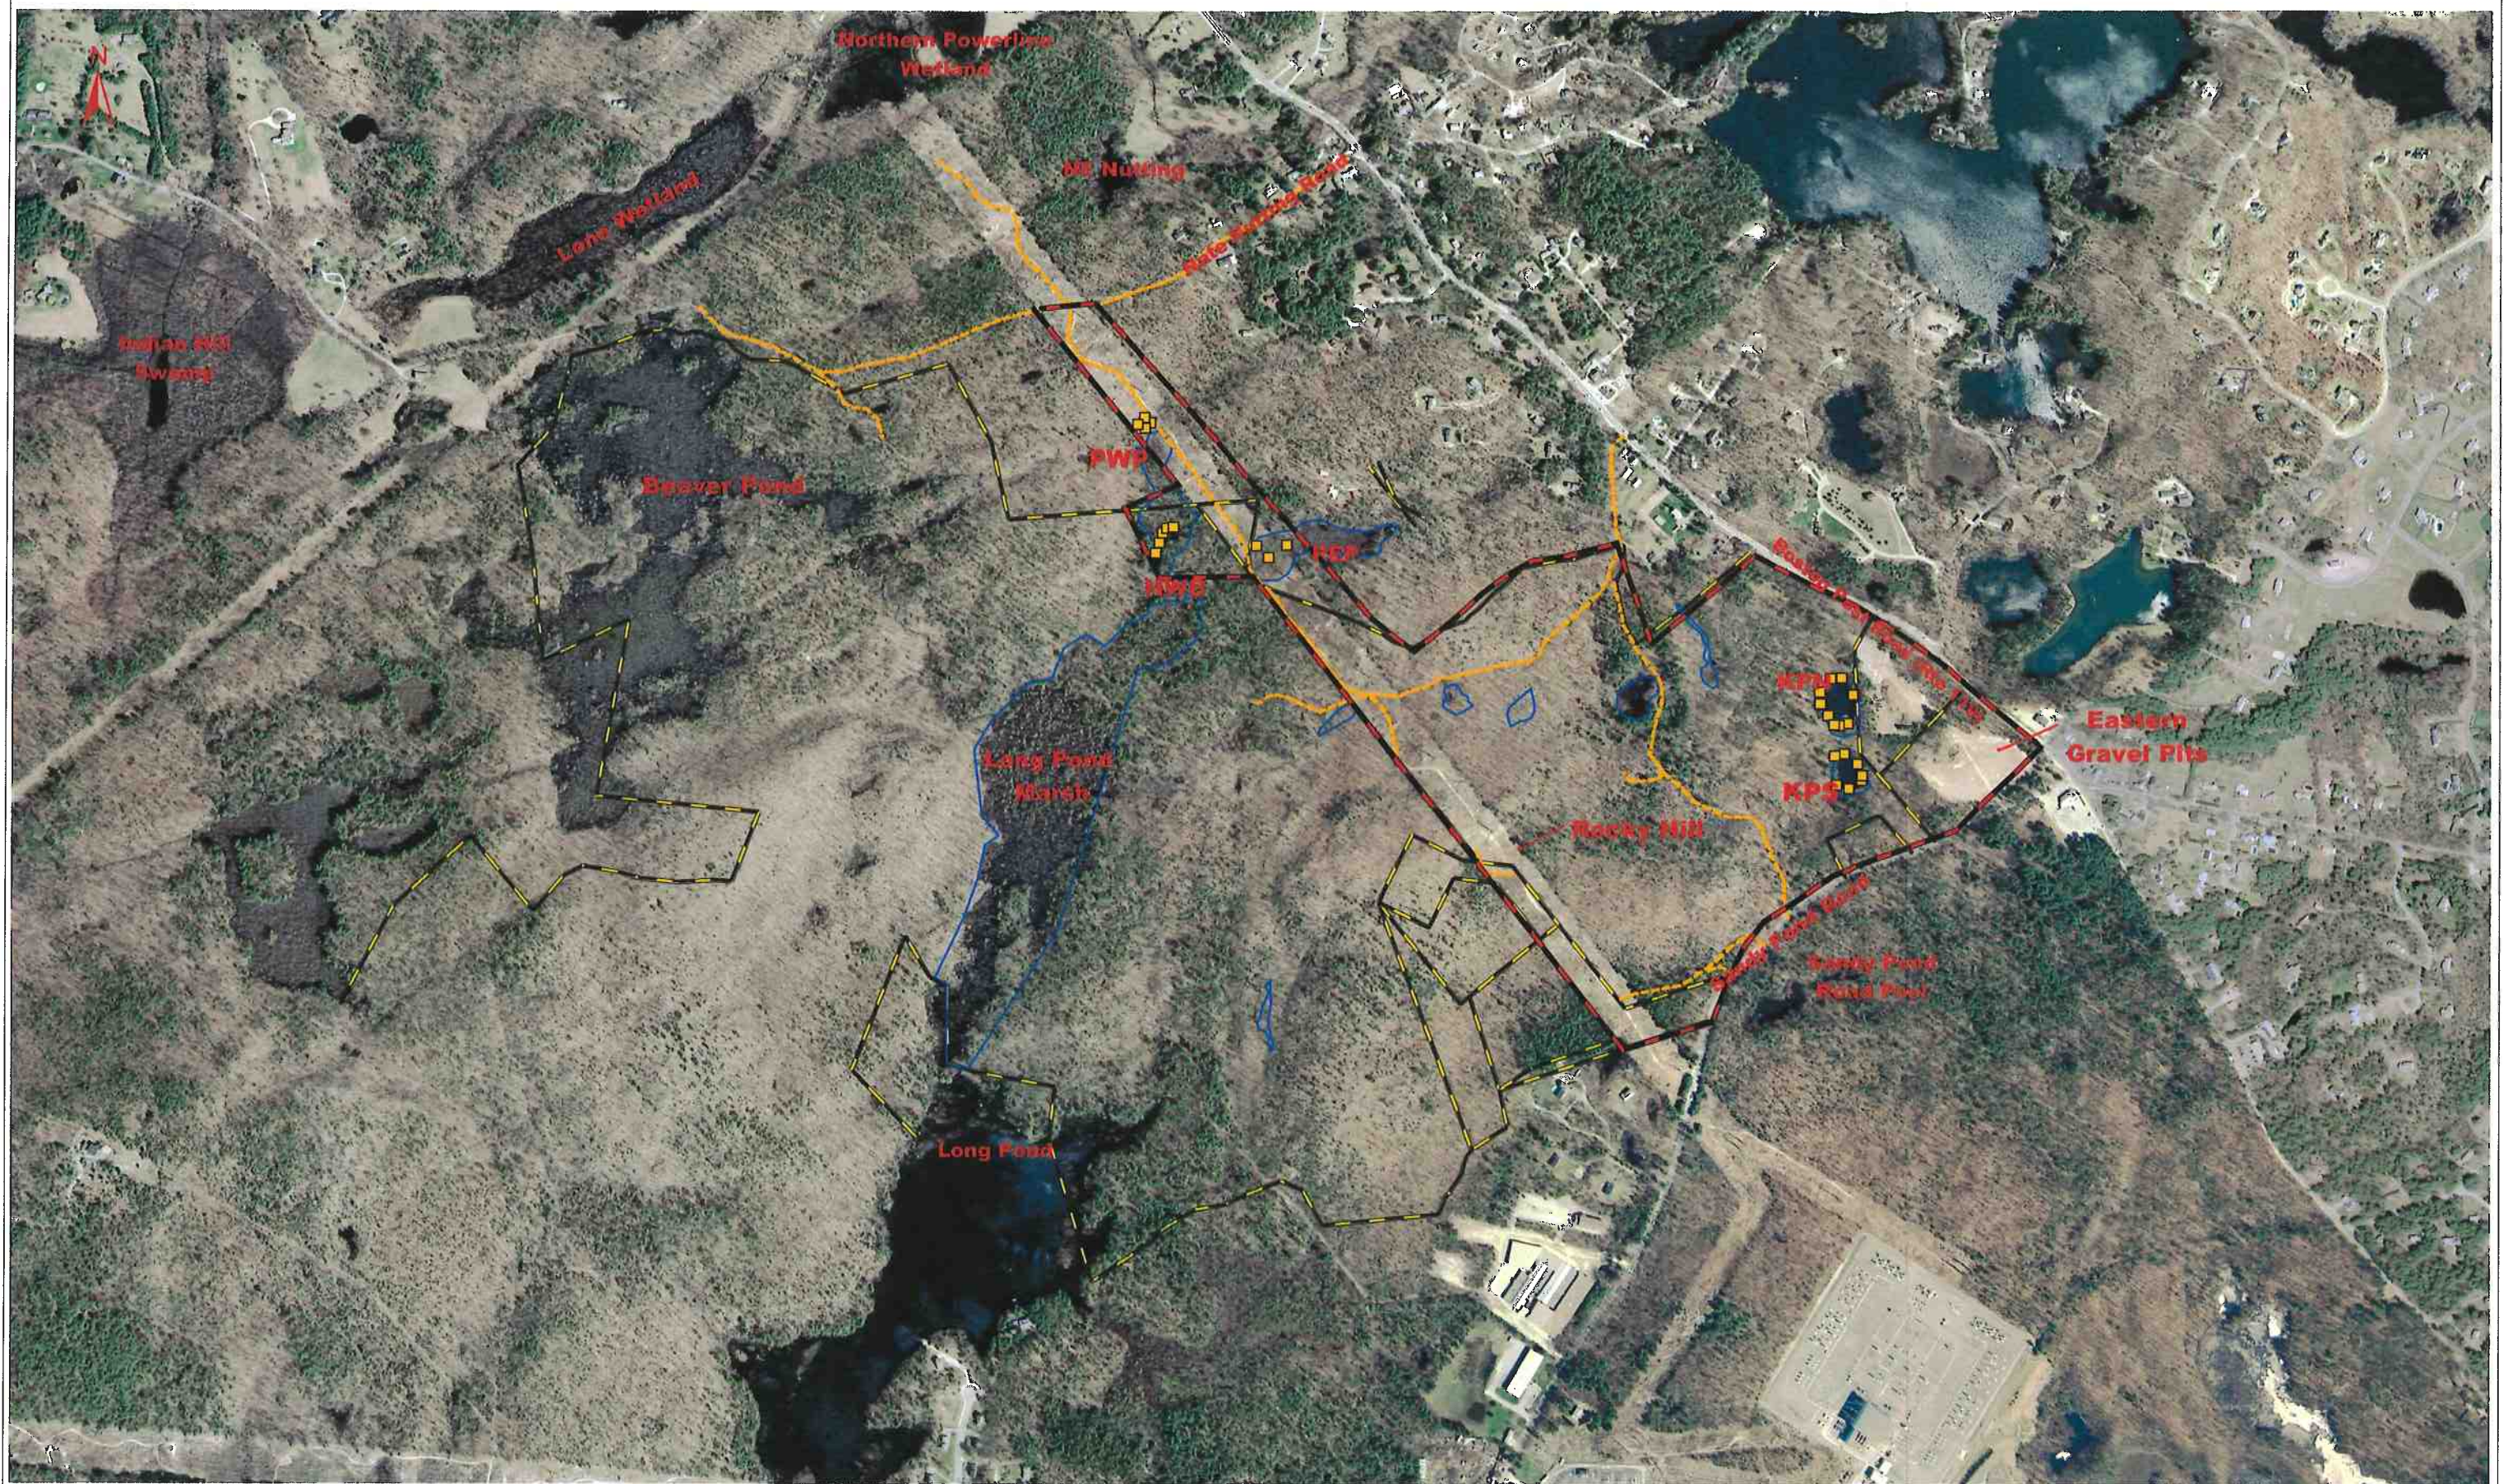
**Figure 1. Wetland & Turtle Trap Locations
Sandy Pond Road, Groton MA**

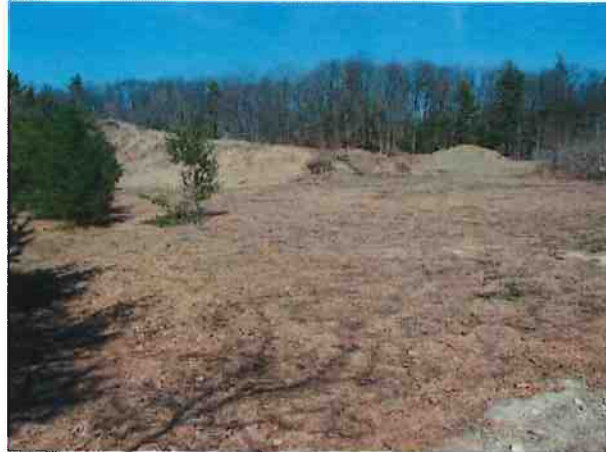
Figure 4. Eastern Gravel Pits (April 15, 2003)

There are two areas of disturbed upland (former gravel mines) located in the extreme northeastern portion of the site, near the junction of Route 119 and Sandy Pond Road (see

Figure 4). Two kettle ponds (described below) lie to the adjacent southeast of the gravel pits.

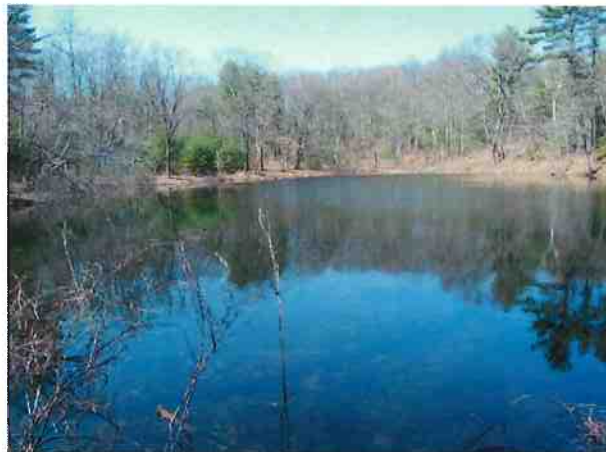
Figure 5a. North Kettle Pool [NKP] (April 15, 2003)

Kettle Pond North and Kettle Pond South ("KPN", and "KPS" respectively) are located in the eastern portion of the site near the intersection of Sandy Pond Road and Route 119. The ponds, which are separated by a forested ridge, are bowl-like topographic depressions that both held more than four feet of water in their deepest points during the course of our study (see Figures 5a and 5b). These ponds are vernal pools as defined by MANHESP guidelines however, they appear to remain flooded in most years. The two basins may be natural topographic features or they may have been enlarged or modified by previous activities. It appears they may have minimally been used as wash ponds for prior gravel operations nearby.

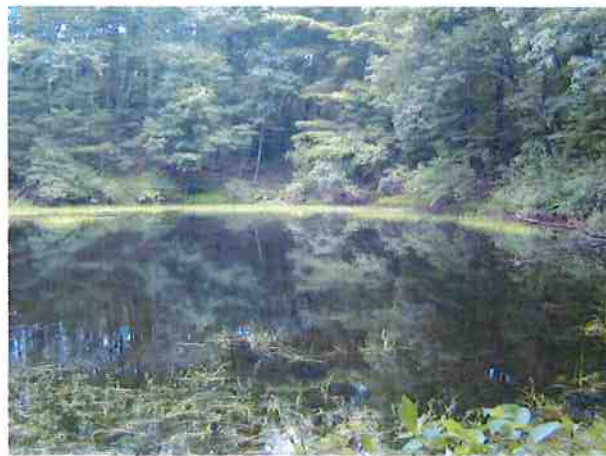
Figure 5b. South Kettle Pool [SKP] (August 8, 2003)

species, see Figure 8). Kettle Pond South contained intricate fairy shrimp and a plethora of green frogs (*Rana clamitans*). Gray treefrog (*Hyla versicolor*, facultative species) were also heard calling from within and in the vicinity of the kettle ponds during May, 2003.

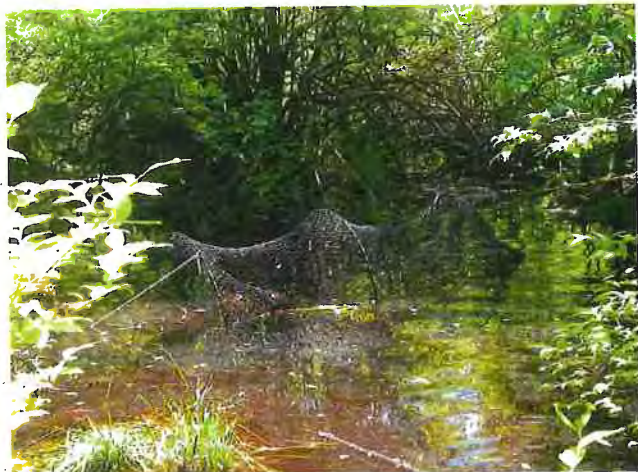
Figure 6. Hoop trap in Highbush Blueberry Wetland (HWP) (June 16, 2003)

The **Highbush Blueberry Wetland (HWB)** is hydrologically connected to the PWP and was differentiated by OA for trapping purposes. This wetland is situated southwest of the powerline easement. The vegetation in this dense shrub swamp is almost exclusively made up of highbush blueberry (*Vaccinium corymbosum*) and buttonbush (*Cephalanthus occidentalis*) (see Figure 6). There are numerous small areas of open standing water in this wetland and OA observed standing water in this wetland up to four feet deep in May and October 2003.

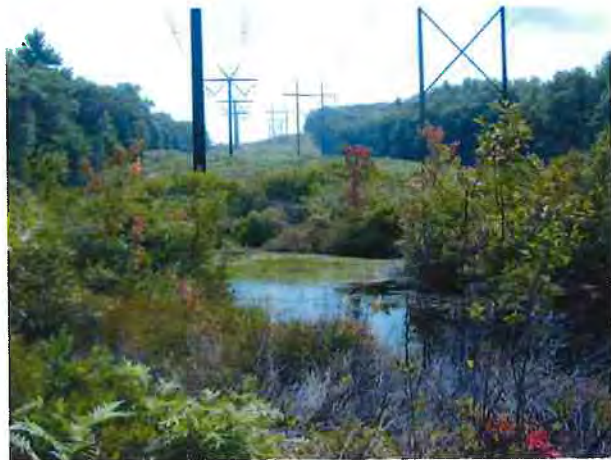
Figure 7. Powerline East Pool (PEP) View to southeast (May 19, 2003)

The **Powerline East Pool (PEP)**, a larger emergent marsh/scrub-shrub wetland, is located to the southeast of PWP (see Figure 7). Shrubs (buttonbush, highbush blueberry, winterberry [*Ilex verticillata*], mountain holly [*Nemopanthus mucronata*]) constitute most of vegetation in this wetland, however, mosses and sedges are also present in patches of open canopy. This wetland bisects the powerline easement and transitions into a forested wetland to the northeast of the easement. As in the PWP, PEP water levels had dramatically receded by the end of July with scattered pockets of standing water remaining thereafter.

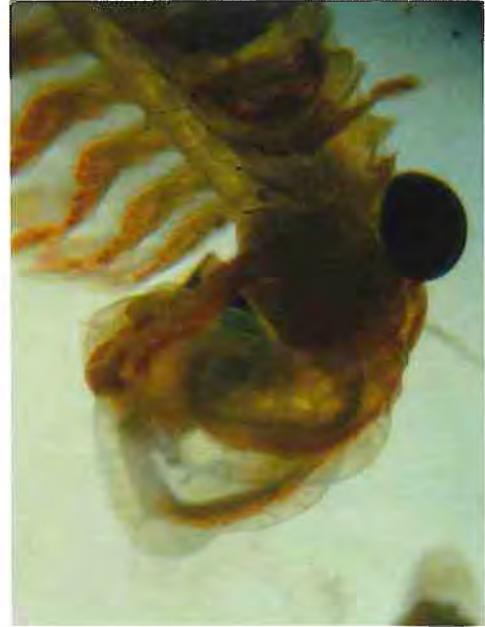
Figure 8. Head of *Eubranchipus intricatus* documented from both kettle ponds.
