Ayer Police Station Fence and Trim Replacement

Ayer Facilities Department
FY24 Capital Request

Fire Station HVAC Repairs

Ayer Library FY24 HVAC and Roof Repair Request

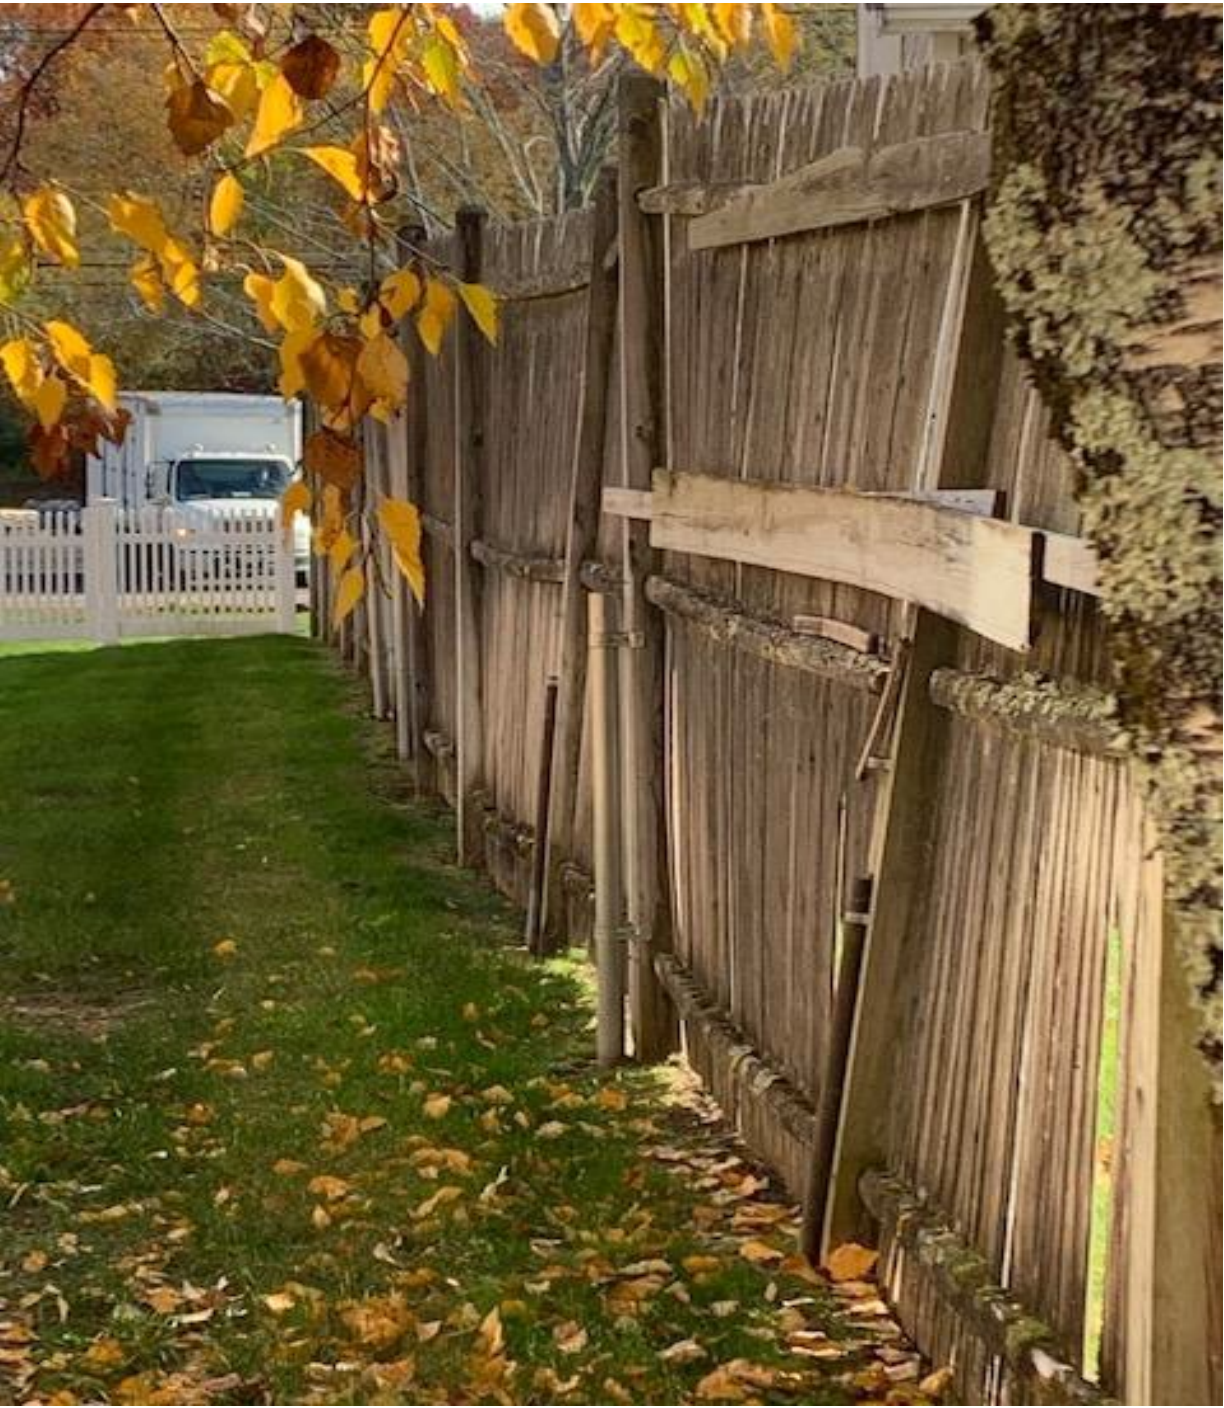
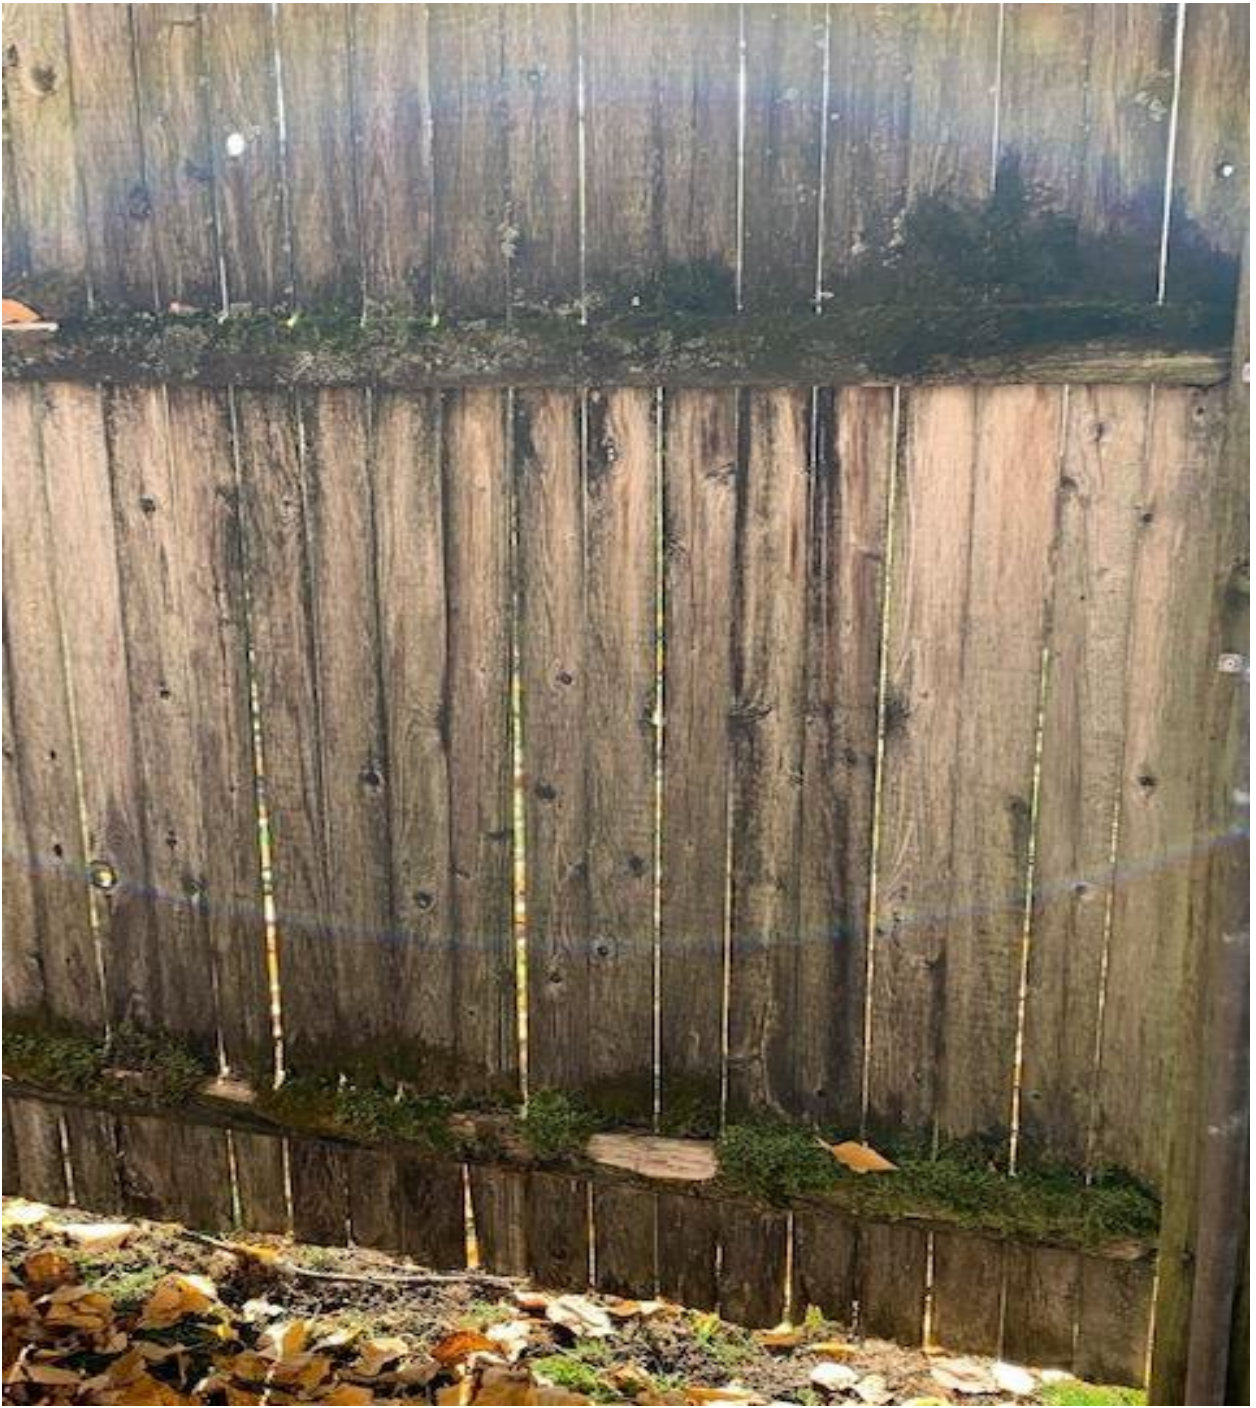
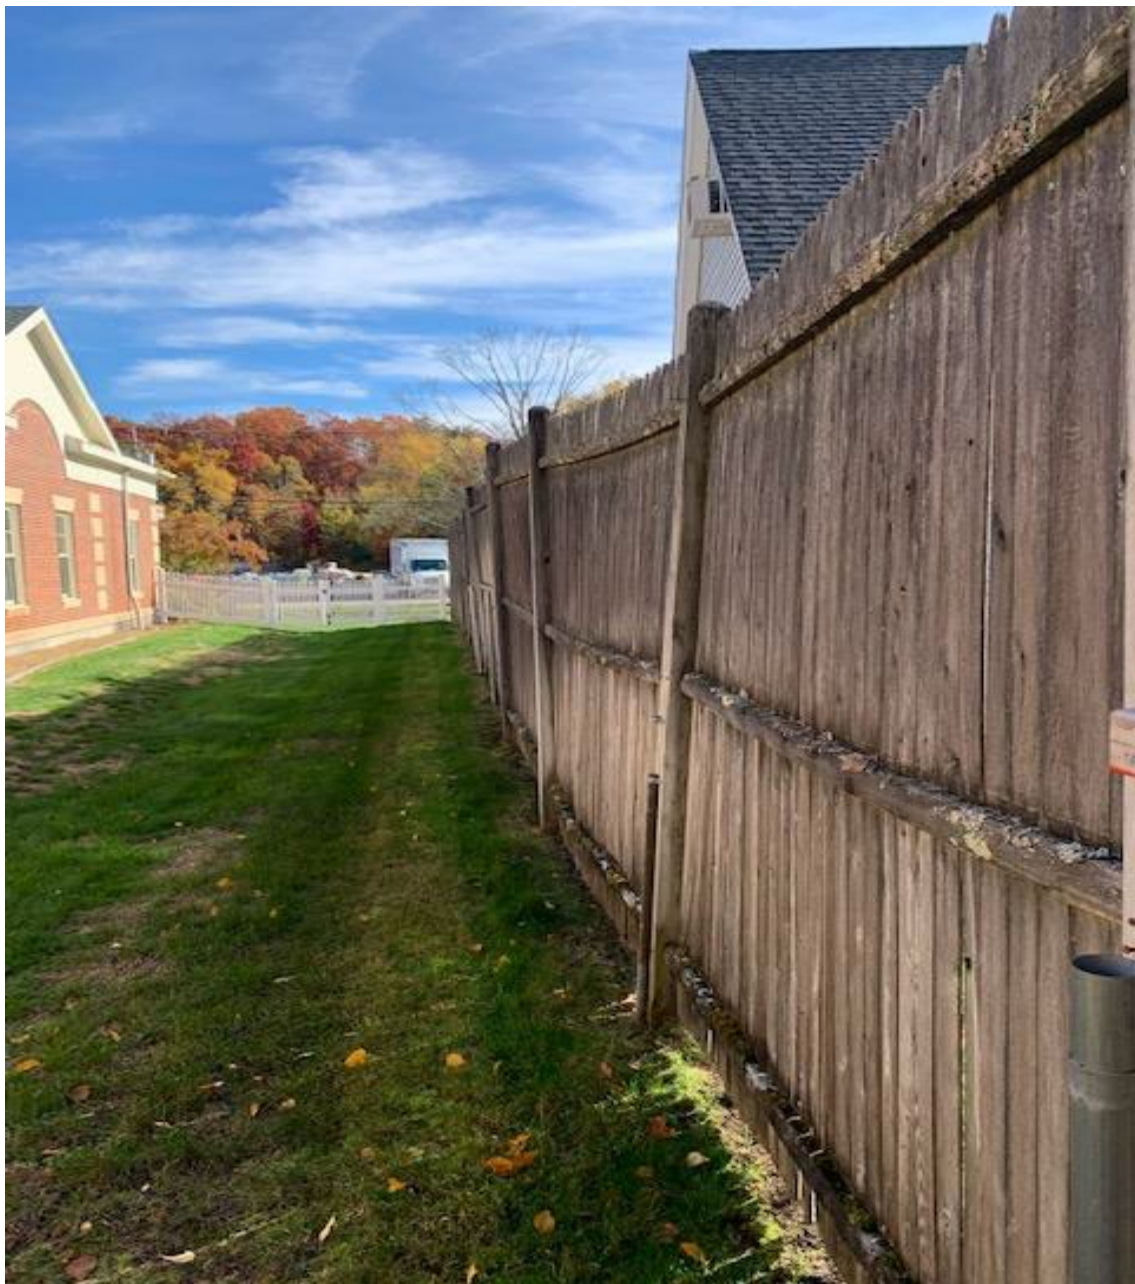
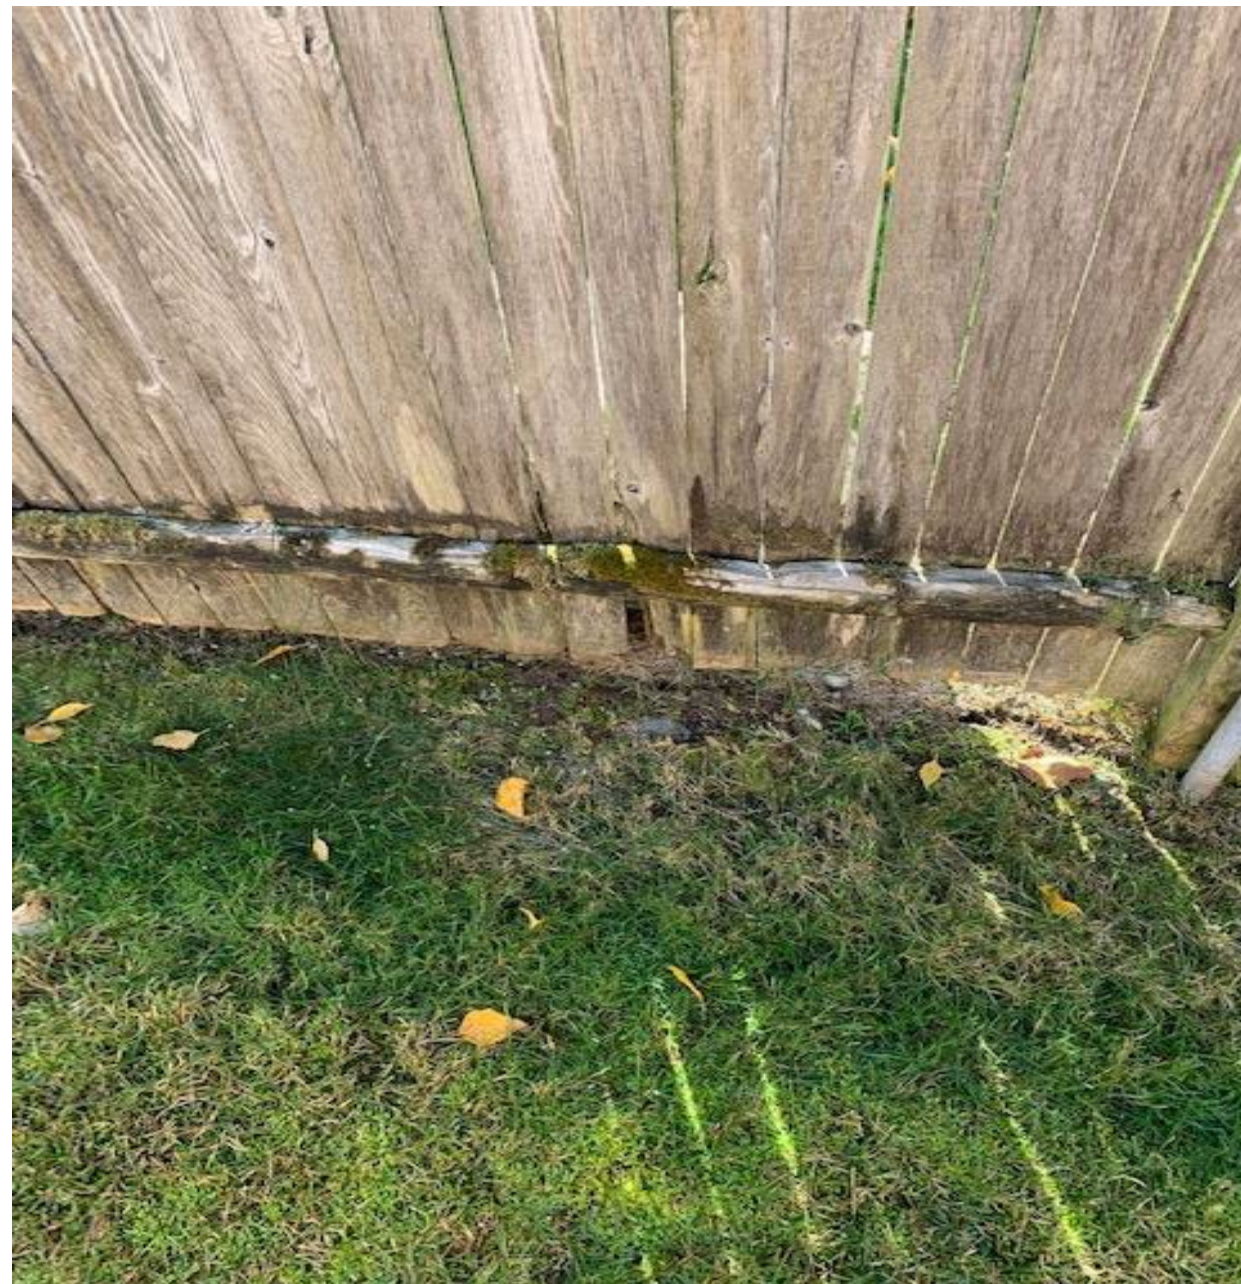
Property Line

- (1) 180 Feet
- (2) 8 Ft Commercial grade white vinyl privacy panels
- (3) 8 Ft white post reinforced with an interior 4x4 P.T post
- (4) All Posts need to be secured with at least 240 pounds of concrete

Dumpster Area

- (1) 32 Feet
- (2) 8 Ft Commercial grade cedar stockade privacy panels
- (3) 8 Ft 4x4 cedar post
- (4) All Post needs to be secured with at least 240 pounds of concrete

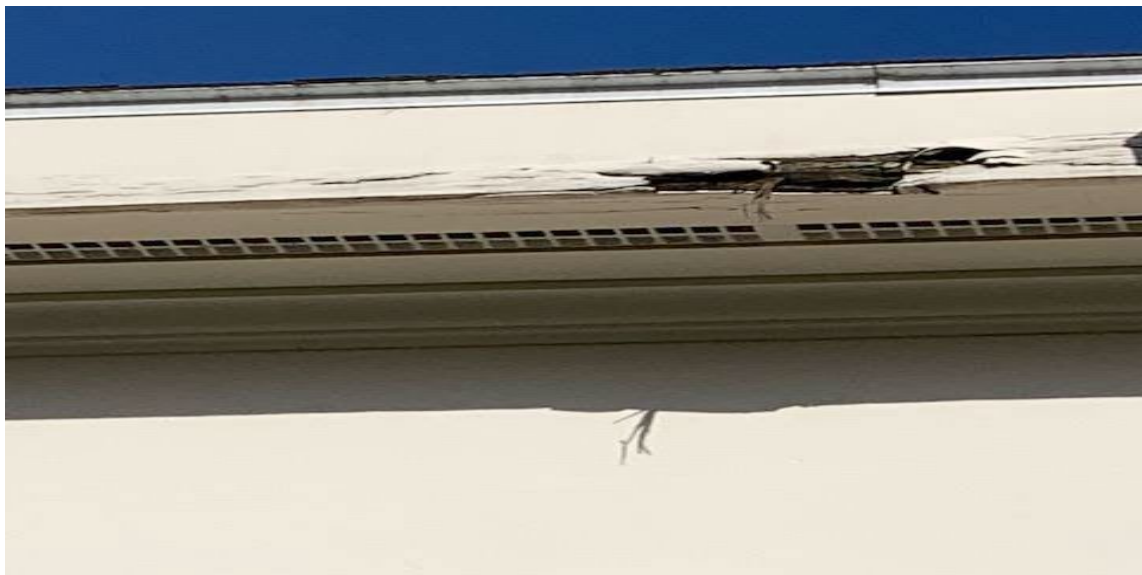
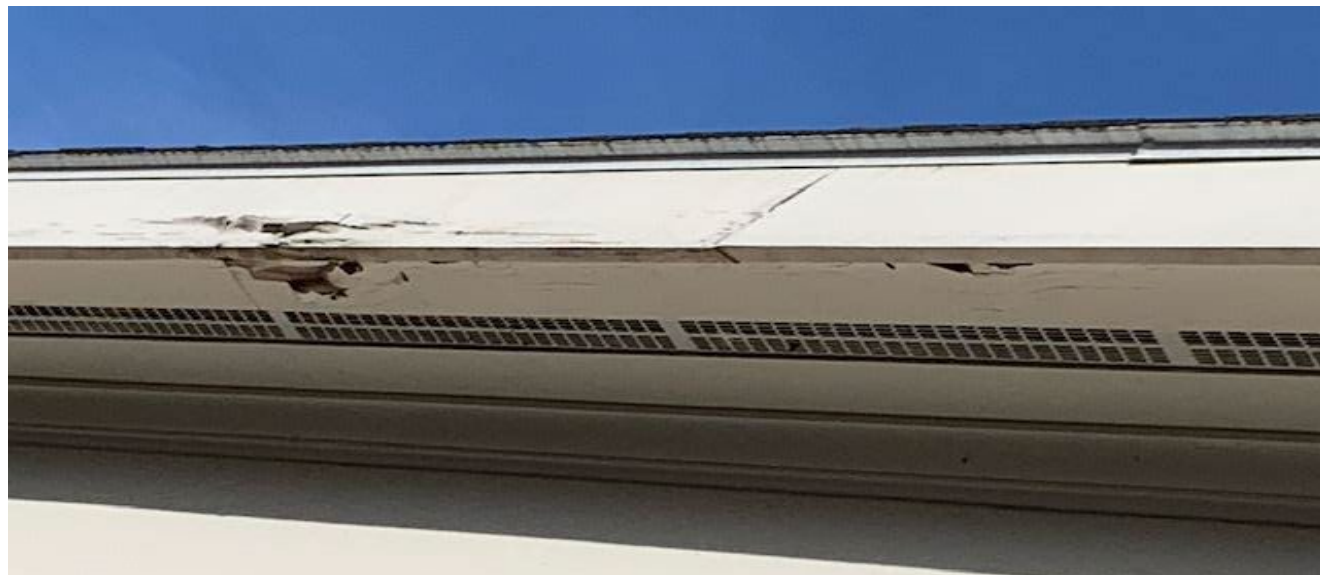
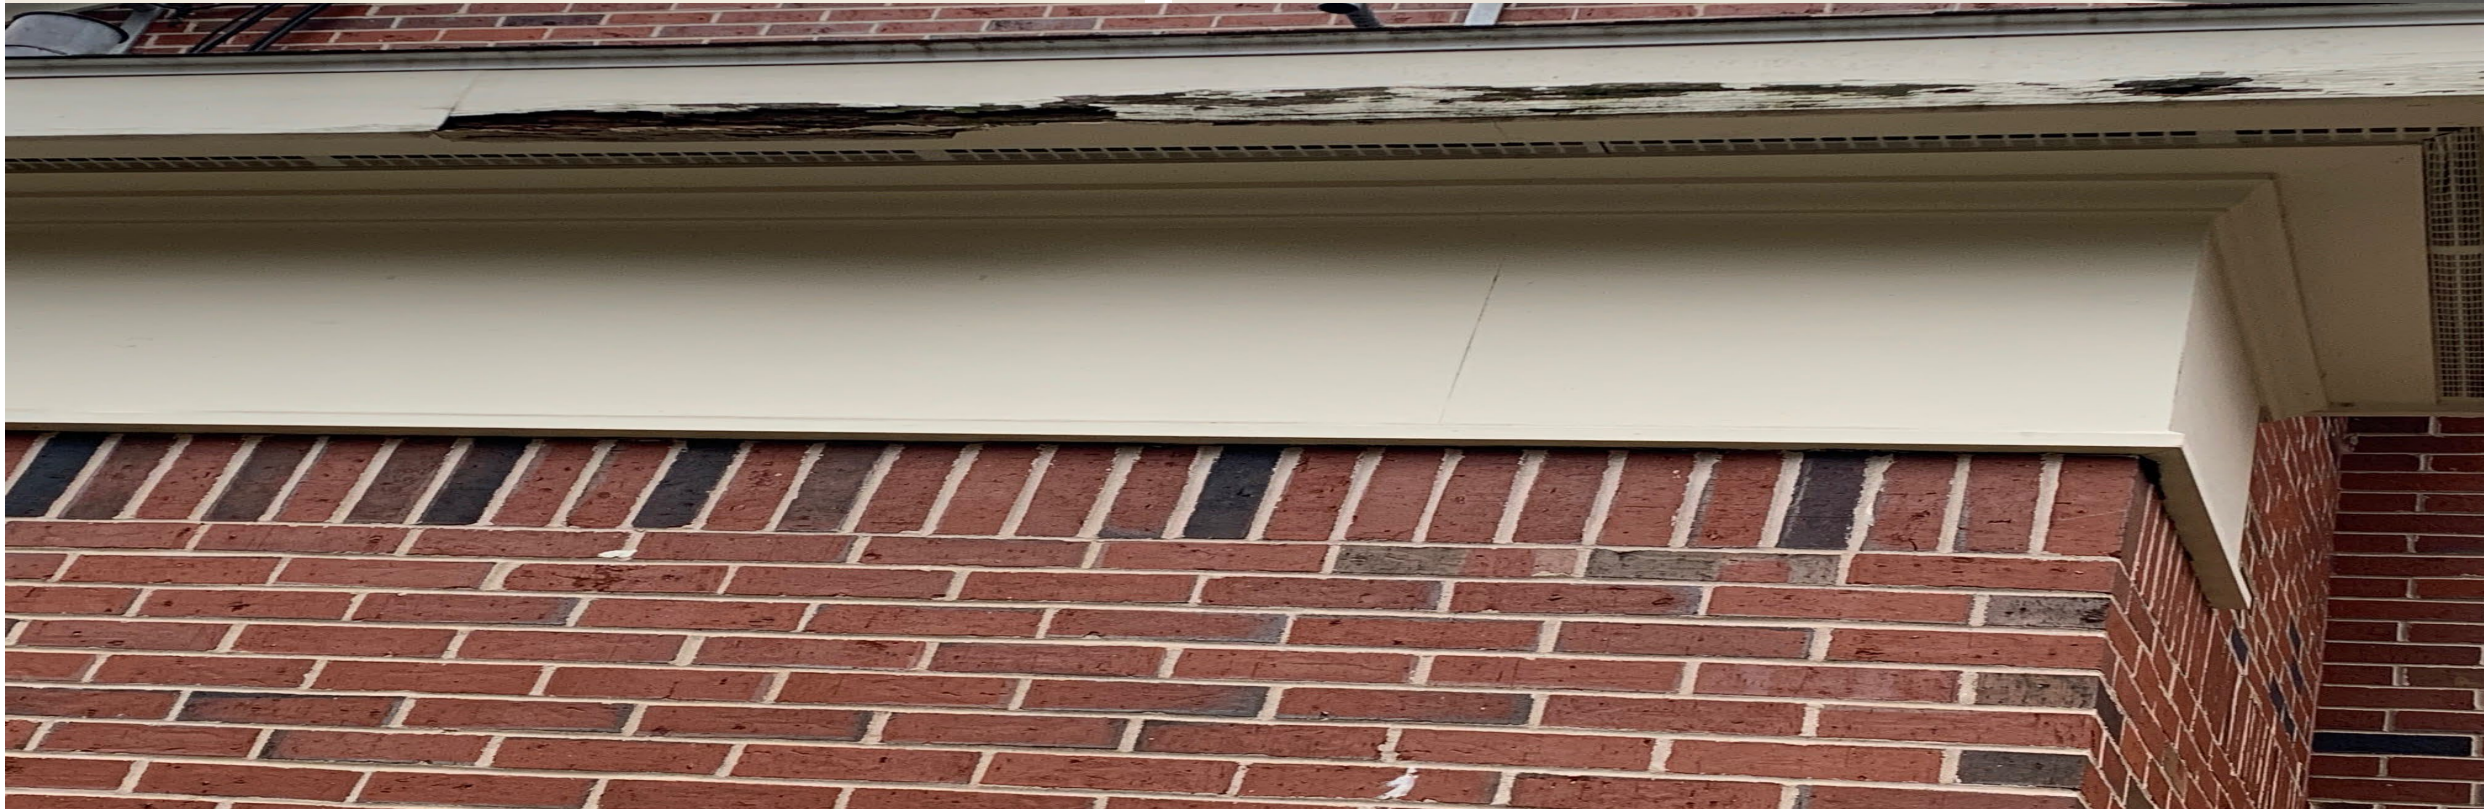
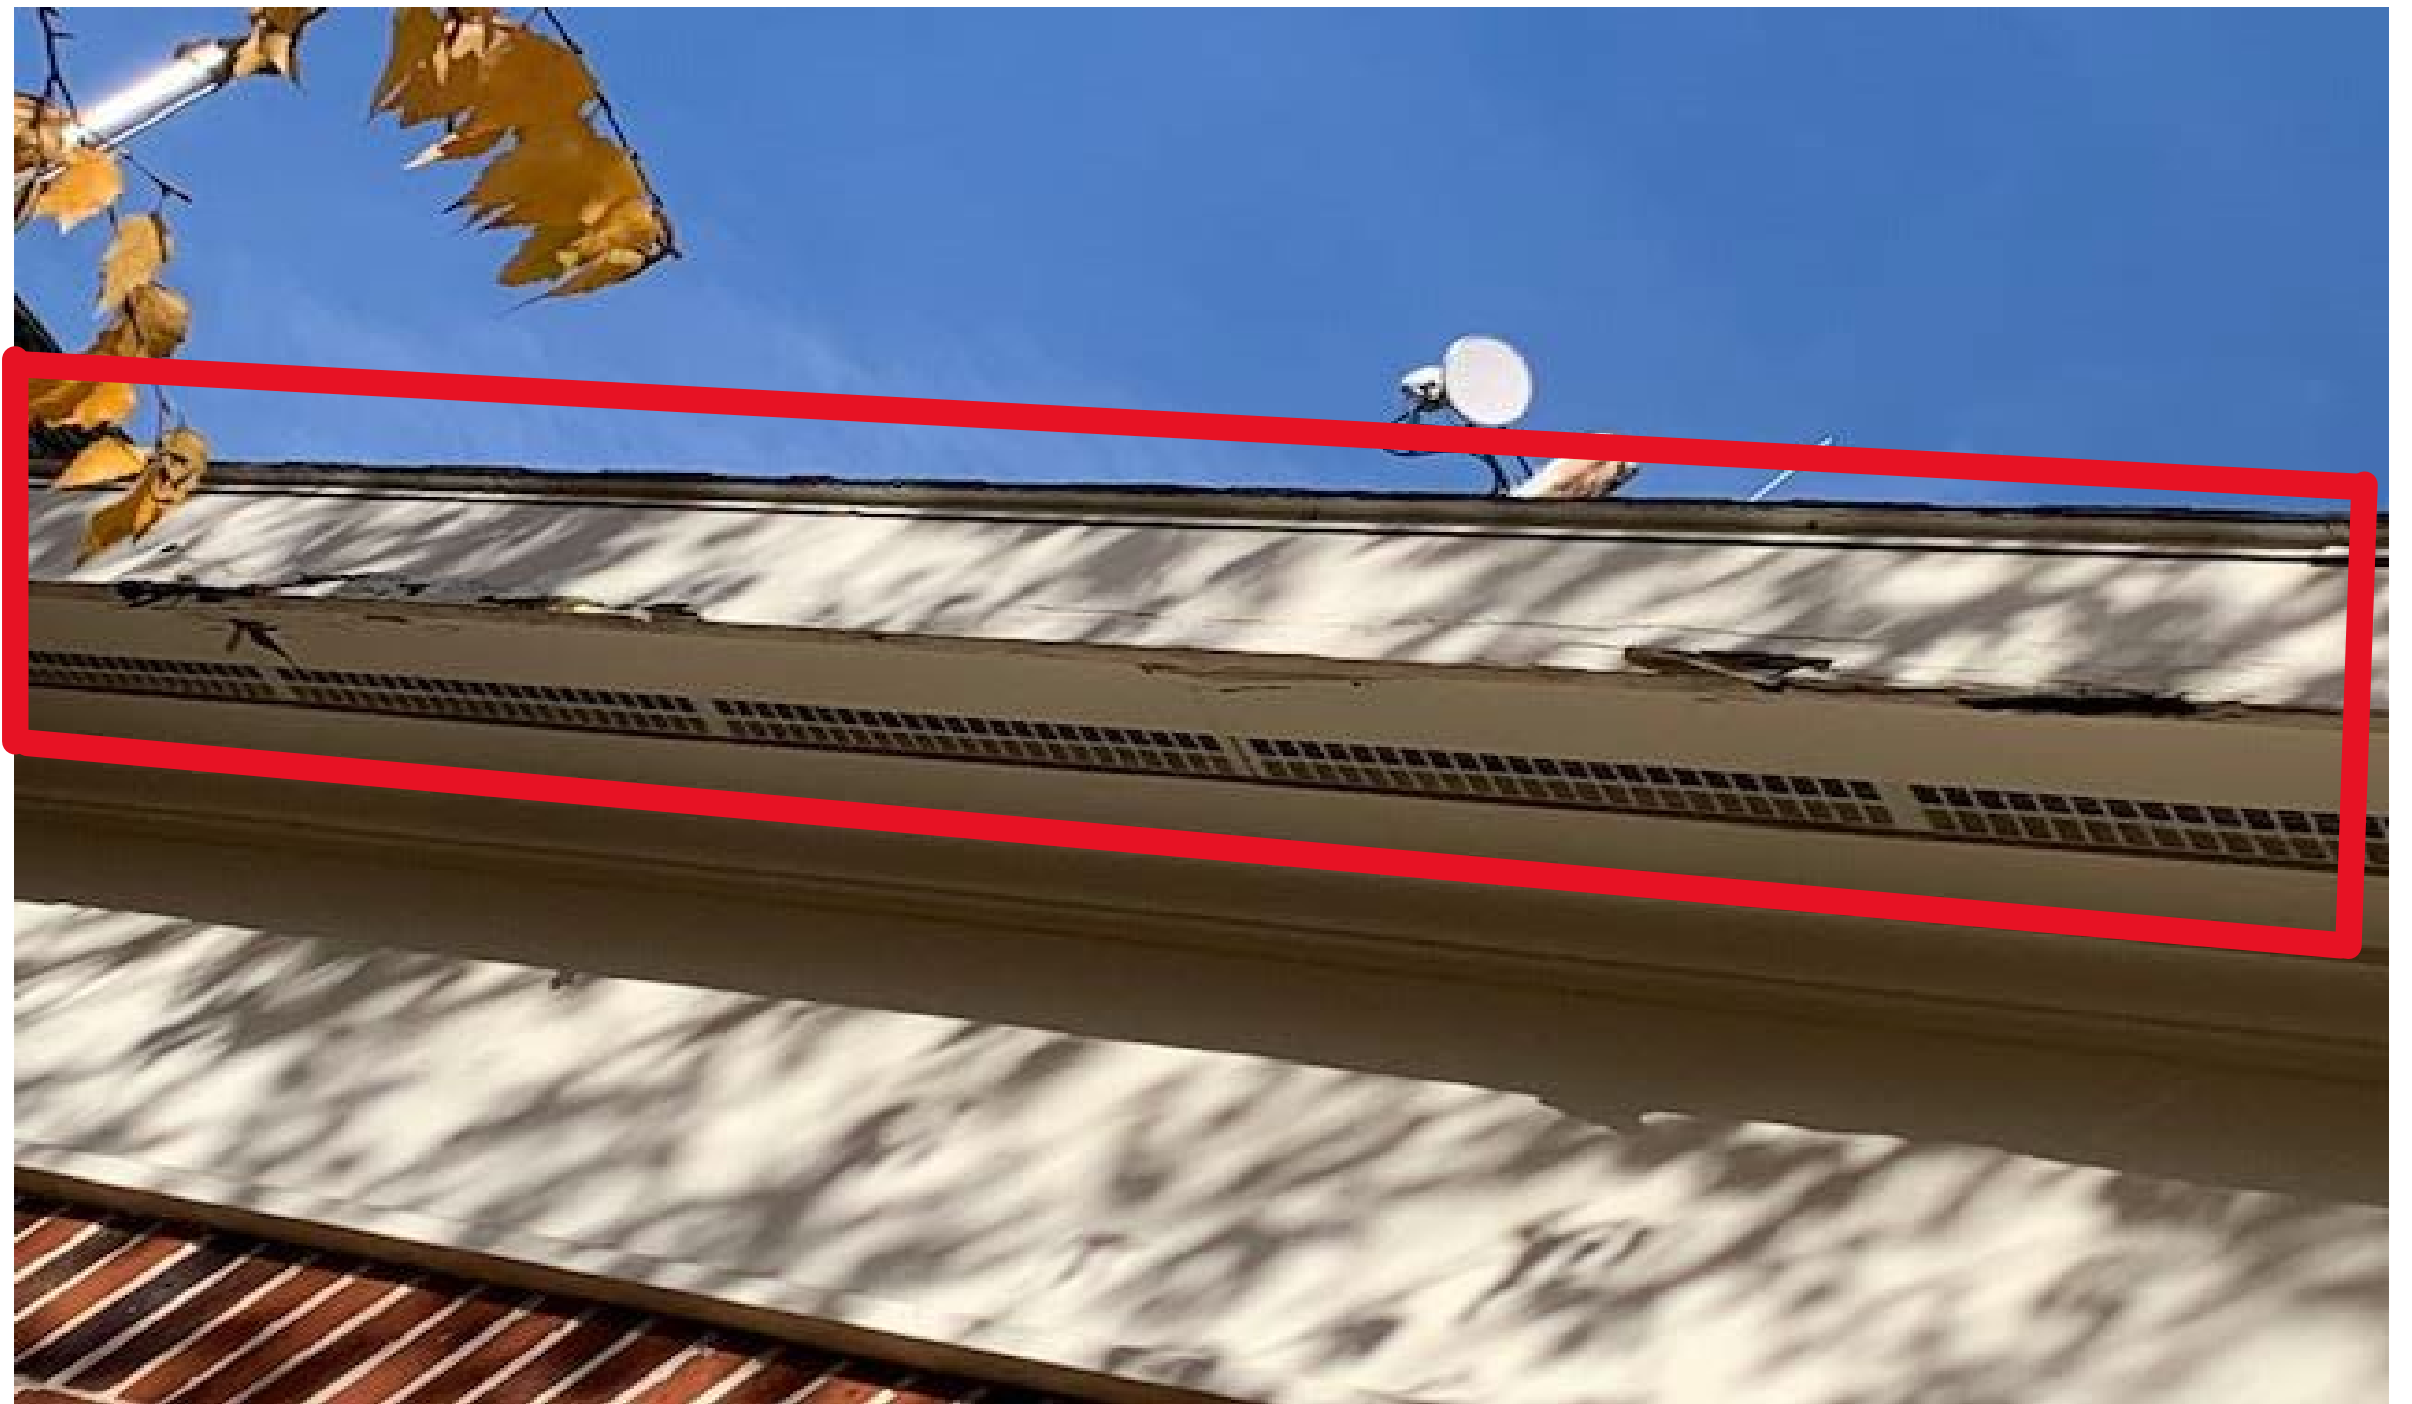
Fascia and Soffit Trim Repairs

- (1) Remove rotten fascia and soffit trim board
- (2) Install new white PVC fascia and soffit trim board to damaged areas
- (3) The Facilities Department would like to replace the entire northeast side of the building fascia trim due to the extent of rot.
- (4) Only replace the soffit in the damaged areas
- (5) Paint to blend in new with old
- (6) Evaluate the extent of damage while rotten trim is removed

- (1) \$10,000.00 is only going to fund replacing extremely damaged areas
- (2) If the Town replaced all 180 Ft of fascia and soffit trim on the Northeast side of the building, it would cost over \$40,000.00 (verbal quote)
- (3) Depending on the fence cost and the amount of trim damage. There might be a phase 2 request in FY25

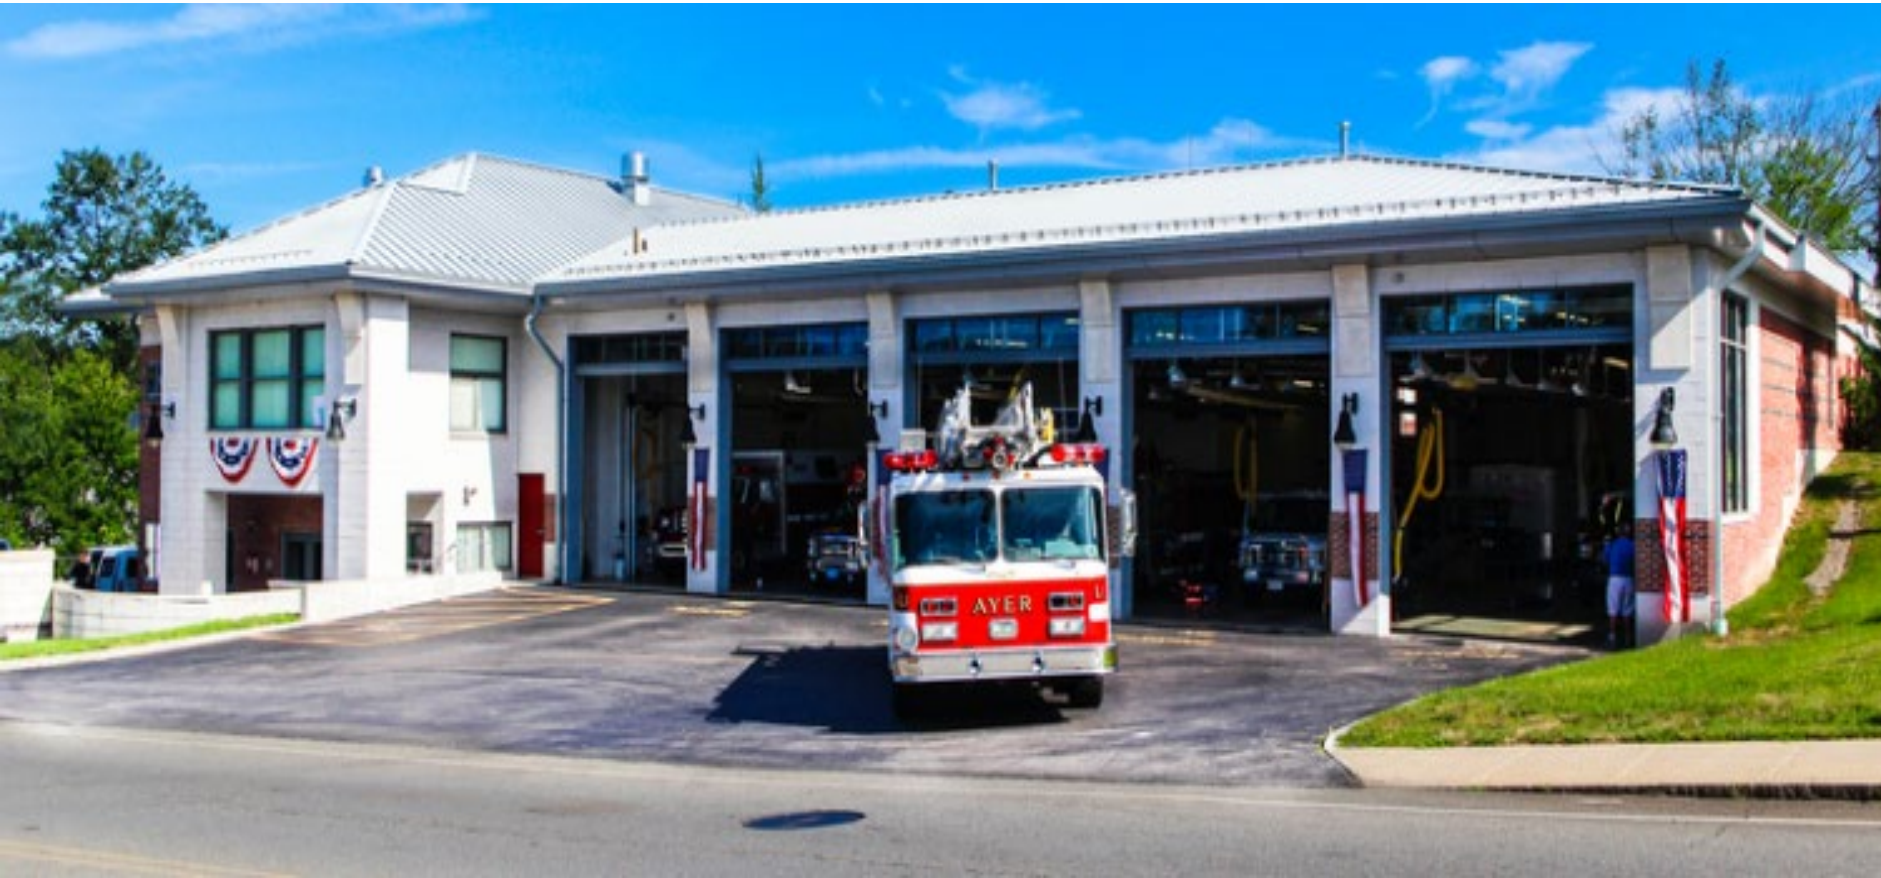
(1) Completely replace the 19-year-old and often failing 20-ton R-22 / gas fed Roof Top Unit

- This unit has taken on 19 severe New England Winters sitting on top of the Fire Station. Compared to other buildings, this unit isn't protected from the weather with tree lines or other buildings. It sits near the end of our downtown corridor
- If we have a sealed system repair or compressor replacement. The estimated cost of a compressor replacement is around \$20,000.00 with unknown lead times. Additionally, R-22 cost are around \$100.00 per pound with our seal system needing between 60lbs – 80lbs of R-22
- While completing repairs to our heat exchanger it was found that our economizer has failed with a repair cost of \$4,000.00

(2) Replacing and reengineering the Roof Top Units curbing. Due to poor original design and failed sheet metal work

- While completed a full inspection of the unit in preparation of this request. It was found that the roof top unit is sitting on a poorly designed curbing system. The original sheet metal installers used additional strips of sheet metal to connect the RTU to the ventilation system. These metal strips have since failed, leaving large gaps between the return, supply, and mixing vents, create poor static pressure and poor efficiency

- The Facilities Department believes every dollar of funding will be needed to install a new RTU. If there is any available funding after the new RTU is installed. We would complete minor repairs to the boiler, control system, and HW system

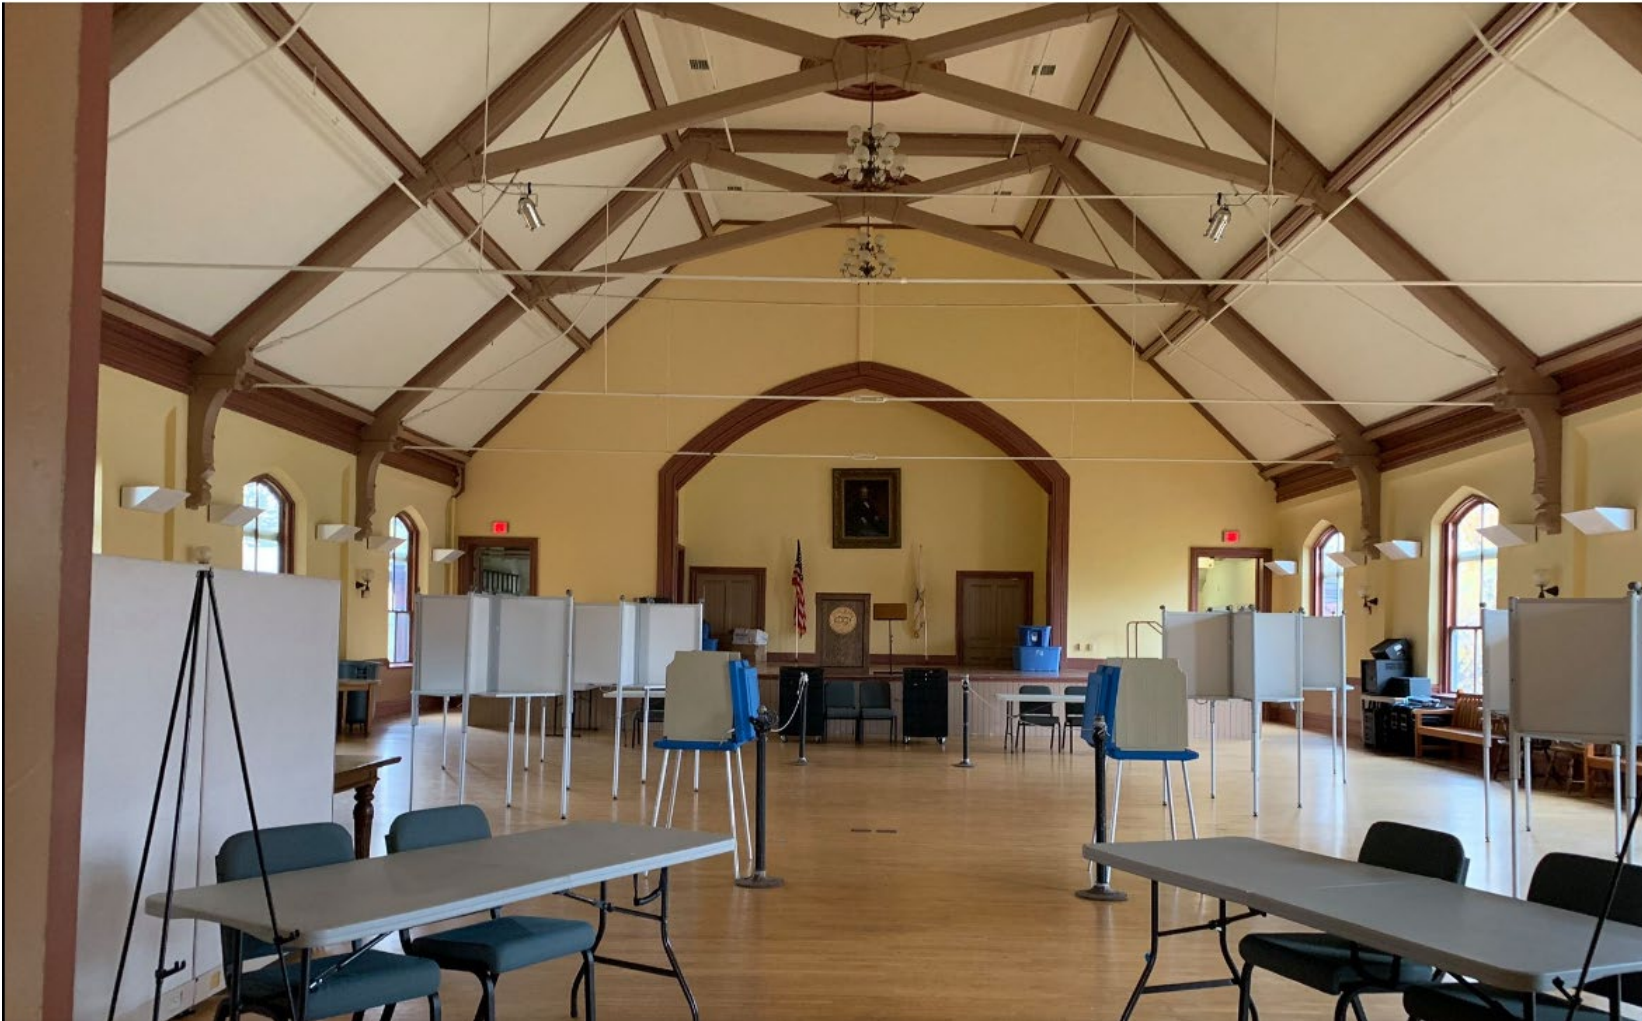
Office Renovations / Repairs / Acoustics

- (1) As a continuation of a successful FY23 Phase 1 Gutter and Roof repair request, this funding request will be used to continue the work to repair the interior wall damage

- (2) After completing inspections and repairs to the slate roof and gutters. It was found that a Phase 2 Gutter and Roof repair request is not needed at this time. Another funding request will be made in FY27 to continue the much-needed preventive maintenance

- (3) Within the \$30,000.00 FY23 budget, Specialized Roofing was able to replace all the leaking, broken, and problematic pieces of slate. Add two new copper downspouts to resolve our water pooling issues. Seal the broken solder joints with elastomeric polyurethane silicone

- (4) The repair budget within this funding request will repair the three most damaged interior walls (Great Hall Columbia Street front corner, Bottom of the staircase bank side exit, and the Columbia Street wall in the Great Hall). These walls moisture readings are extremely low since gutter and slate roof repairs.
