Ayer Police Station Fence and Trim Replacement

Ayer Facilities Department
FY24 Capital Request

Fire Station HVAC Repairs

Ayer Library FY24 HVAC and Roof Repair Request

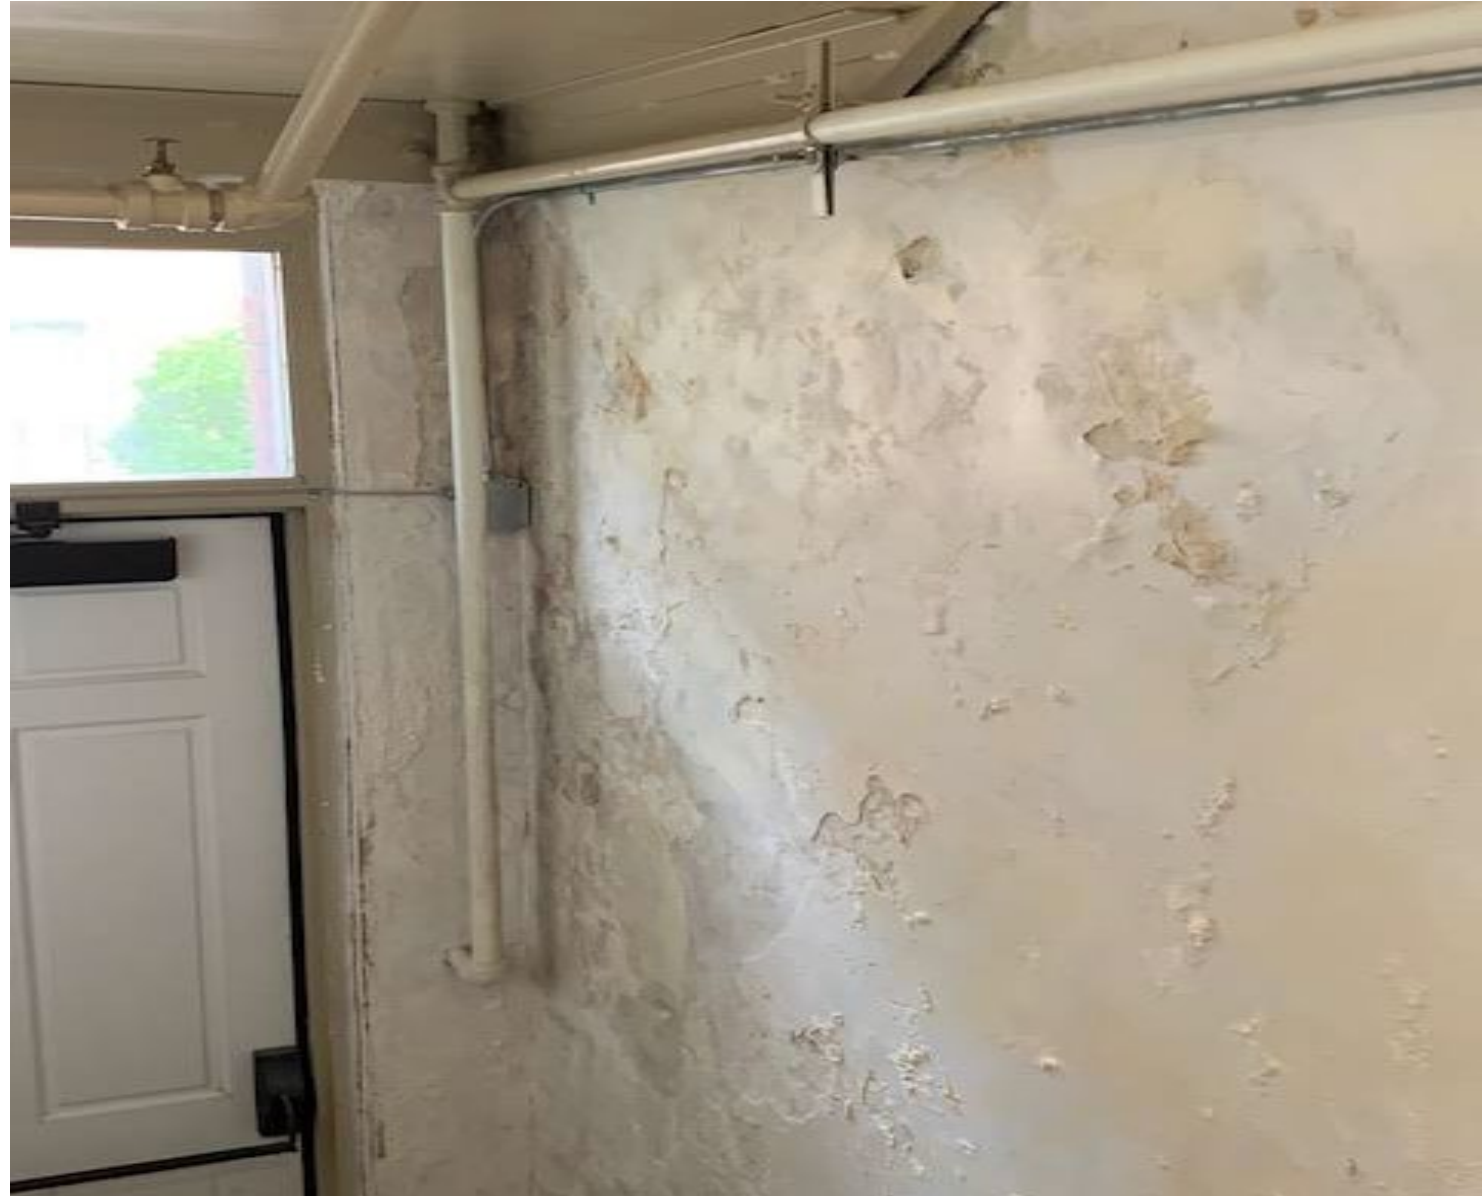
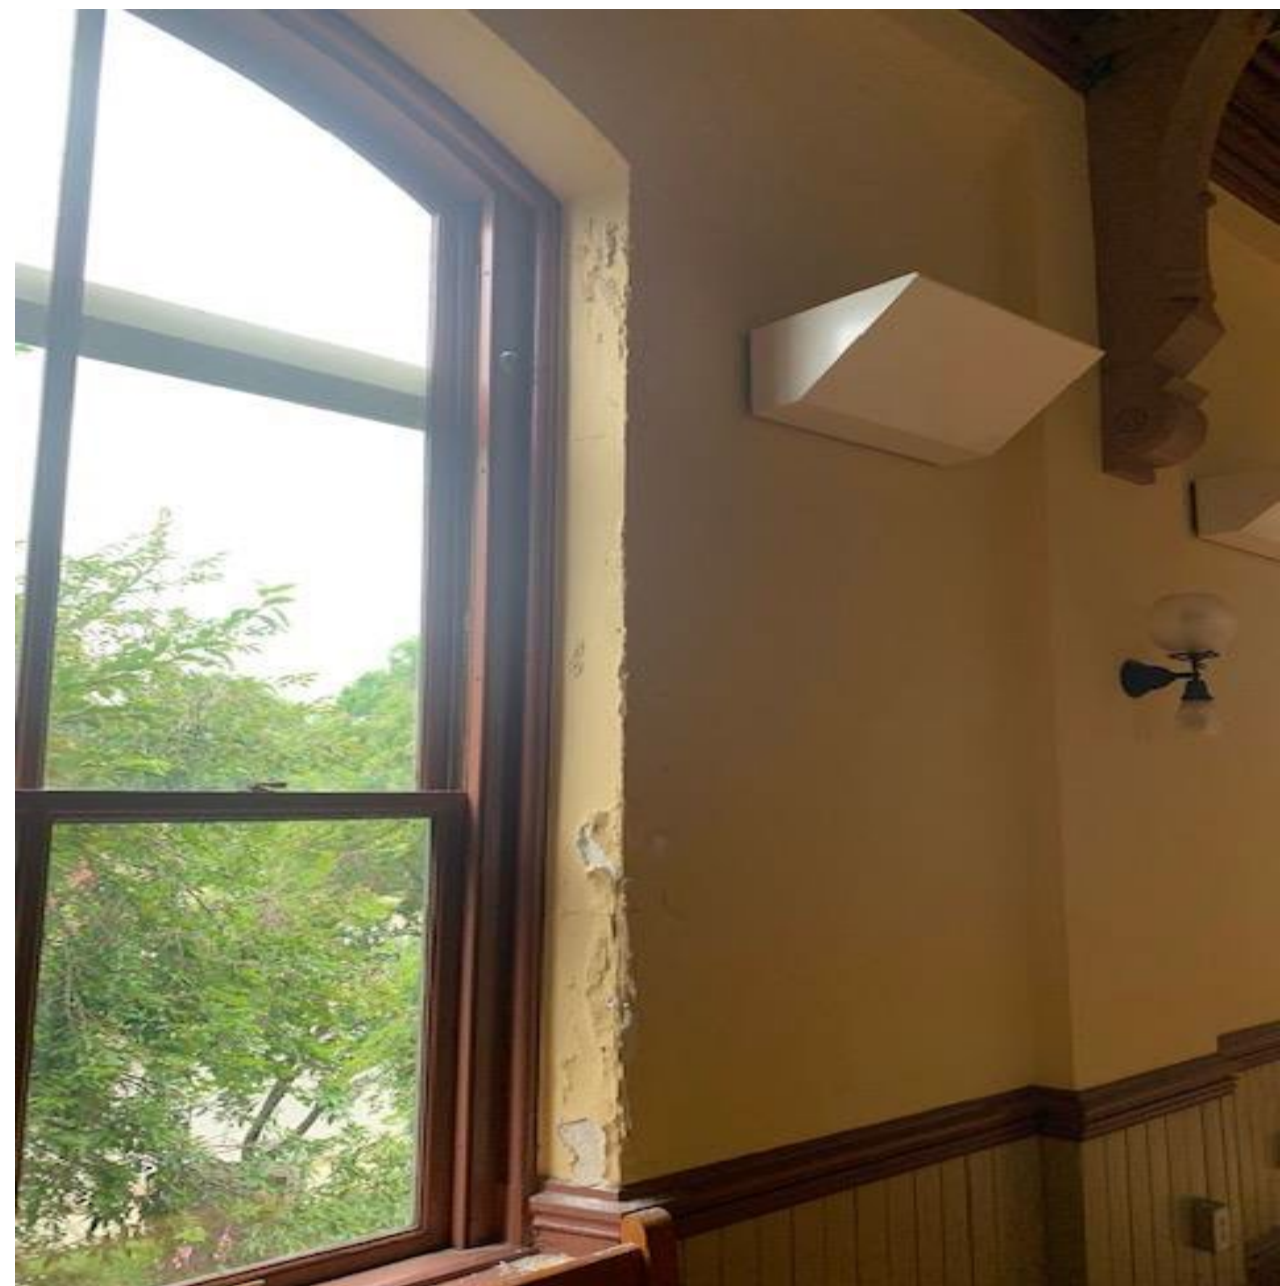
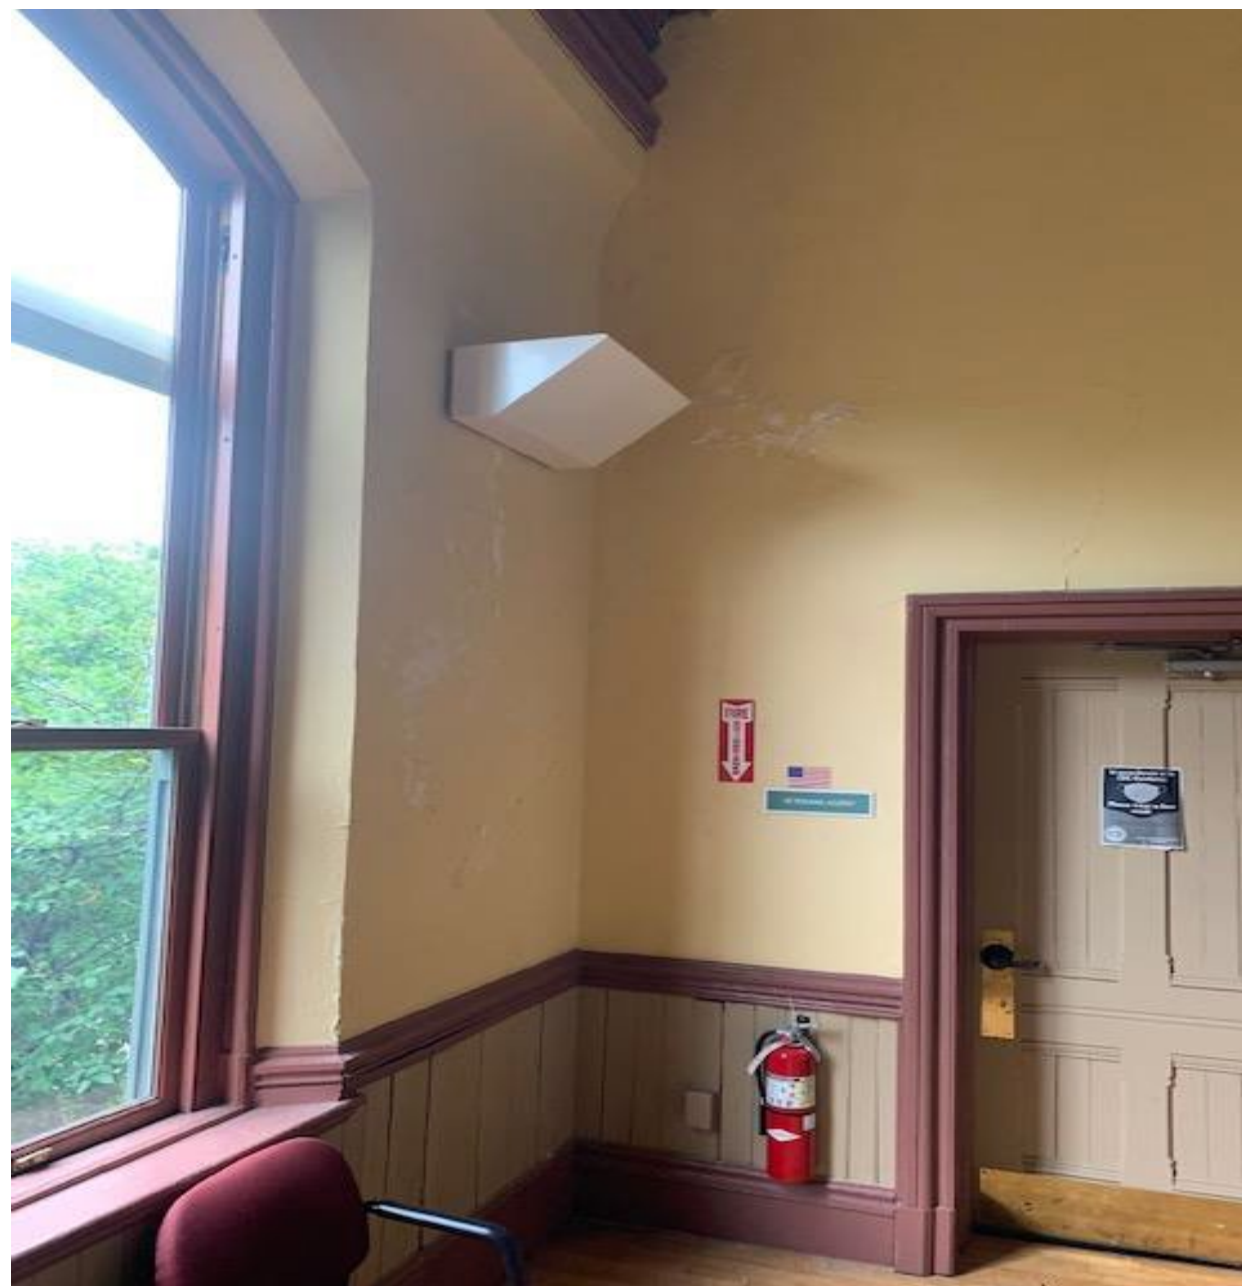
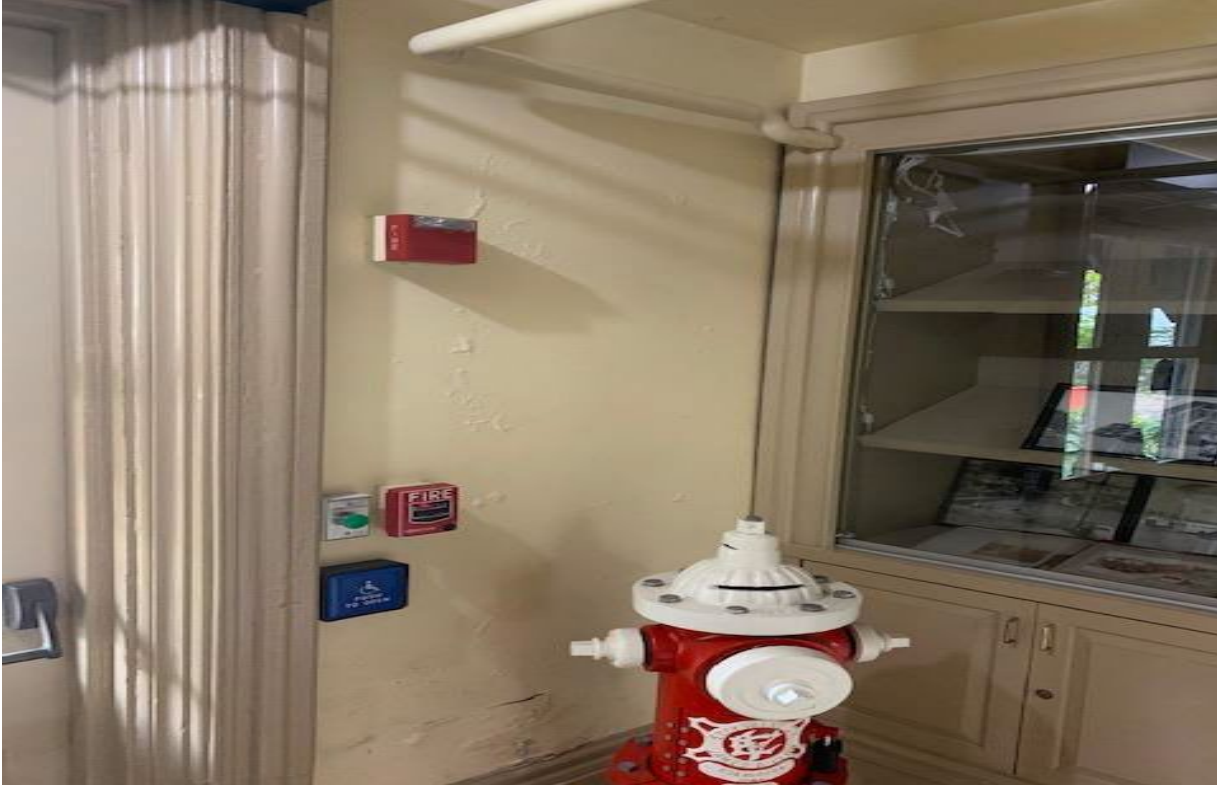
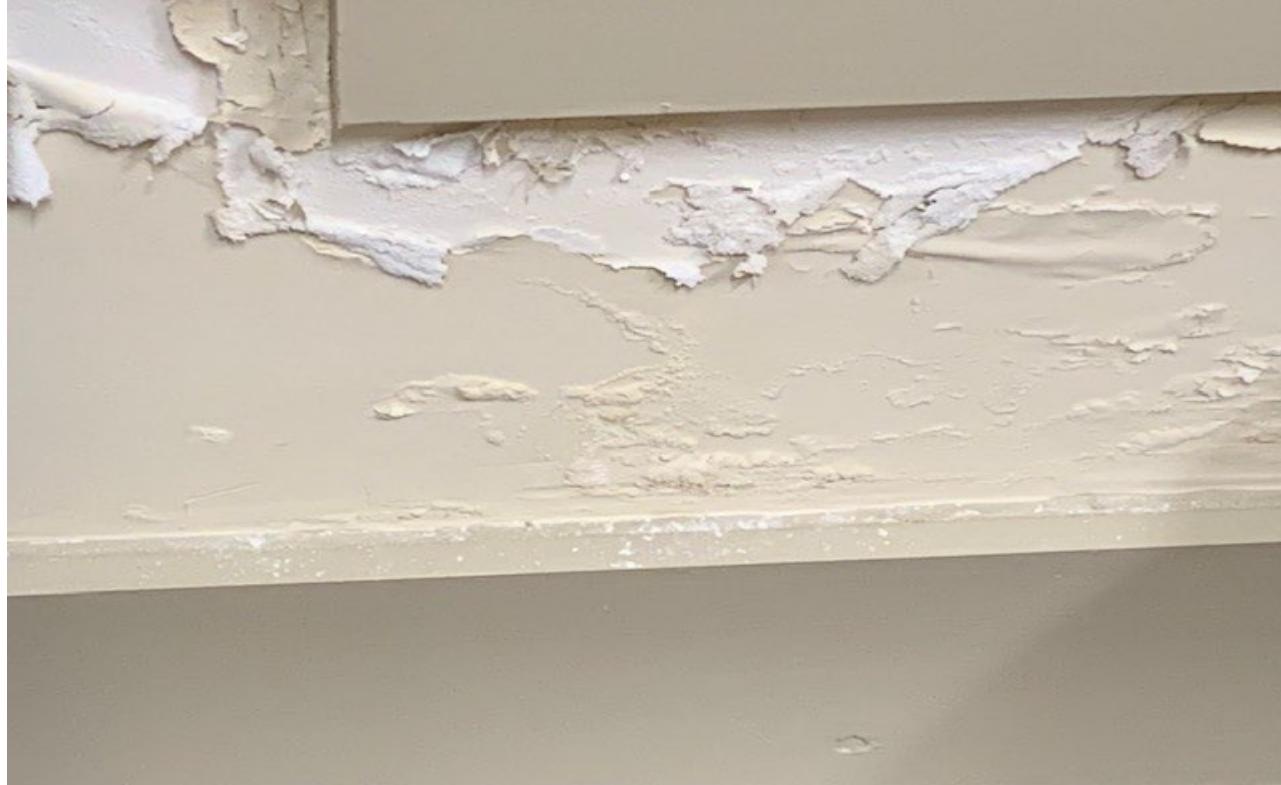
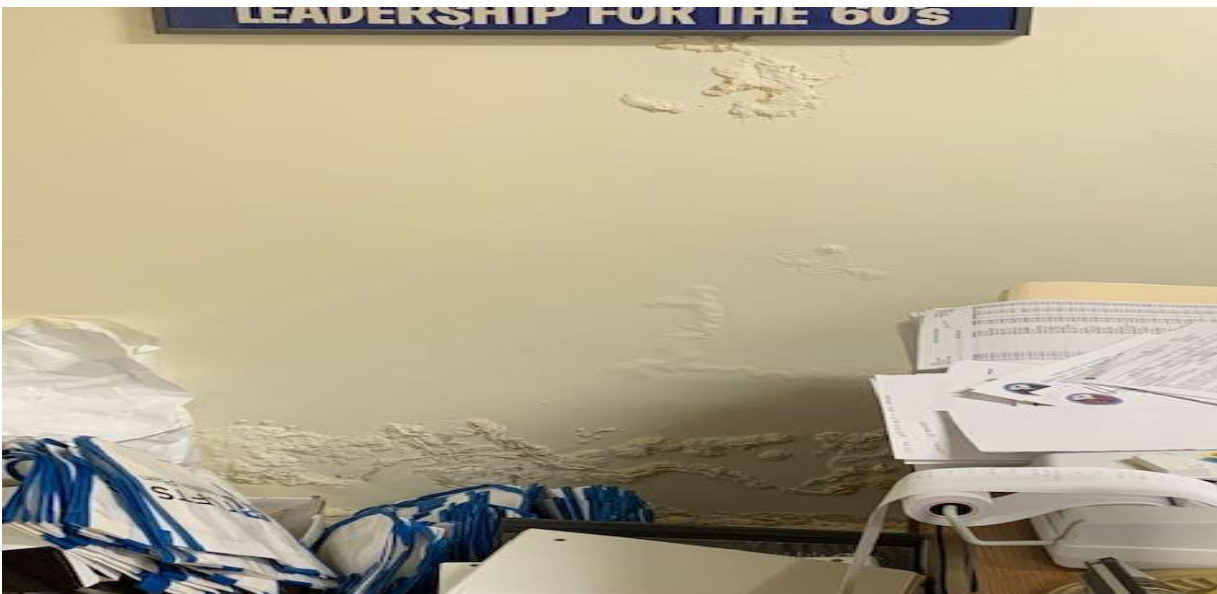
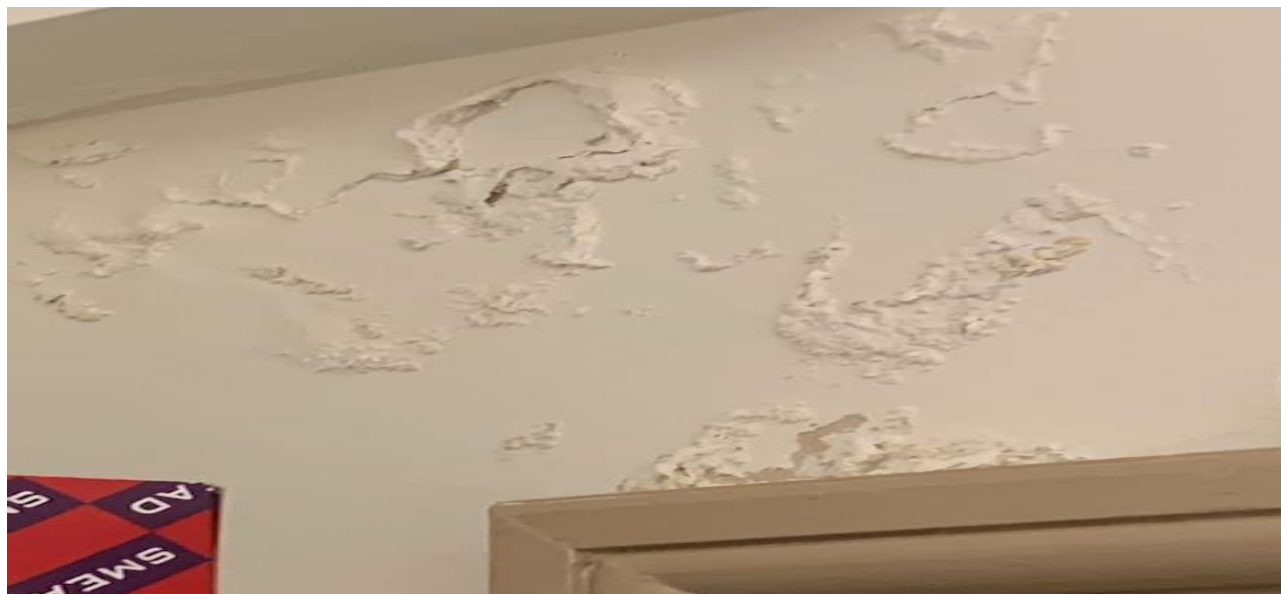
Repairs

- (4) The repair budget within this funding request will repair the three most damaged interior walls (Great Hall Columbia Street front corner, Bottom of the staircase bank side exit, and the Columbia Street wall in the Great Hall). These walls moisture readings are extremely low since gutter and slate roof repairs.

- (1) As a continuation of a successful FY23 Phase 1 Gutter and Roof repair request, this funding request will be used to continue the work to repair the interior wall damage

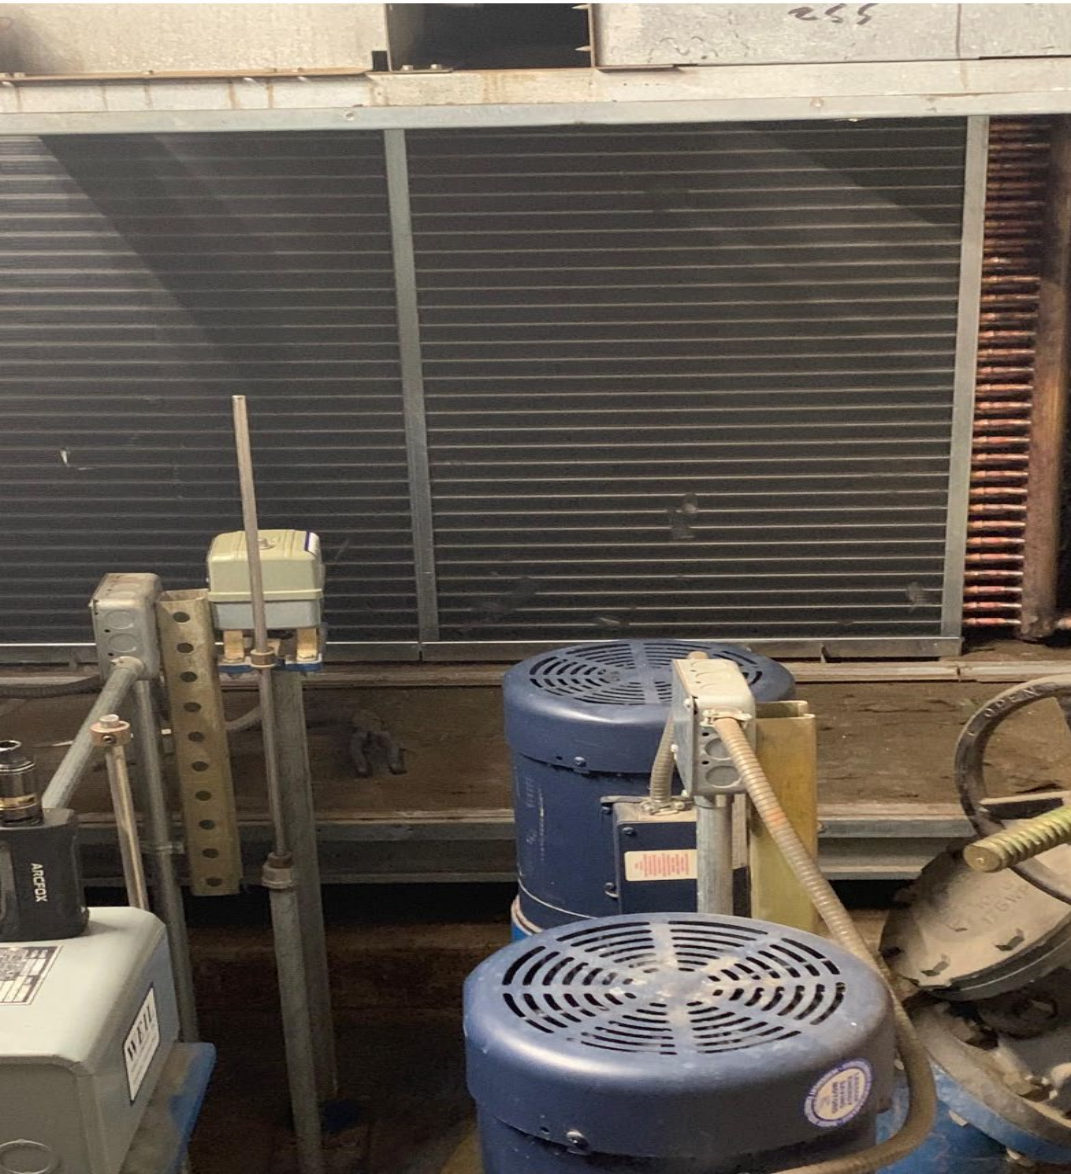
- (1) Replace failing condenser to UV-1
- (2) Continue repairs failing stand-a-lone P-Tac's
- (3) Complete any unforeseen repairs that will come about this Winter

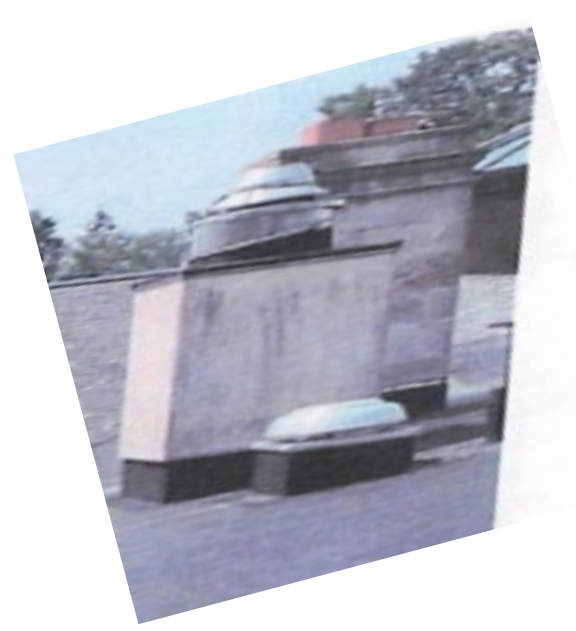
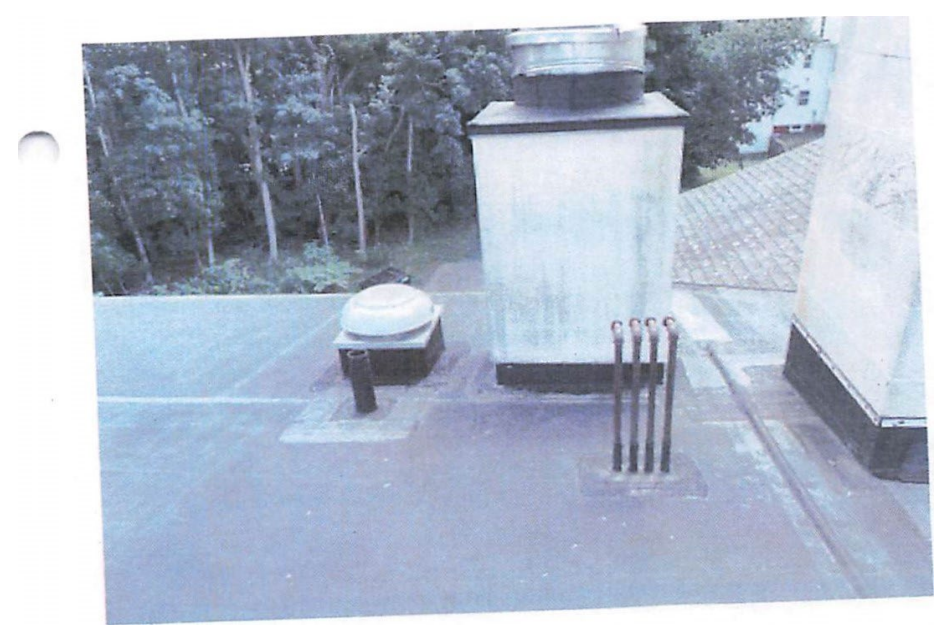
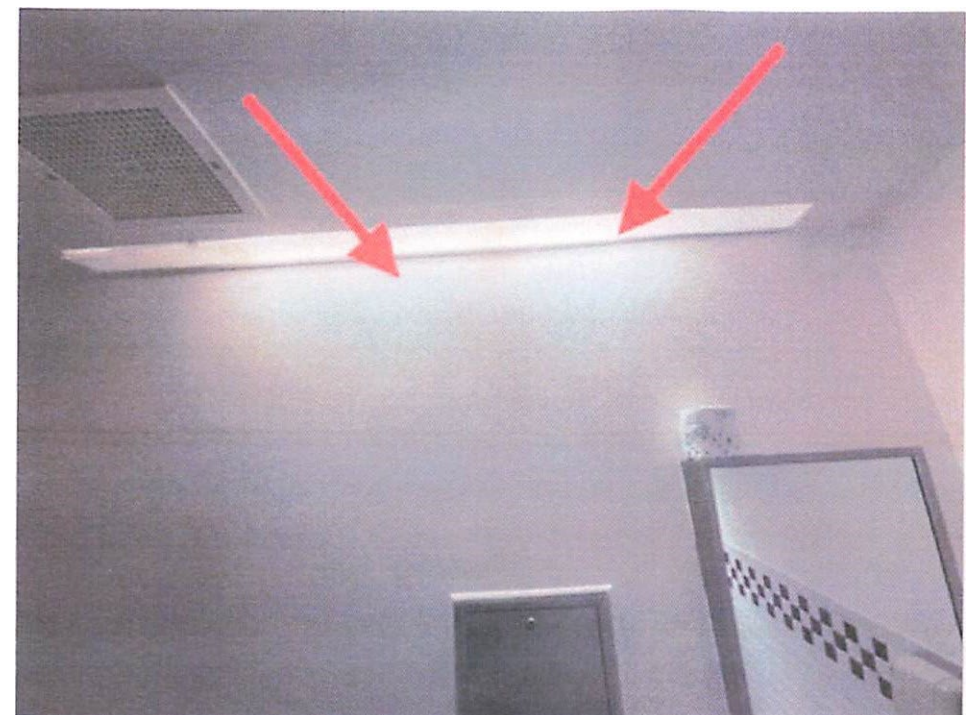
Areas of concern

- This request is to complete roof repairs around the main furnace chimney and above the Adult Reading Room
- The Facilities Department will have a roof life span audit completed, while contract completes repairs
- Damage to the equipment in either area could create catastrophic results
