Shirley Street/ West Main Street Culvert Capital Improvement Project

Shirley Street Bridge

West Main Street Culvert

Ayer Department of Public Works January 2016

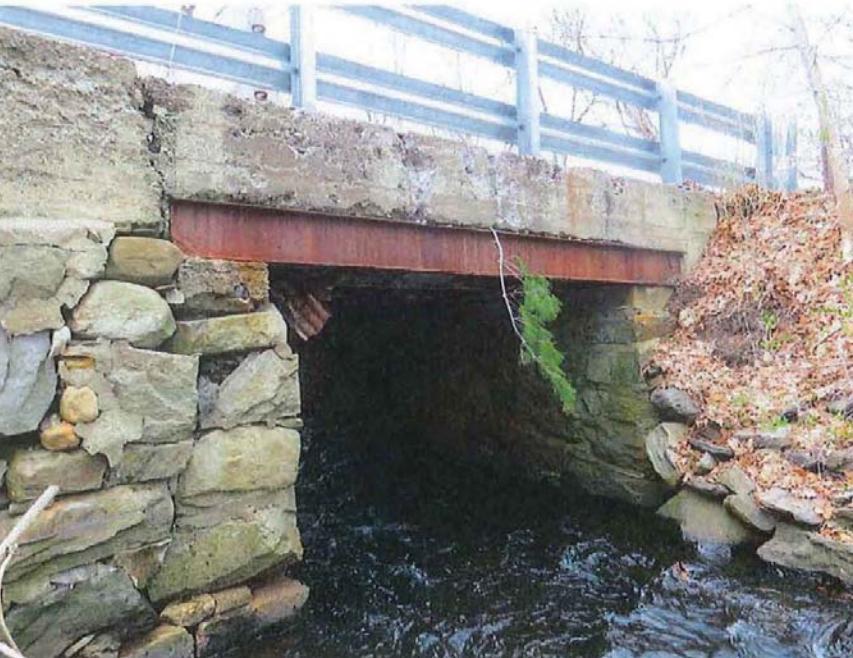
- Open-Bottom style culvert carrying Shirley Street over Nonacoicus Brook
 - Maximum span is approximately 11.5 feet
 - Width approximately 34 feet
 - Stone abutments with jackarch concrete deck
- Nonacoicus Brook is fed by Grove and Plow Shop Ponds and flows downstream to the Nashua River

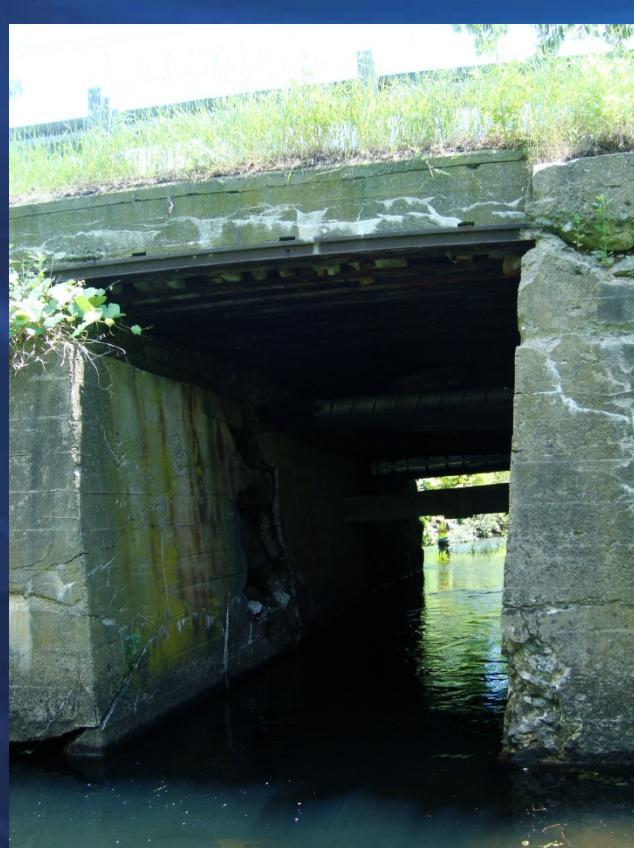
- Open-Bottom style culvert carrying West Main Street over Nonacoicus Brook
 - Span varies from 7 to 10 feet
 - Width approximately 52 feet
 - Stone abutments with railroad rail supported deck
 - Serves approximately 8,000 vehicles per day
- Approximately 130-feet downstream of Shirley Street Bridge
