CENTRAL FIRE STATION BUILDING ASSESSMENT

14 WASHINGTON STREET, AYER, MA
JUNE 20, 2012

CENTRAL FIRE STATION
BUILDING ASSESSMENT
JUNE 20, 2012

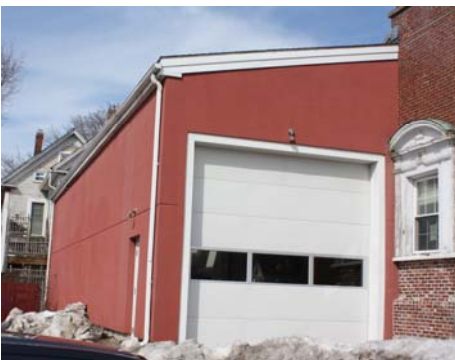
Figure 2: 1996 addition.

The 1996 addition has created half of these floor level changes, one on the first floor and two on the second floor. At the same time, the 1996 addition is the most visible to the public, from the street, and it is neither sensitive to the original architecture nor appealing on its own. It is constructed of poor quality materials and the spaces it encloses provide no views to the exterior. For these reasons, it is safe to conclude that the 1996 addition is more of a liability than an asset to future uses and, as such, is recommended for demolition.

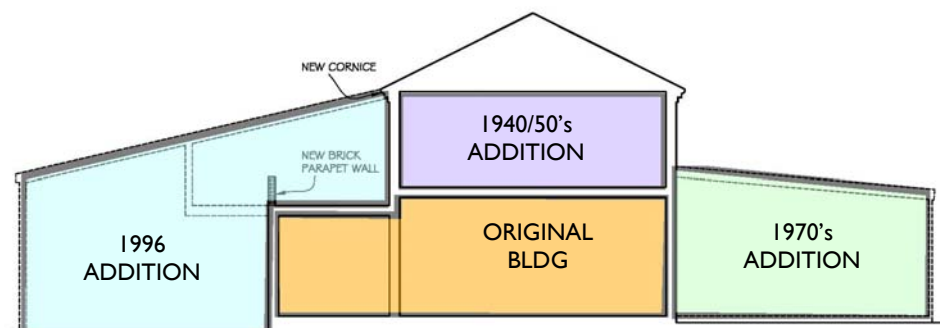
A major barrier to the usability of the building is the level changes on both floors. (See Figure 5.) The 1940/50's

Figure 5: Building section showing additions.

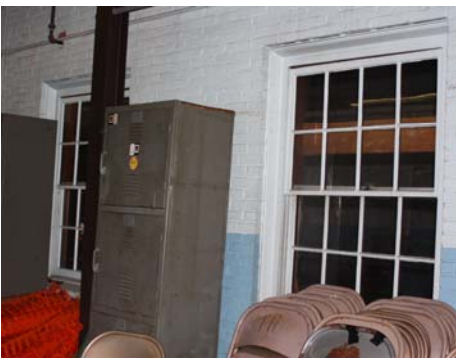
Figure 8: Restoring original windows will bring natural light into building.

On balance, then, it may be more prudent to also demolish this section of the building so that the original brick wall and window openings on the north side of the apparatus bays can be restored. (See Figure 8.) With the 1970's addition removed, the building would be reduced to just under 5,200 GSF.

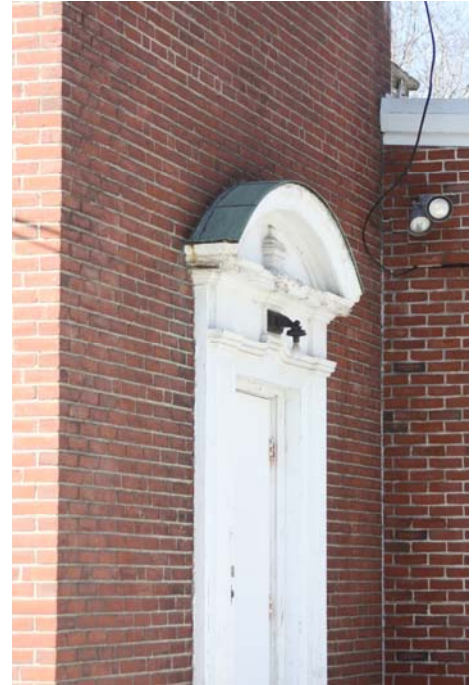
Figure 11: Decorative door mantel.

Complete removal of window components down to existing masonry openings is recommended. Existing window sills have horns that extend into the surrounding brick. (See Figure 10.) These should be replaced with a non-wood material. Cast stone sills would be durable and a good match to the parapet copings. To replace the vinyl windows, new aluminum clad wood units are recommended to provide a maintenance-free exterior and a historical appearance. Some of the more elaborate wood casings, such as the arched door pediments on the north and south sides, should be carefully restored or replicated in either PVC, polyurethane, or cedar. (See Figure 11.)

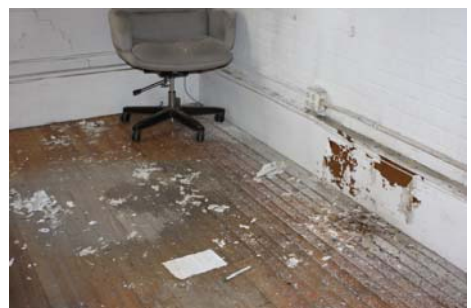
Figure 17: Wood strip flooring.

historical materials, practicality should reign. Wood flooring is difficult to maintain, particularly in a space that might be frequented by the public.

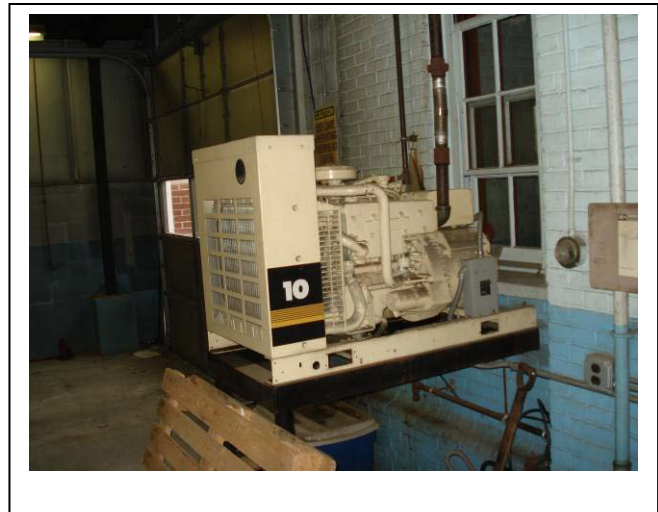
10 KW Stand-by Generator

Due to the age, condition and specific fire station design of the electrical system, plus the fact a single phase generator cannot be easily adapted to a three phase building, we recommend the entire electrical system be replaced.
