AYER-SHIRLEY REGIONAL SCHOOL DISTRICT

Elementary Schools Facilities Assessment

April 6, 2018

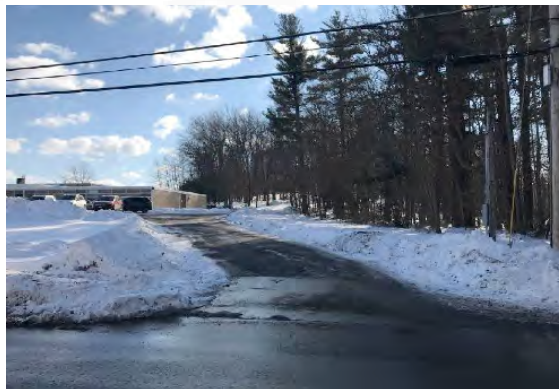
Approach to Page Hilltop

There exist four (4) curb cuts servicing the site from the south side of Washington Street. Heading eastward, the first curb cut accesses a faculty parking lot on the west side of the existing building. The next curb cut is access-only, and services the front entrance of the school where bus drop-off and visitor parking occur. This one-way loop exits the site from an egress-only curb cut shared by a one-way circulation faculty parking lot. The final curb cut is a shared access drive between Page Hilltop Elementary School and Ayer-Shirley Regional High School. This two-way drive separates the two school campuses and leads to the rear of the school. Vehicles for student drop-off bear right to the designated drop-off area near the parking and secondary entrance. Vehicles for faculty, staff and visitors continue into the rear parking areas. The pavement condition of the vehicular entrances and interior circulation system ranges from fair to poor throughout the site. There little evidence of repaving operations.

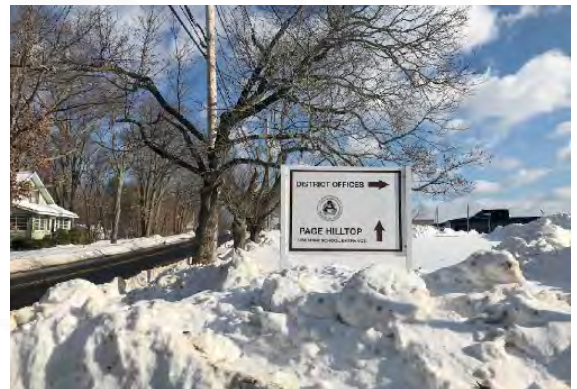
Page Hilltop Elementary signage

The site signage is adequate, with some of the sign faces showing heavy wear and are becoming difficult to read. No bicycle racks, benches, tables or trash receptacles were observed around the perimeter of the building.

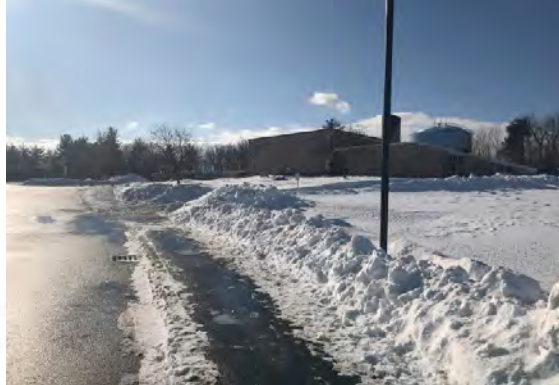
Pedestrian sidewalk

There exists a bituminous concrete sidewalk that runs along the south side of Washington Street. This intersects with a connecting bituminous concrete walk which leads to the main building entrance. A bituminous concrete sidewalk lines the perimeter of the building on the east side. A concrete ramp and stairs lead to the secondary school entrance. There is no walkway that completes the connection around the entire perimeter of the building. The condition of the bituminous sidewalk pavement throughout the site should be characterized anywhere from fair to poor. The remaining doors on the building all open directly onto parking areas or onto concrete courtyards.

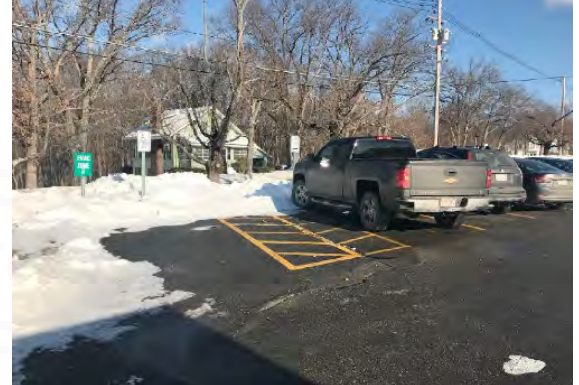
Pedestrian accessibility

accessible parking spaces are located in the northeast parking lot closest to the building entrance. The parking spaces, signage, access aisle and accessible route all do not appear to comply with current MAAB standards. Two (2) accessible spaces are located in the southeast parking lot adjacent to the concrete ramp leading to the secondary entrance. The parking spaces, signage, access aisle and accessible route all do not appear to comply with current MAAB standards. All of the curb cut ramps on the site do not appear to comply with MAAB standards, with the exception of one, which appears to have been part of the high school construction. Most of the existing doors leading into the building appear to be MAAB compliant.

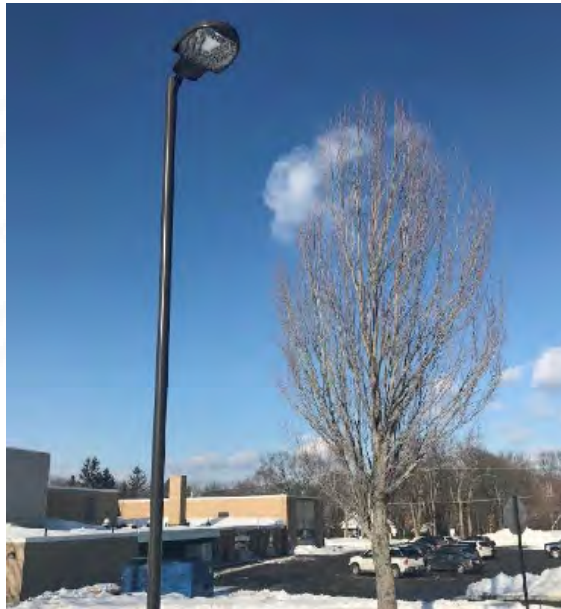
Lighting near pedestrian sidewalk

Exterior wall-mounted or overhead-mounted lighting exists at most entrance doors to the building. The parking areas are predominantly illuminated by wall mounted lights. The shared access road is lit with pole mounted LED light fixtures, which appear to have been part of the High School construction.

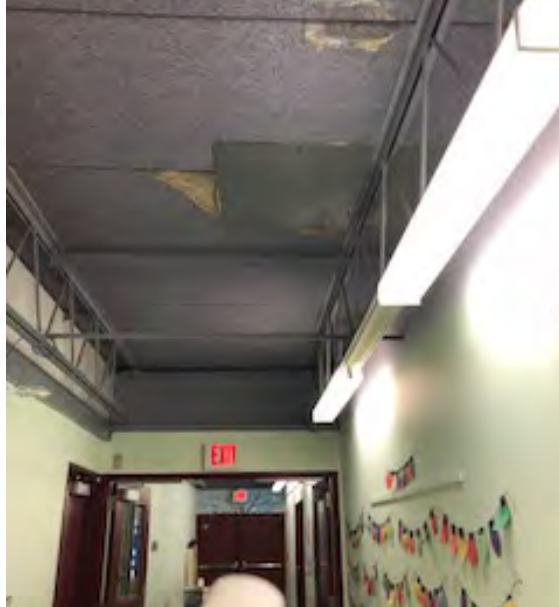
Ceiling in hallway

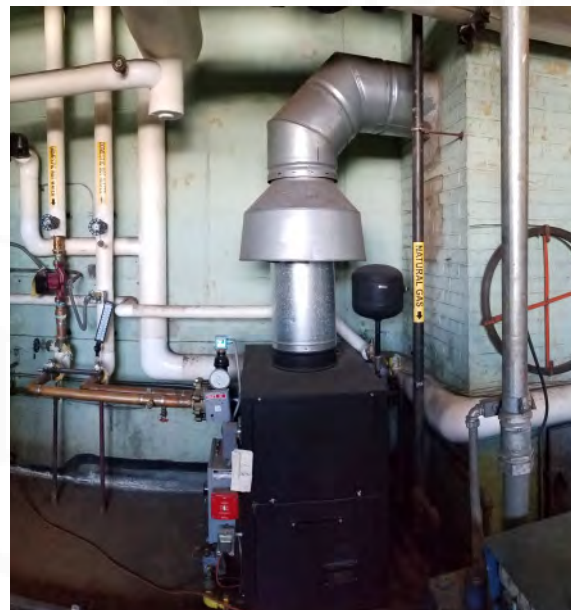
Piping system

The steam piping system serving the Page portion of the school is original to the building (1964) and is fraught with issues. Some of the steam piping is buried under the slab-on-grade to route to the various unit ventilators served. This piping fails on a regular basis requiring slab excavation

to repair the piping. The hot water piping is a combination of steel and copper piping with mixed ages from original equipment (54 years) to recent repairs and modifications. The steam piping is steel and a portion is original to the Page School with sections replaced/repared through the years. All of the piping systems should be viewed as dated, operating well past the expected service life of 40 to 50 years.

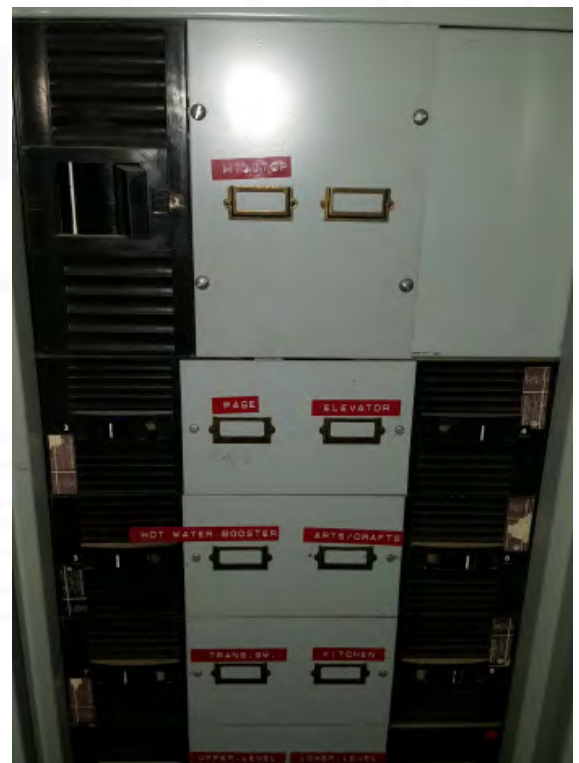
The main electric serviced equipment appears to be in fair condition, although there are no signs of routine maintenance or testing. Power distribution throughout the school is supported by various equipment manufacturers and vintages based on when each section of the school was built. Part replacements for much of the electrical equipment requires procurement of reconditioned after-market materials due to their age. Most all the electrical distribution is operating beyond its expected useful life.

Electrical panel

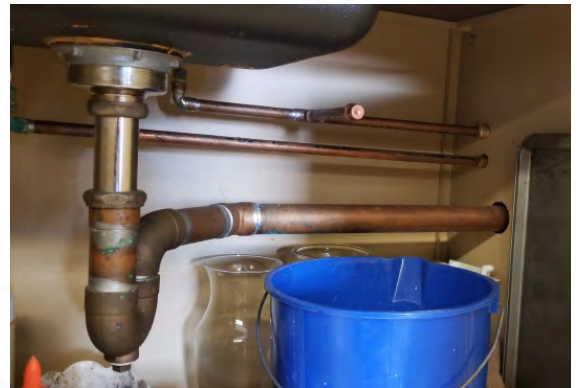
Sink in classroom

Most plumbing fixtures seen are in working condition. In general, the fixtures appear to have served their useful life. As far as water conserving fixtures, their use is governed by provisions of the Plumbing Code. Essentially, the code does not require that plumbing fixtures be up-graded, but where new fixtures are to be installed, as may be required by other codes or to address other building concerns, new fixtures need to be supplied with lead free water piping systems. However, in general all new compliant fixtures are recommended.

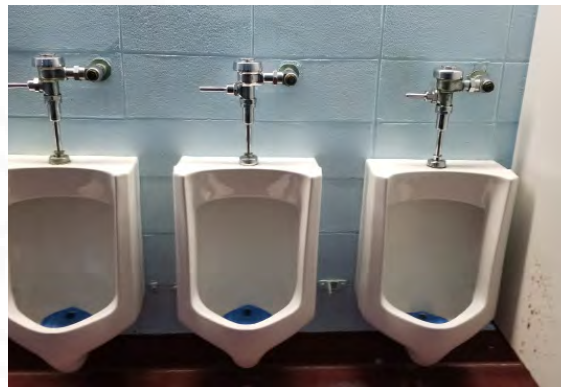
Urinals in restroom

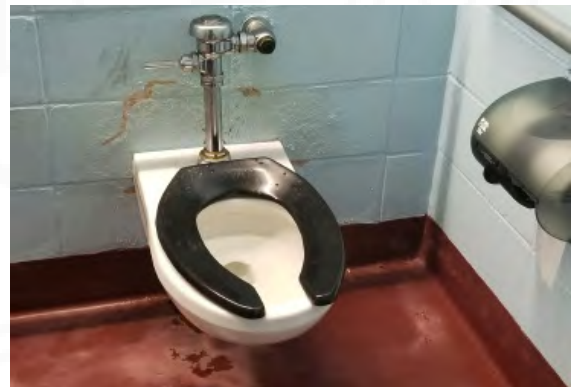
Toilet in restroom

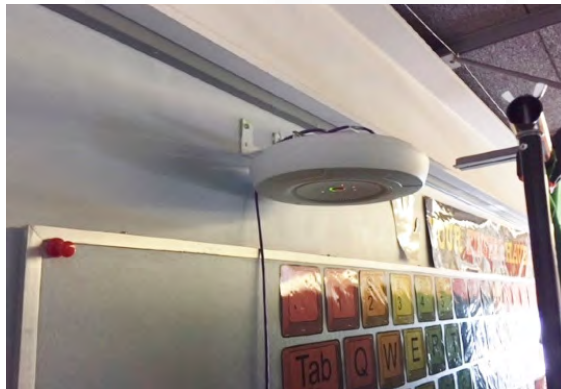
Each school has several IDFs. The IDFs are not dedicated spaces, but wall mounted racks and/or cabinets in existing classrooms, offices or storage spaces. These spaces do not have adequate power or environmental treatment. The MDF and IDFs are connected via fiber backbone. Horizontal cabling for data and voice from the MDF and IDFs to endpoints is Category 5. A substantial amount of cabling at Lura A. White is run exposed with below ceiling penetrations.

AP Installation

Any future project should include the installation of horizontal cabling based on current standards at the time of design and dedicated MDF/IDF rooms with proper power and environmental treatments.

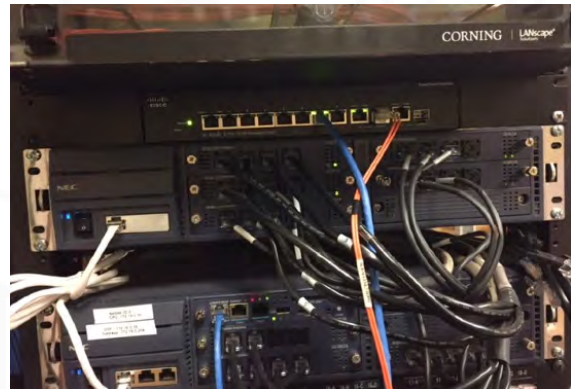
NEC phone system in MDF rack

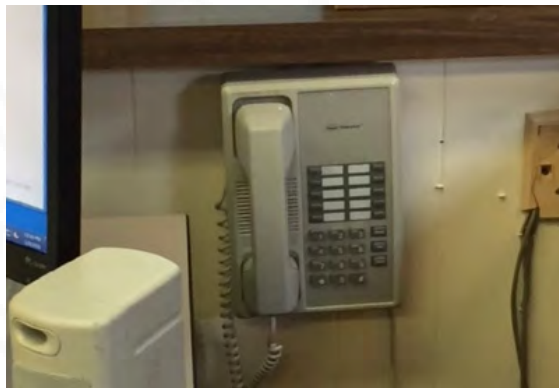
The Intercom systems at each facility are only partially functional and consist of various disparate parts that have been integrated over the years. Classrooms are equipped with two-way speakers, secondary clocks and call buttons. Much of the equipment is no longer functional. Many spaces are using battery operated clocks that are not synchronized. Bell system in not functional. Classroom speakers and call switches are original. Many of the speakers at each school are non-functional. All of the call switches at each school are non-functional. The corridors at Lura A. White do not have any intercom speakers at all. All classrooms depend on the classroom phones to initiate communication with the front office. The intercom main equipment is located in the Main Office of each school. Master clock systems at each school are non-functional for the most part. Any future project at either school should provide a new intercom and master clock system based on current technology and include redundant communication from all classrooms to the Main Office. New systems should be integrated with, but not dependent upon the phone system for functionality.

Intercom interface

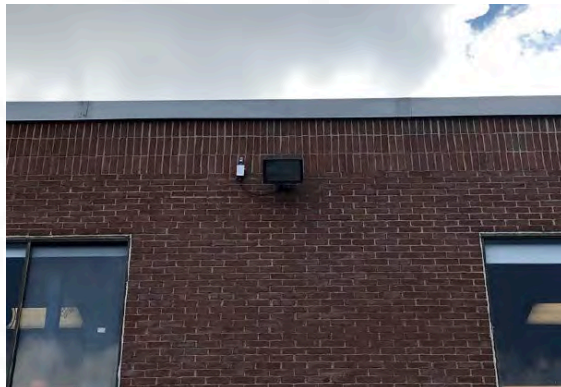
Exterior wall-mounted or overhead-mounted lighting exists at most entrance doors to the building. The parking areas are predominantly illuminated by pole mounted lights.

Lighting on side of school

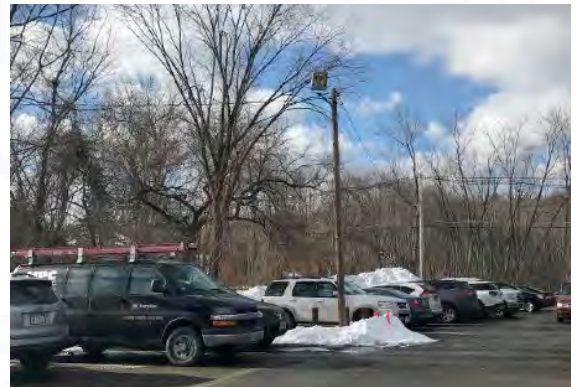
Lighting in parking lot

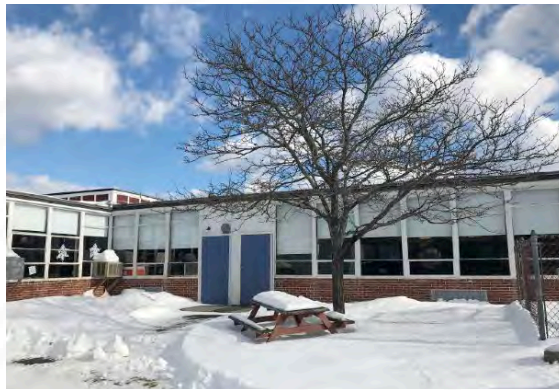
Site vegetation includes mature deciduous trees throughout the north and west sides of the building. Mature shrub plantings are found to the north of the building as well. There also exist formal lawn areas to the north and west. The condition of the site vegetation ranges from good (deciduous and evergreen trees) to fair (shrub plantings).

Vegetation near congregation areas

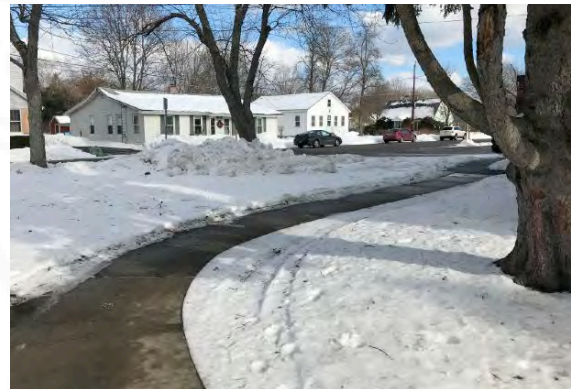
Vegetation lining pedestrian sidewalk

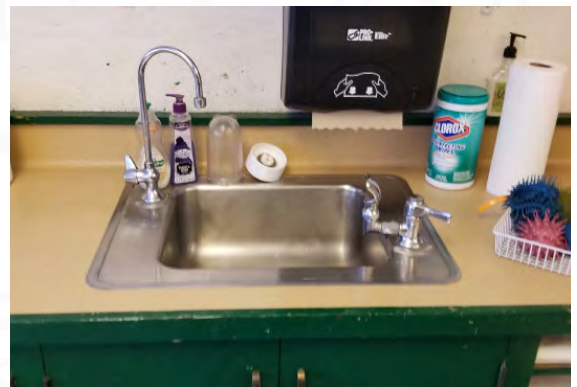
Typical sink in classroom

Most plumbing fixtures seen are in working condition. In general, the fixtures appear to have served their useful life. As far as water conserving fixtures, their use is governed by provisions of the Plumbing Code. Essentially, the code does not require that plumbing fixtures be up-graded, but where new fixtures are to be installed, as may be required by other codes or to address other building concerns, new fixtures need to be supplied with lead free water piping systems. However, in general all new compliant fixtures are recommended.

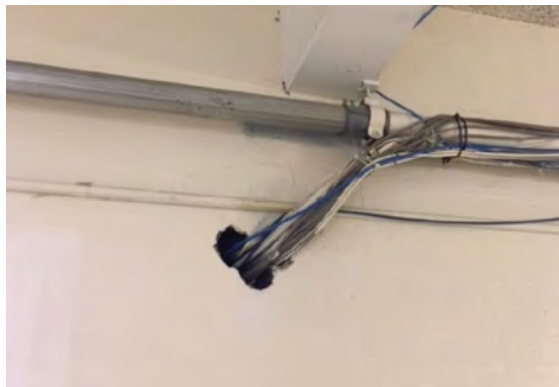
The wireless hardware at each school is Xirrus 802.11ac. Most of the APs were installed relatively recently and are based on current standards. Most APs within the schools are mounted based on availability of data outlets because of the difficulty in adding cabling due to building/ceiling conditions. Many are in less than ideal locations. Network hardware consists primarily of Extreme Networks (District Standard) Gigabit PoE switches. It is a relatively flat network, with VLANs configured for the wireless network.

Corridor cabling

Any future project should provide updated networking hardware for the MDF and IDFs based on current technology and expand upon the wireless infrastructure with special attention paid to coverage and bandwidth.

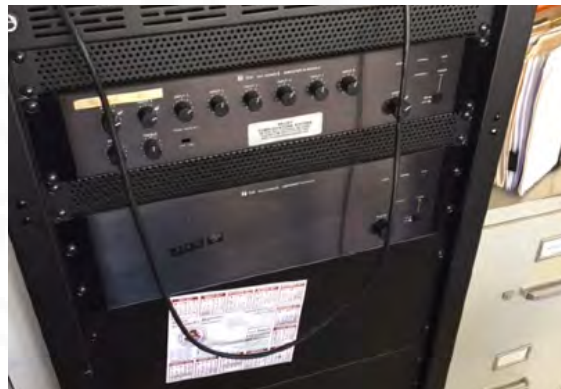
The Intercom systems at each facility are only partially functional and consist of various disparate parts that have been integrated over the years. Classrooms are equipped with two-way speakers, secondary clocks and call buttons. Much of the equipment is no longer functional. Many spaces are using battery operated clocks that are not synchronized. Bell system is not functional. Classroom speakers and call switches are original. Many of the speakers at each school are non-functional. All of the call switches at each school are non-functional. The corridors at Lura A. White do not have any intercom speakers at all. All classrooms depend on the classroom phones to initiate communication with the front office. The intercom main equipment is located in the Main Office of each school. Master clock systems at each school are non-functional for the most part. Any future project at either school should provide a new intercom and master clock system based on current technology and include redundant communication from all classrooms to the Main Office. New systems should be integrated with, but not dependent upon the phone system for functionality.

Amplifiers and microphone

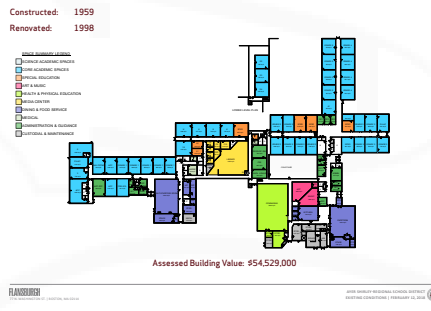
Page Hilltop Elementary School Floor Plan

- No compliant accessible route from parking lot to the main building
- Parent drop-off area is inefficient and lacks proper student safety measures
- Site vegetation in poor condition
- Pedestrian circulation bituminous sidewalk in poor condition
- Site drainage appears to be poor

- Exterior Envelope: Low R-value and masonry requires repairs
- Roof System: Low R-value, replace with proper insulation to increase R-value
- Window System: Low R-value windows throughout, replace with high performing windows
- Interior Walls: Repair and paint throughout; add acoustical treatment as needed
- Flooring Replace all flooring throughout building
- Ceilings: Replace ceilings throughout to accommodate new lighting and improve acoustics
- Door & Hardware: Systems are in various states of disrepair. Replace and provide for handicap compliant hardware
- Interior Trim: Needs to conform with NFPA Flame Spread code

- Sink locations are not handicap accessible
- Furniture is a variety of different manufacturers and vary in age
- Kitchen needs outdated cooking equipment and servery
- Lack of storage space throughout school
- Casework in fair/poor condition

- Air temperature controls are antiquated
- Ductwork no distributing air efficiently
- Air handling units have exceeded their expected maximum service life
- Update boilers to efficient fas-fired style
- Fuel oil storage not equipped with leak detection

- The existing main disconnect and fused distribution panel should be tested and replaced, if needed
- Interior lighting should be replaced
- Existing exit signs should be replaced
- All site lighting should be replaced
- Duplex outlets are sparsely located throughout and need upgrades
- Full smoke coverage required for fire alarm system
- Fire alarm devices not mounted at ADA heights
- Communications, clock, and sound systems are antiquated

- Existing water and waste piping systems have exceeded their life expectancy
- Plumbing fixtures are in fair condition and non-compliant with current codes
- No back-flow preventer on the domestic water system
- Kitchen equipment needs additional grease traps
- Water heaters nearing the end of their life expectancy

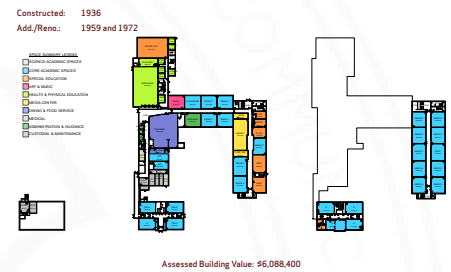
Lura A. White Elementary School Floor Plan

- No compliant accessible route from parking lot to the main building
- Parent drop-off lacks proper student safety measures
- Pedestrian circulation pavement in poor condition
- Vegetation ranges from good to fair condition

- Exterior Envelope: Low R-value and masonry requires repairs
- Roof System: Replace to increase R-value
- Window System: Low R-value windows throughout, replace with high performing windows
- Interior Walls: Repair and paint throughout; add acoustical treatment as needed
- Flooring Replace all flooring throughout building
- Ceilings: Replace ceilings throughout to accommodate new lighting and improve acoustics
- Door & Hardware: Systems are in various states of disrepair. Replace and provide for handicap compliant hardware
- Interior Trim: Needs to conform with NFPA Flame Spread code

- Sink locations are not handicap accessible
- Furniture is a variety of different manufacturers and vary in age
- Kitchen needs outdated cooking equipment and servery
- Lack of storage space throughout school
- Casework in fair/poor condition

- Automatic temperature controls & pneumatic controls antiquated
- Ductwork no distributing air efficiently
- Air handling units have exceeded their expected maximum service life
- Boilers in good condition
- Fuel oil storage lacks leak detection
- Heating piping system has exceed its life expectancy

- The existing main disconnect and fused distribution panels should be tested and replaced, if needed
- Interior lighting throughout the school is in fair condition and should be replaced
- Existing exit signs should be replaced and additional signs provided
- Duplex outlets are sparsely located throughout and need upgrades
- Emergency lighting competent to be checked and made operational
- Full smoke coverage required for fire alarm system

- Existing water and waste piping systems have exceeded their life expectancy
- Plumbing fixtures are in fair condition and non-compliant with current codes
- Lack of flow preventer on the domestic water system
- Water heaters nearing the end of their life expectancy
- Gas supply to kitchen needs hood interlock gas valve
