Stormwater Asset Management Plan

Ayer, Massachusetts

November 2022

Tighe&Bond

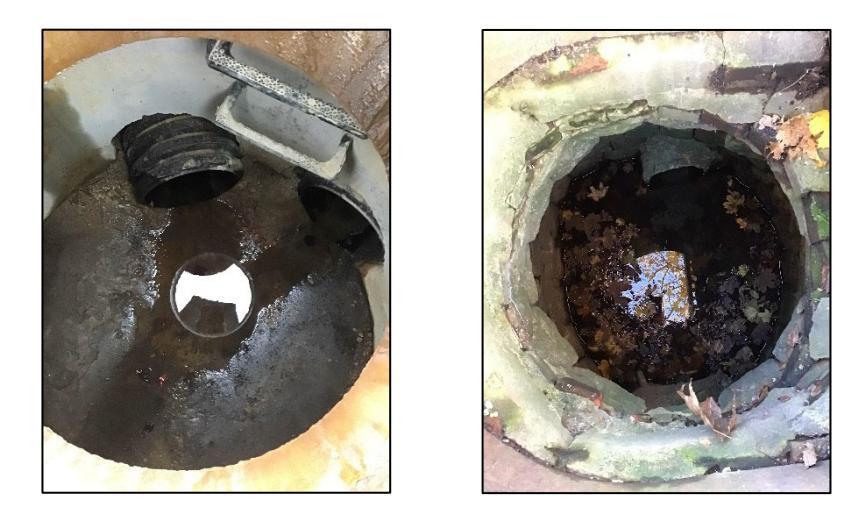
Figure 3-5 Example of a Precast Drain Manhole (Left) and Brick/Block Catch Basin (Right)

Figure 3-5, above, includes an example of a drain structure that is in good condition (the precast drain manhole on the left) and an example of a drain structure that is in fair condition (the brick/block catch basin on the right). While some repairs could be made to improve the structure in fair condition, it can still perform its intended function for the stormwater system unless the structure was undermining the roadway.

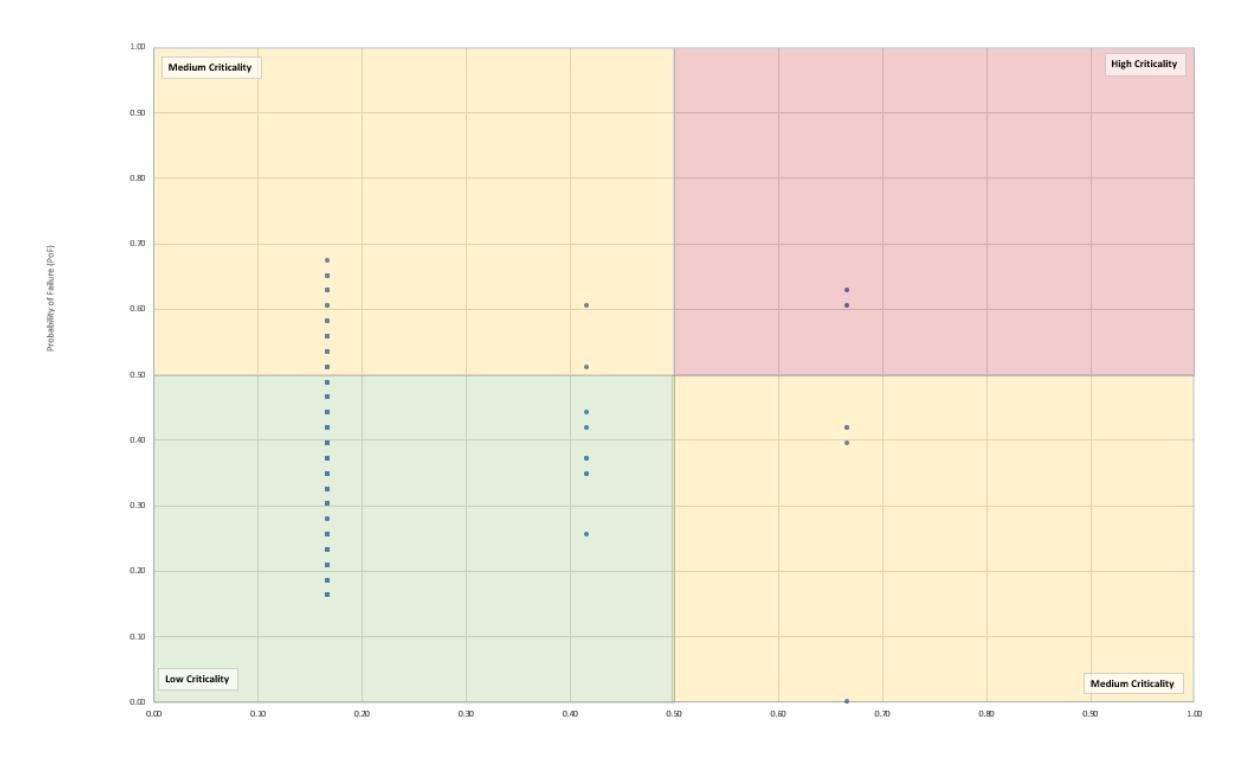
Figure 5-2 Drainage Pipe Risk Matrix

Asset risk matrices were created within Excel and the results are shown in Figures 5-2 through 5-4 below. Each asset is shown per its risk category assigned based on the Consequence and Probability of Failure. The Stormwater System Inventory and Evaluation, Attachment E, identifies the high, medium and low risk assets, and the priority ranking. Note that each dot in Figure 5-2 through 5-4 below may represent multiple assets with the same score.
